SERVICE BULLETIN

No. 445

Piper Aircraft Corporation

Subject: Fuel Cap Inspection

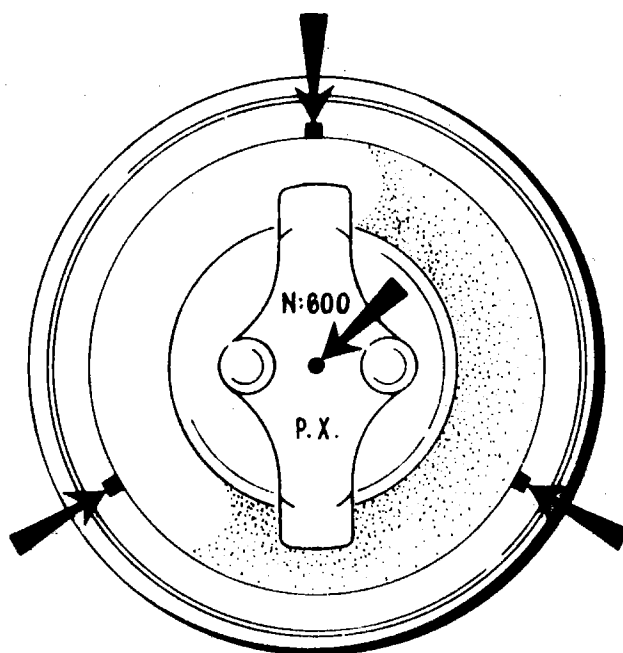
Purpose: To provide instructions to inspect the fuel tank filler caps for presence of a vent hole in the cap dome. Fuel starvation could occur if one or both fuel cap (s) are non-vented.

1. Visually inspect the fuel tank filler caps; properly vented caps will have a vent hole in the cap's center, with three (3) smaller apertures around the cap circumference. Refer to attached sketch for an illustrated description of the proper cap.
2. If proper caps are installed, no further action is required.
3. If existing caps do not appear as illustrated on the attached sketch, replace cap (s) - Reference Material Required, below.
4. Make appropriate log book entry.

Material Required: Fuel Tank Filler Cap, Piper part number 454-039; one (1) each or two (2) each required per aircraft, depending on the number of tanks installed - as required per Instructions, above.
