SERVICE BULLETIN

No. 485

Piper Aircraft Corporation

Rerouting of Rudder Control Cables.

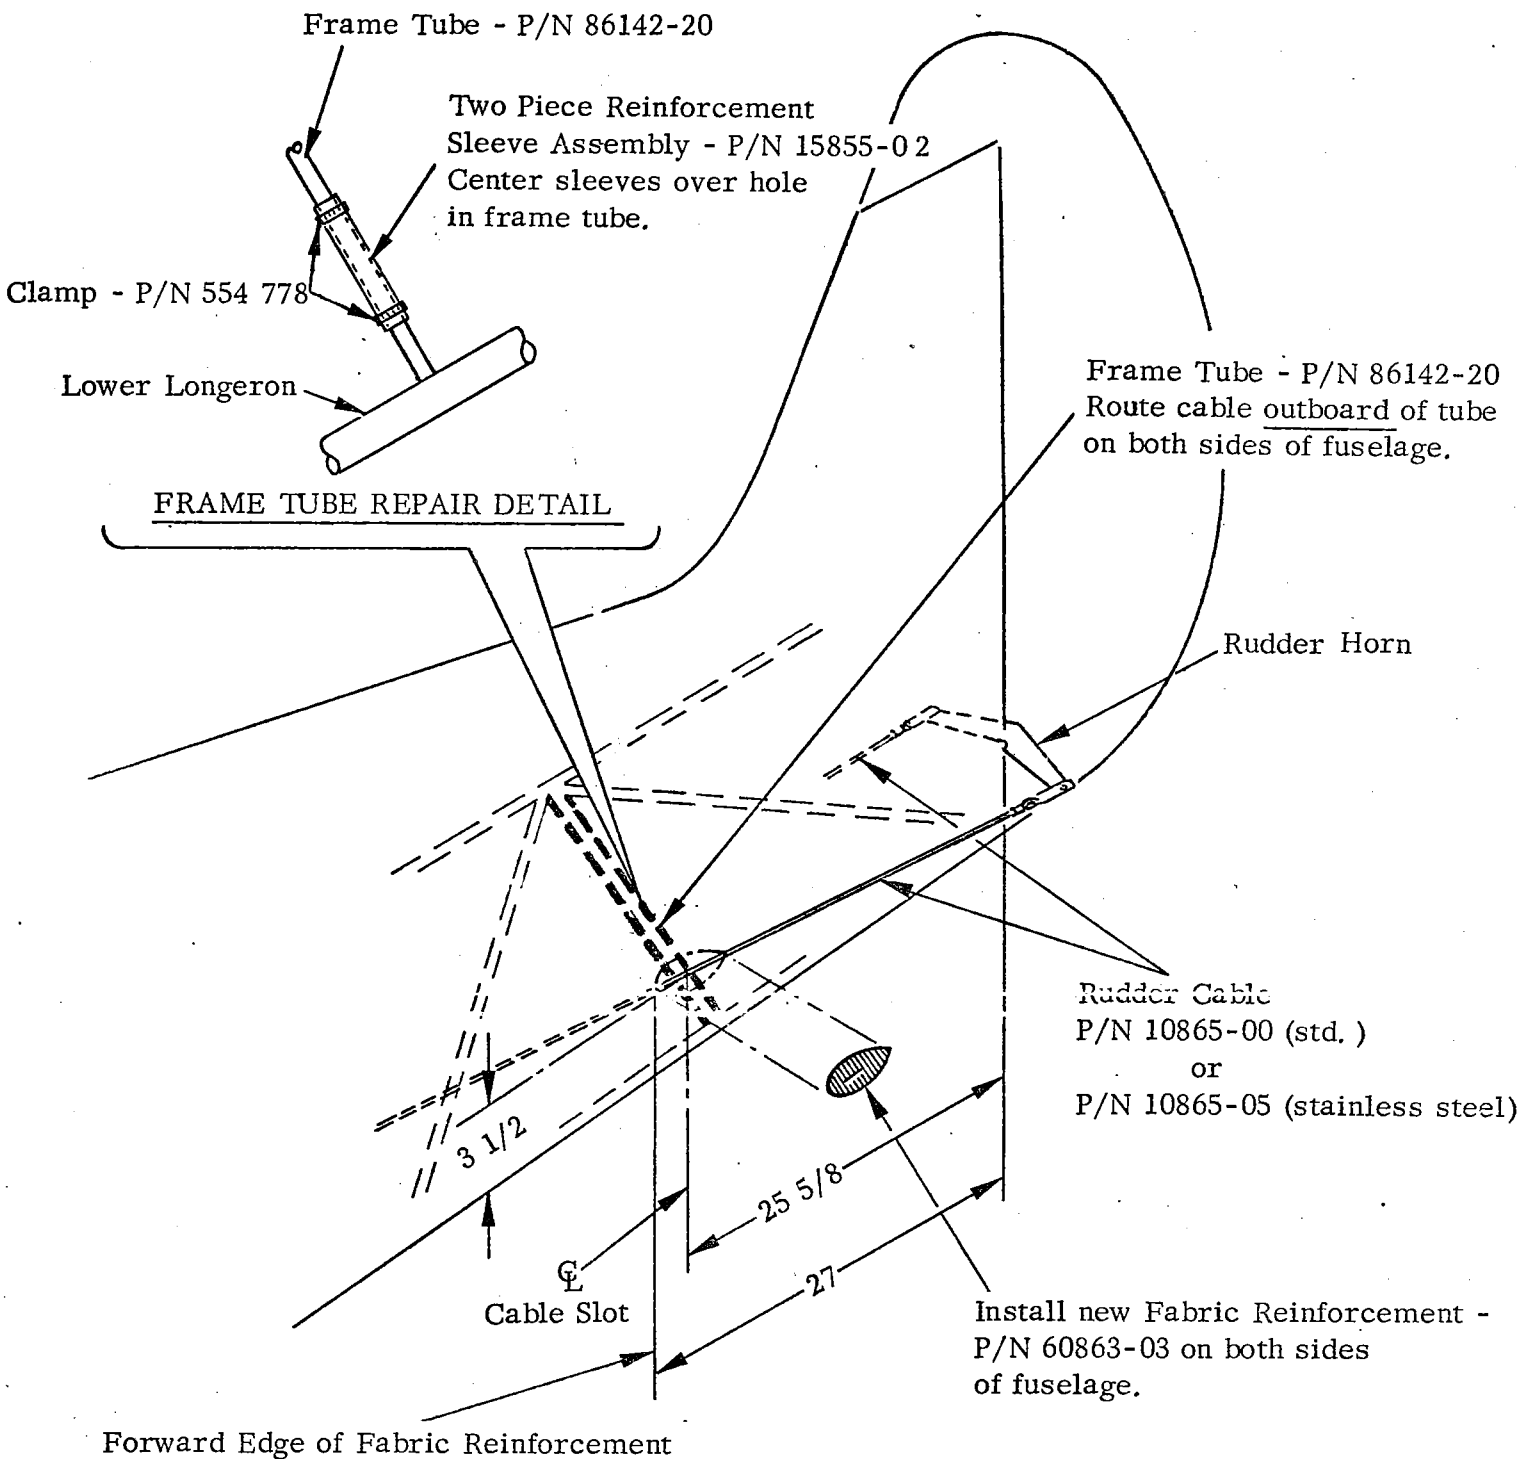
INSTRUCTIONS

Reports from the field indicate that the left and right rudder control cables were misrouted inboard of the vertical frame tubes in the optional Metal Fuselage Bottom Panels which allows the possibility of cable contact with the tubes. This condition can cause premature wear, fraying, and possible parting of the cable resulting in loss of rudder control.

1. Remove left and right rudder control cables from rudder horn at lower end of rudder post.
2. Working thru access holes in side of fuselage, pull cables back thru fabric into interior of fuselage.
3. Locate and install new fabric reinforcement P/N 60863-03 in new location on both sides of fuselage. Open fabric at reinforcement slot.
4. Reroute cables outboard of P/N 86142-20 frame tubes and out thru the slot in the new reinforcement. (Replace cable(s) if indications of wear are evident.)
5. Attach cables to rudder horn and safety.
6. Make standard fabric repair at original reinforcement location.
7. If rudder cable(s) has worn through the frame tube(s), install reinforcement sleeve assembly P/N 15855-02 as shown in repair detail above.
