# SERVICE BULLETIN

No. 759

Piper Aircraft Corporation

Subject: Exhaust muffler inspection and modification,  
Piper Part Number 12433-00, 12433-14,  
12232-00.

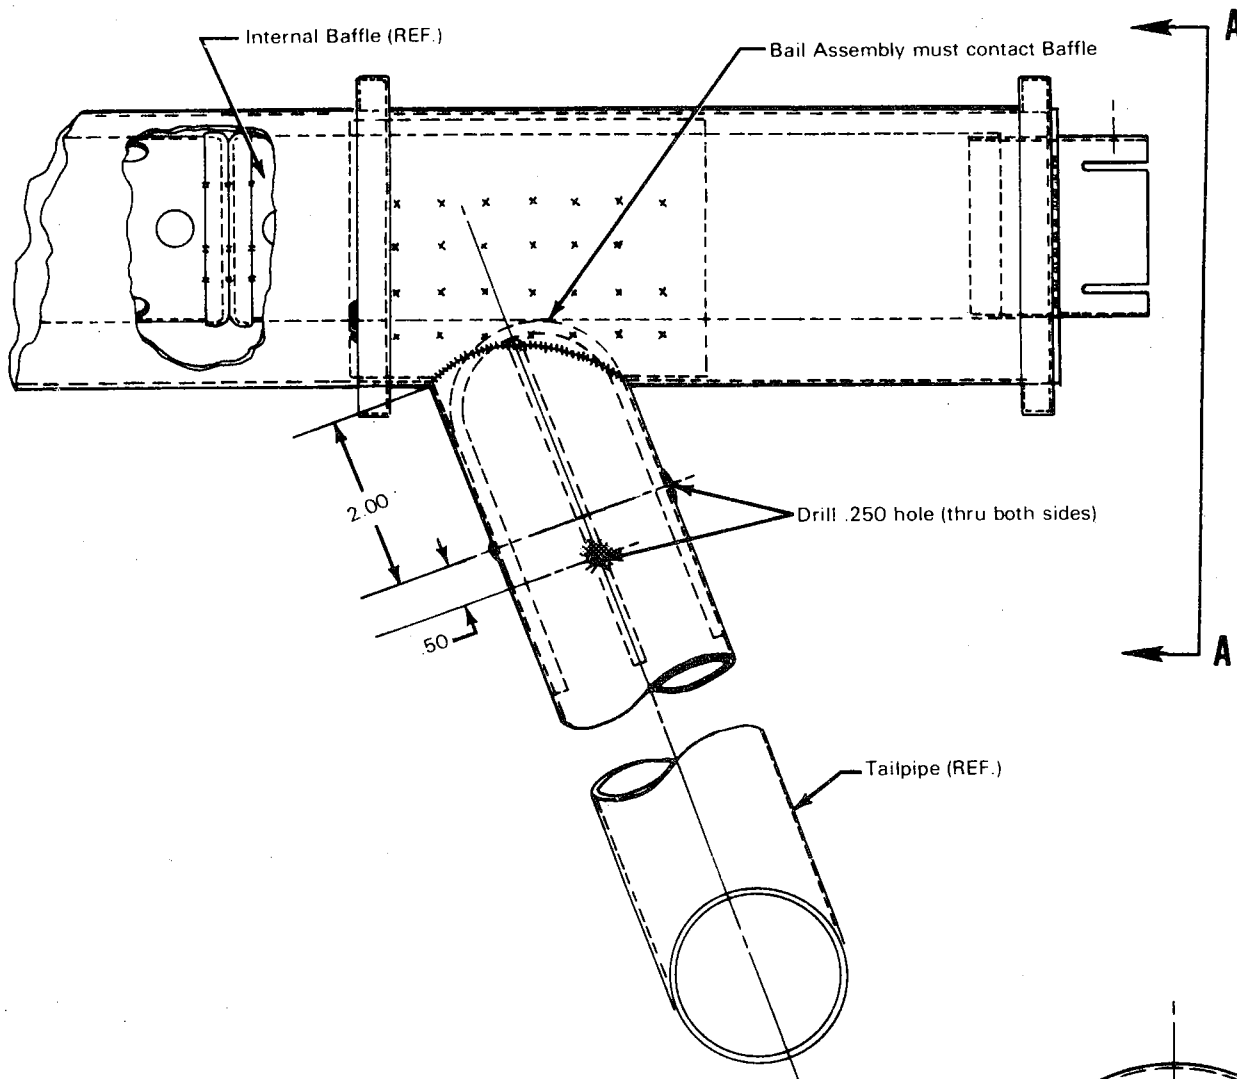
It has been determined that if the internal baffle in the mufflers of the above referenced aircraft fails, a restriction of the muffler outlet may occur. The resulting engine power loss may be enough to prevent continued flight.

7. Remove shroud from muffler assembly and comply with AD 68-05-01.
8. Drill two 1/4 inch (.250) holes through the tailpipe as shown in the following sketch.
9. Install bale assembly, Piper Part Number 452 093 into tailpipe, curved end toward the muffler until contact is made with the internal baffle. The deflector must be installed so that the opposing legs cover the four holes that have been previously drilled.

10. Rosette weld by suitable method the bale through the four 1/4 inch holes in tailpipe.
11. Reassemble muffler assembly and reinstall on aircraft. Install exhaust system components and reconnect any lines, wire, and hoses that were removed. Attach engine properly and reinstall engine cowling that was removed.
12. Make appropriate log book entry stating compliance of this Service Release.
