SERVICE No. 1020 BULLETIN

DATE: July 10, 1998

Inspection of the ARTEX 110-4 ELT and
ELT Attachment Bracket

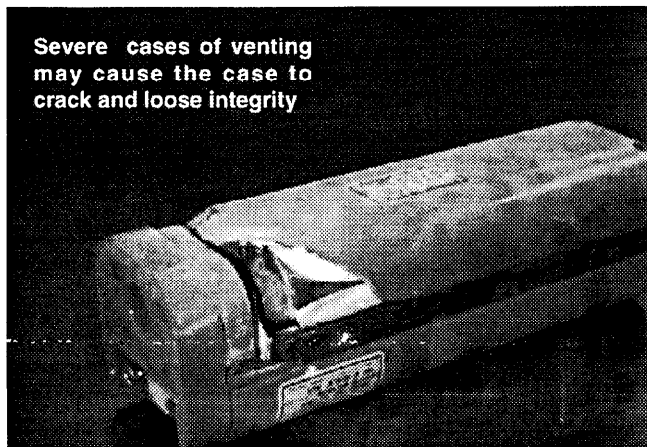
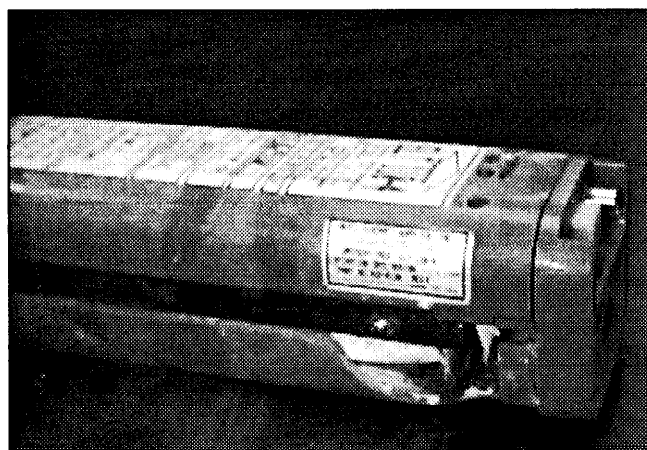
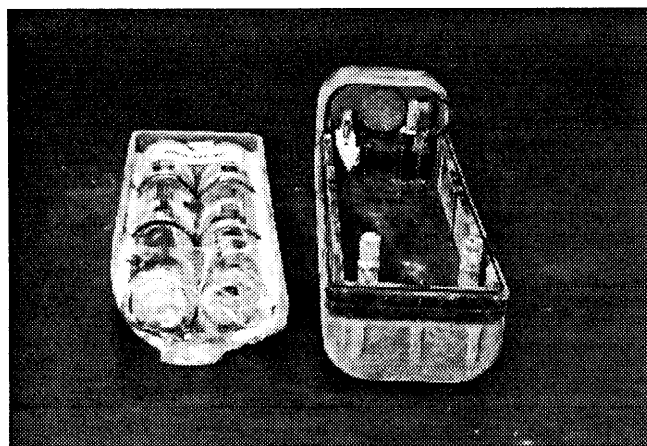
**ELT Battery Pack
(Severe Damage from Battery Venting)
REPLACE UNIT**

3. If the ELT battery pack does not pass the criteria as set forth in the ARTEX publication, the ELT battery pack must be replaced with a new ELT Battery Pack, Piper Part Number 758-696. *(See the data tag and corrosion photographs on page 3.)*

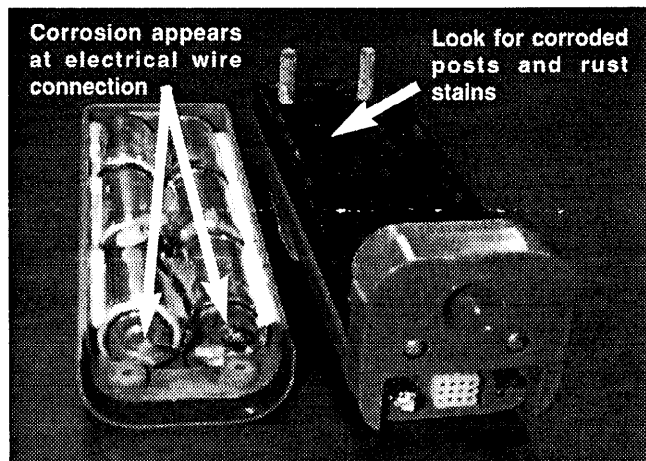
**ELT Battery Pack
(Light Damage from Battery Venting)
REPLACE UNIT**

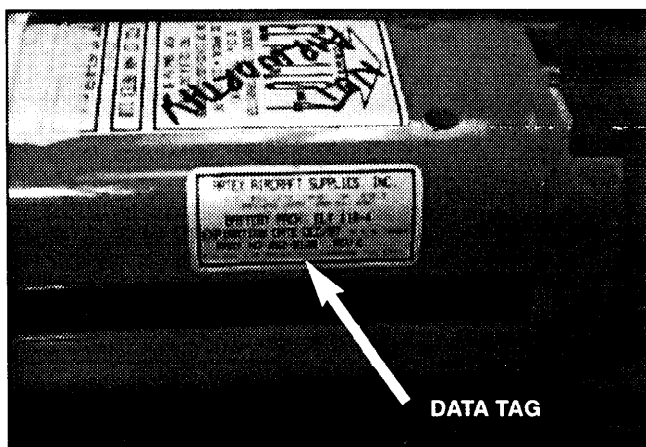
**ELT Battery Pack with Data Tag
(Identifies Unit and shows Expiration Date)
If Beyond Expiration Date REPLACE UNIT**

4. If the ELT battery pack is not defective, return it to service for use until the expiration date listed on the data tag. *See the data tag photograph on page 3.*
