Service Letter No. 373

March 29, 1962

SUBJECT: Installation of Oil Shields on Airborne Mechanisms Dry Vacuum Pumps, Models 113A1 and 113A5

MODELS AFFECTED: PA-22-108 Colts - Serial Nos. 22-8000 to 22-9256 inclusive
PA-24 and PA-24 "250" Comanches - Serial Nos. 24-2176 to 24-2987 inclusive
PA-28 Cherokees - Serial Nos. 28-1 to 28-494 inclusive

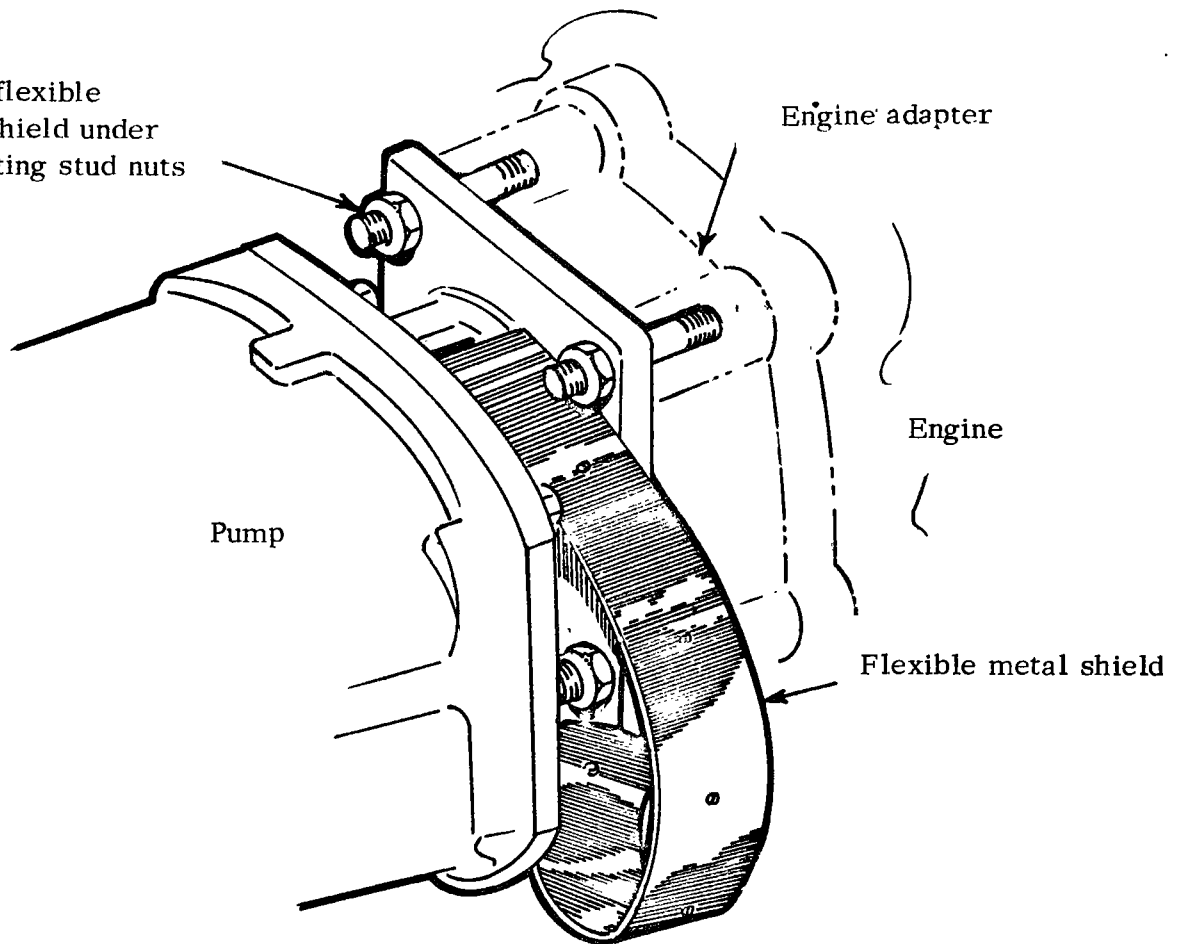
It has been determined that occasionally oil or cleaning solvents have entered the ventholes in the face of the mounting flange of the 113A1 and 113A5 Airborne Mechanisms dry vacuum pump.

Install flexible
metal shield under
4 mounting stud nuts

A flexible metal shield, part number 756 143, which is easily installed by threading under the pump mounting bolts, has been designed to protect these openings. Removing the pump is not necessary and the shield does not require fastening as the spring tension of the shield will hold it in its proper position, once installed. Installation of this shield is recommended on the subject aircraft equipped with Airborne Mechanisms Dry Vacuum Pumps. See sketch on the reverse side of this letter.

During installation or removal of the pump, the shield should be removed to prevent damage to the shield.

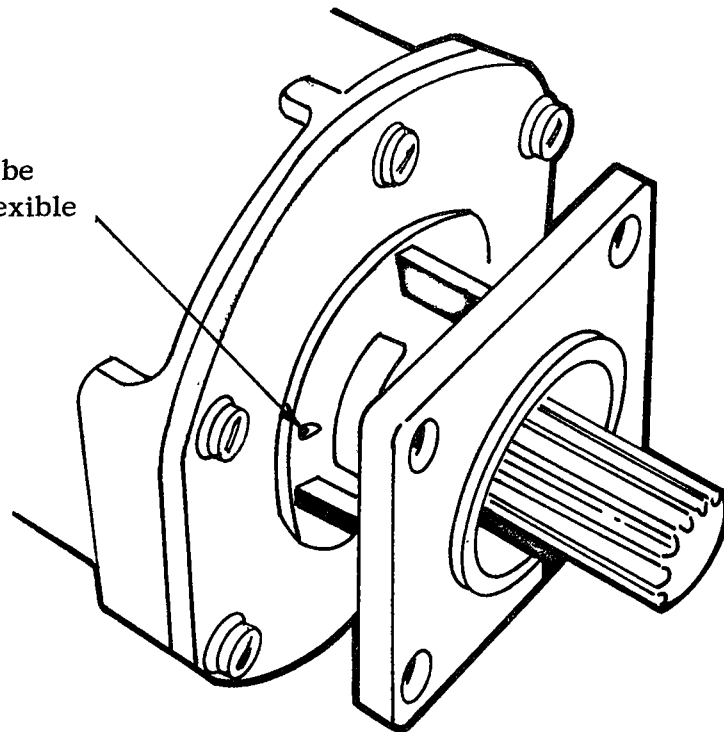
Vent holes to be
covered by flexible
metal shield
