Service Letter No. 155

To: All Distributors and Owners of PA-18 "105"

Subject: Muffler Tail Pipe Shroud

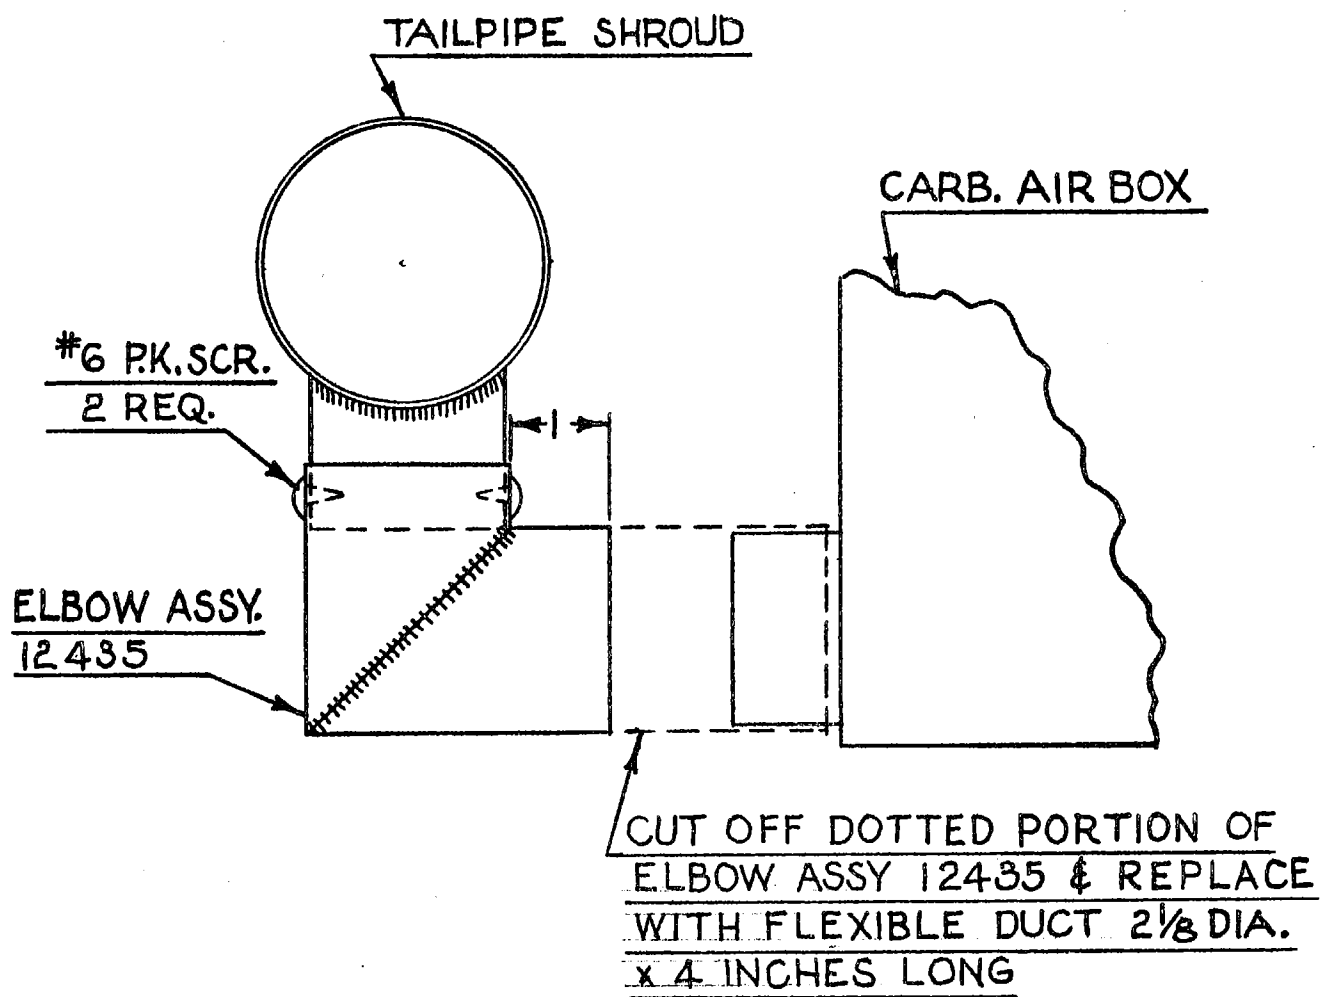
It has been brought to our attention that the carburetor air take-off tube on the muffler tail pipe shroud has been cracking at the weld, resulting in partial loss in carburetor heat.

We recommend that the elbow between the shroud take-off tube and the carburetor air box be modified as per the sketch on the reverse side of this letter.

The piece of flexible duct required can be obtained at no charge from your nearest Piper Distributor. The factory will ship immediately a sufficient quantity of parts to take care of all the airplanes affected in their respective territories.
