Service Letter No. 186

SUBJECT: Clearance between the Engine Mount and the Exhaust Tail Pipe and  
Clearance in the Nose Wheel Steering Mechanism

MODELS AFFECTED: All Model PA-22 Airplanes

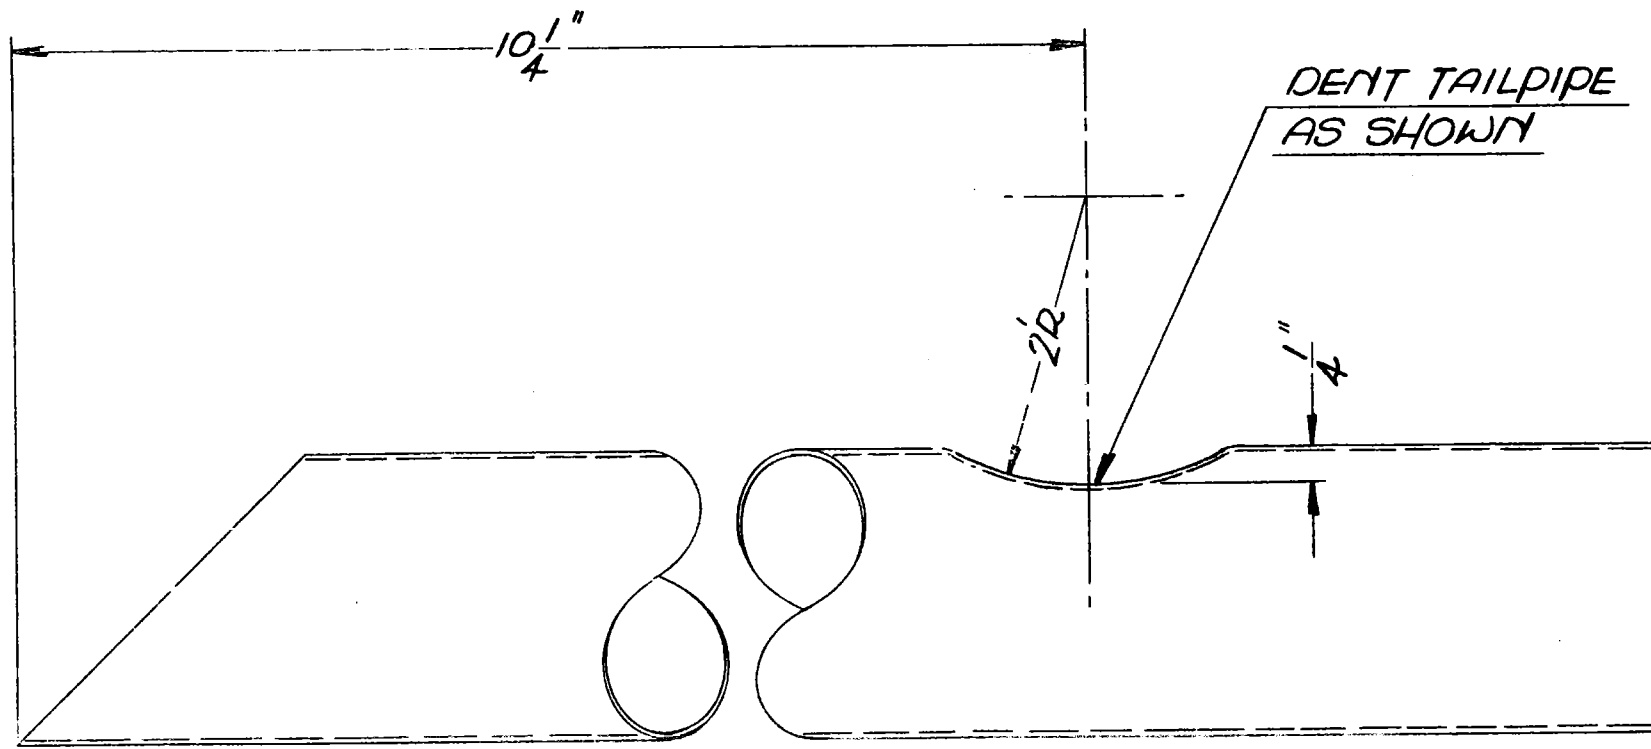
Sketch for Service Letter No. 186

It has been brought to our attention that the clearance between the engine mount and the tail pipe on the subject model airplane is not adequate and in some cases the tail pipe has rubbed the diagonal motor mount tube causing the tube to become somewhat grooved, due to the rubbing and scrubbing action of the tail pipe.

In the event it is impossible to obtain the proper clearance then the tail pipe should be modified in accordance with the attached sketch.

It has been reported that there have been cases of interference between the cross-over exhaust stacks and the nose wheel steering rod ends. We suggest that you investigate the possibility of this condition existing in your airplane and take corrective action if necessary. Proper clearances can be obtained by denting the exhaust stack tubes at the points of contact by using the same steps and dimensions as shown in the tail pipe sketch.
