Service Letter No. 188

SUBJECT: Flap Cable Installation

MODELS AFFECTED: PA-18A Airplanes with serial numbers 18-1248, 18-1262, 18-1266 to 18-1280 incl., 18 1283, 18-1286, 18-1287, 18-1299, 18-1302, 18-1308, 18-1309, 18-1311, 18-1313, 18-1315, 18-1319, 18-1320, 18-1321, 18-1322, 18-1325, 18-1326, 18-1327, 18-1654 and 18-1312.

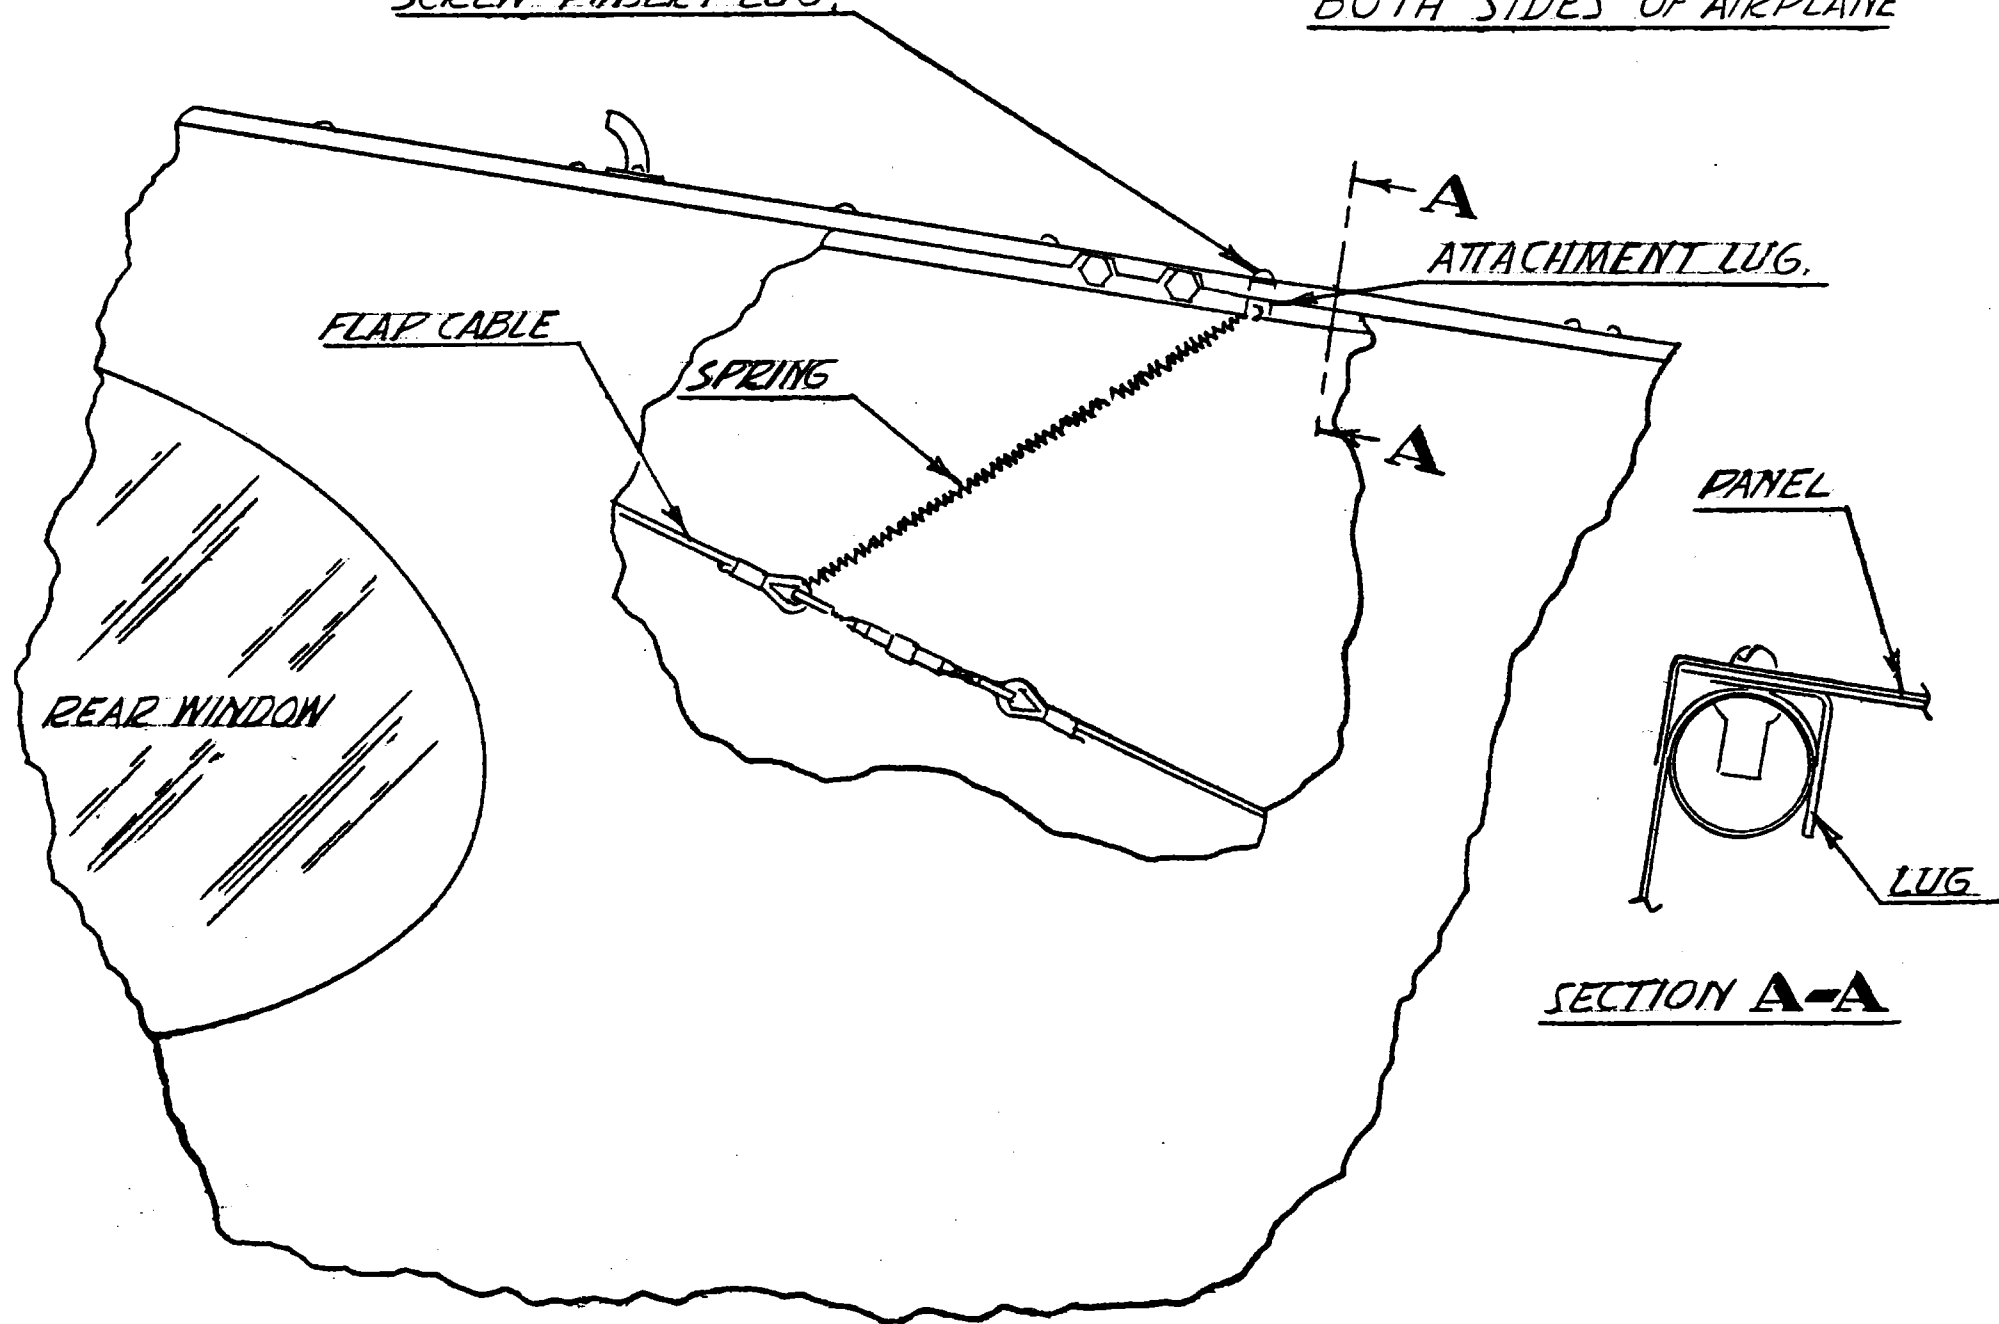
It has been brought to our attention that there is a possibility of the flap cables on the PA-18A becoming fouled between the hopper and the diagonal fuselage tube.

The probability of fouling is very slight, however, and can only happen when either or both flaps are forced down without the use of the flap handle in the cockpit. When the flap is forced down it allows the cable to sag and slide down between the hopper and the fuselage tube.

REMOVE THIS RD. HD. MACH.
SCREW & INSERT LUG.

We have a service fix for this particular problem and will make available to any PA-18 airplane owner, whose airplane bears one of the above listed serial numbers, our kit number 752 236 at No Charge. The time required to install this kit is approximately 15 to 20 minutes.

1. Remove the two (2) round head machine screws as indicated in the sketch.
2. Using the baggage compartment door as an access hole, insert the lug which is attached to the spring between the longerons and the hopper cover support panel so that the hole in the lug lines up with the hole from which you removed the machine screw.
3. Reinsert the machine screws and tighten. (The assistance of a second person will be necessary to accomplish this.)
4. Attach the other end of the spring to the flap cable by inserting the end coil on the spring through the flap cable thimble hole at the front end of the turnbuckle.
