Service Letter No. 334

June 16, 1960

SUBJECT: Reinforcement - Fuel Cell Filler Neck

MODELS AFFECTED: PA-23-250 Aztec and Navy UO-1 - Serial Nos. 27-2 to 27-199 inclusive

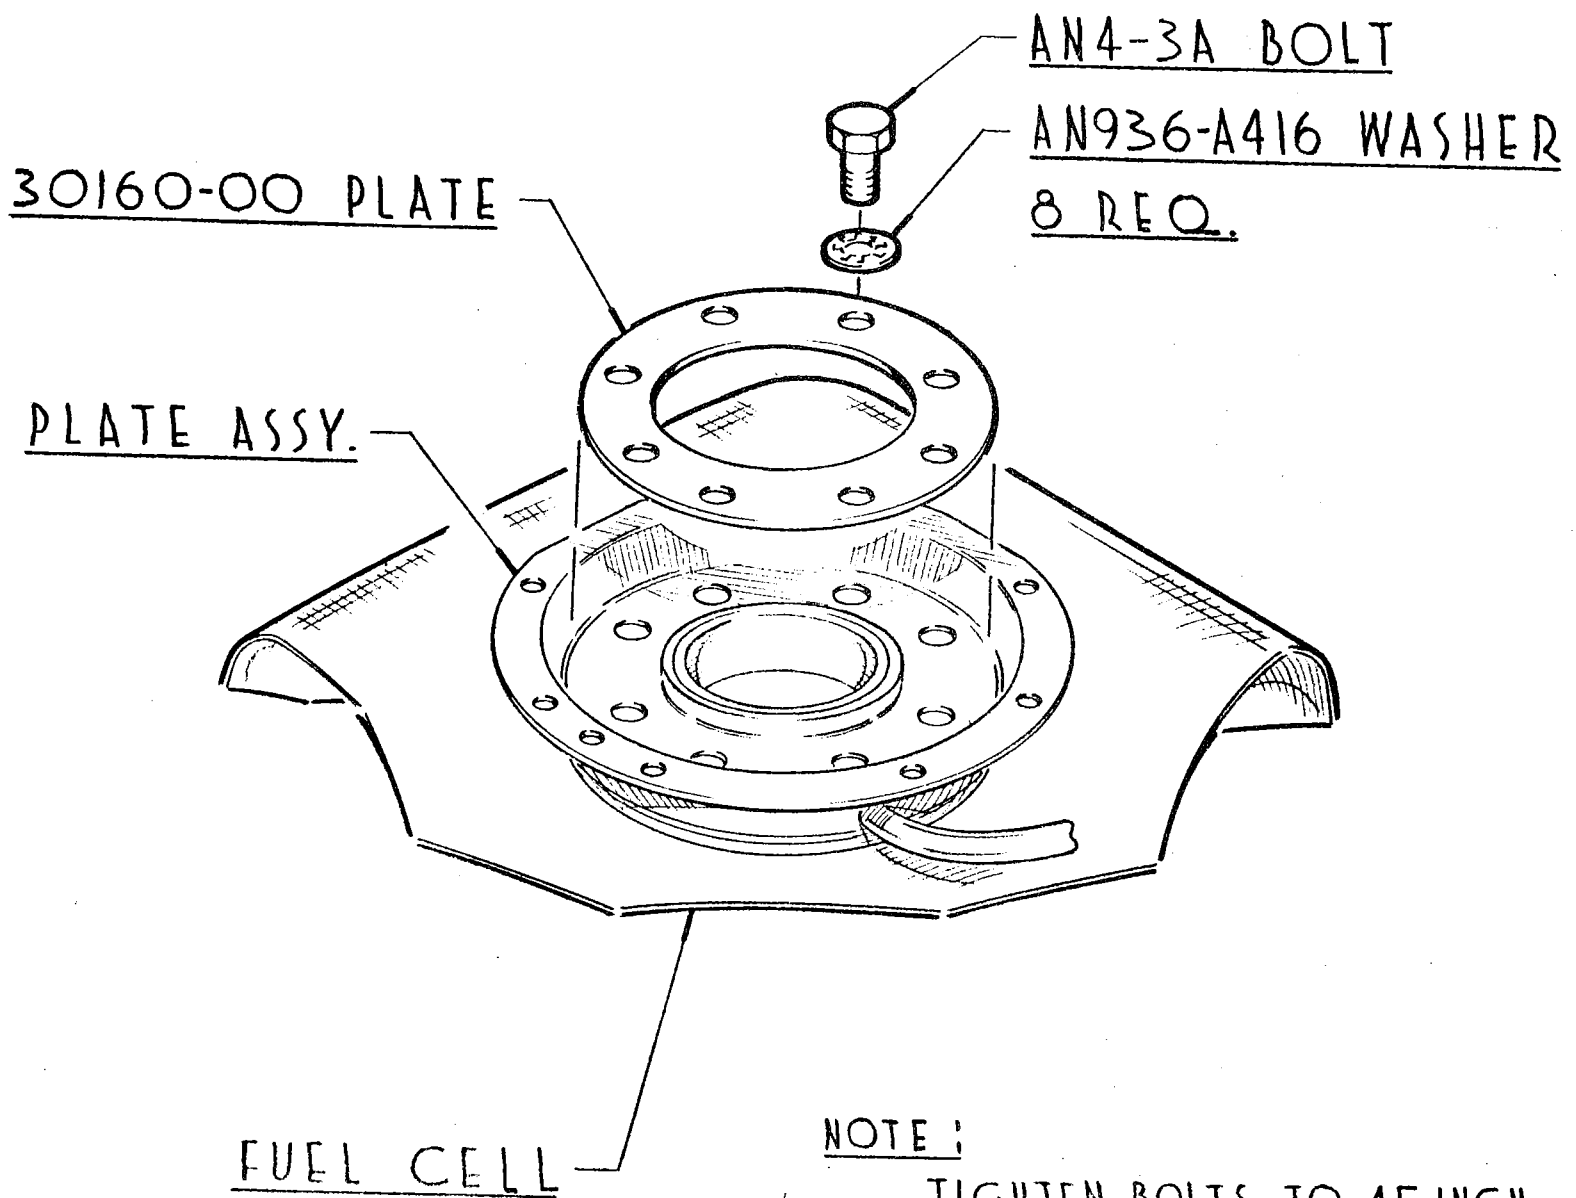
To prevent the possibility of fuel seepage between the fuel cell filler neck and plate assembly, a reinforcing plate, part number 30160-00, shall be installed in each fuel cell as shown in the sketch on the reverse side of this letter.

The note on the sketch, "Torque bolts to 45 inch pounds and relieve to 25 inch pounds" is to eliminate any possible distortion that may exist in the plate assembly. When removing the bolts from the fuel cell filler neck, caution should be exercised to prevent fuel cell from dropping into wing compartment.
