Service Letter No. 472 (Supersedes No. 452)

SUBJECT: B. F. Goodrich Service Bulletin No. E-65-30
(Conduit Installation Modification)

MODELS AFFECTED: PA-23-250 and PA-E23-250 (six place) Aztec C's

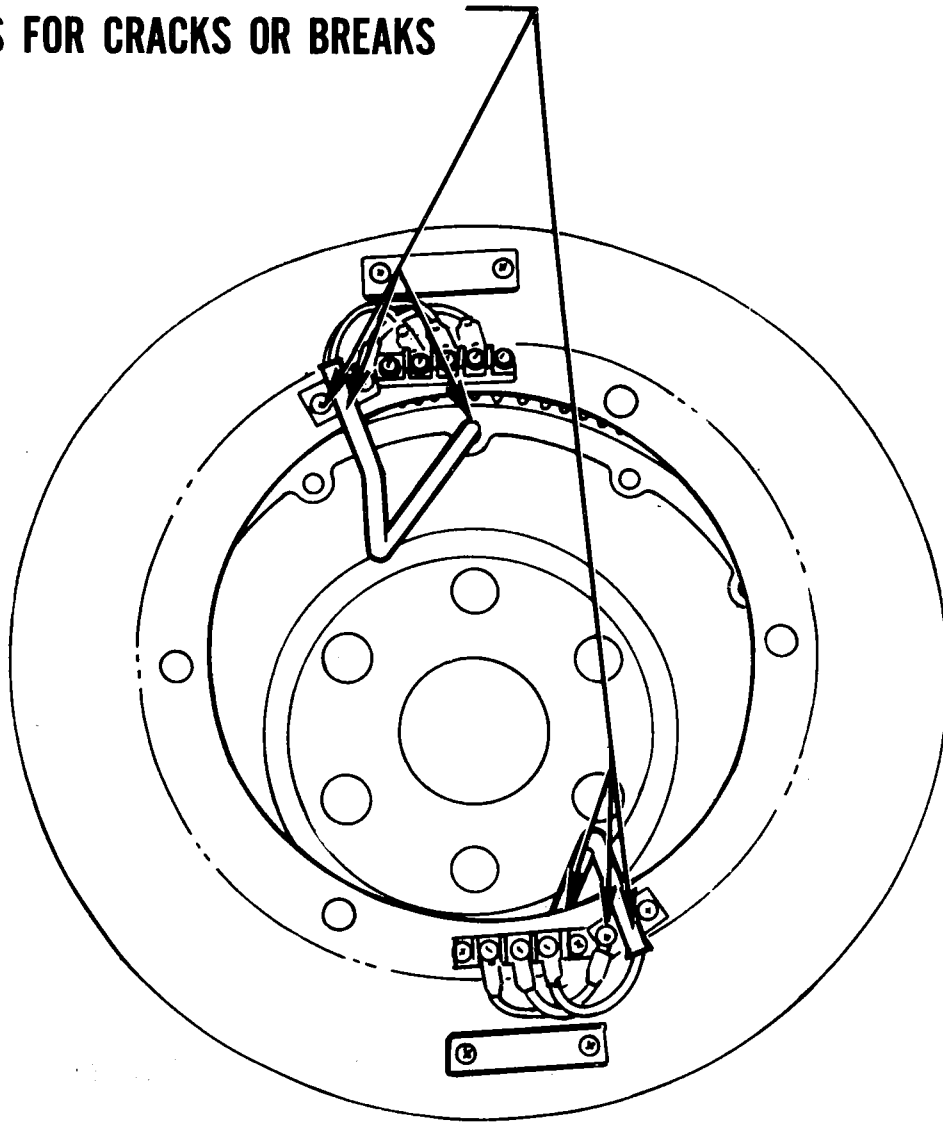
Conduit installation modification kit 757 017 contains the necessary material and instructions to accomplish this modification, however, it is requested that the conduits, Piper part number 753 922 (B. F. Goodrich part number 3E1388 or 3E1388-1) be inspected for possible cracks and if a crack is found the conduit be replaced before the subject kit is installed. (See sketch on reverse side of this letter.)

**CHECK AT THESE ATTACHMENT
POINTS FOR CRACKS OR BREAKS**

All Aztec C aircraft with B. F. Goodrich Electrical Propeller De-Icer Systems installed, as indicated above, must have modification kit 757 017 installed to prevent possible failure of B. F. Goodrich conduits, Piper part number 753 922 (B. F. Goodrich part number 3E1388 or 3E1388-1).
