SERVICE LETTER

No. 591

Subject: Wing Front Spar Inspection and Reinforcement

Models Affected: PA-23-235, PA-23-250, PA-E23-250 and PA-23-250 (Six Place) Aztec

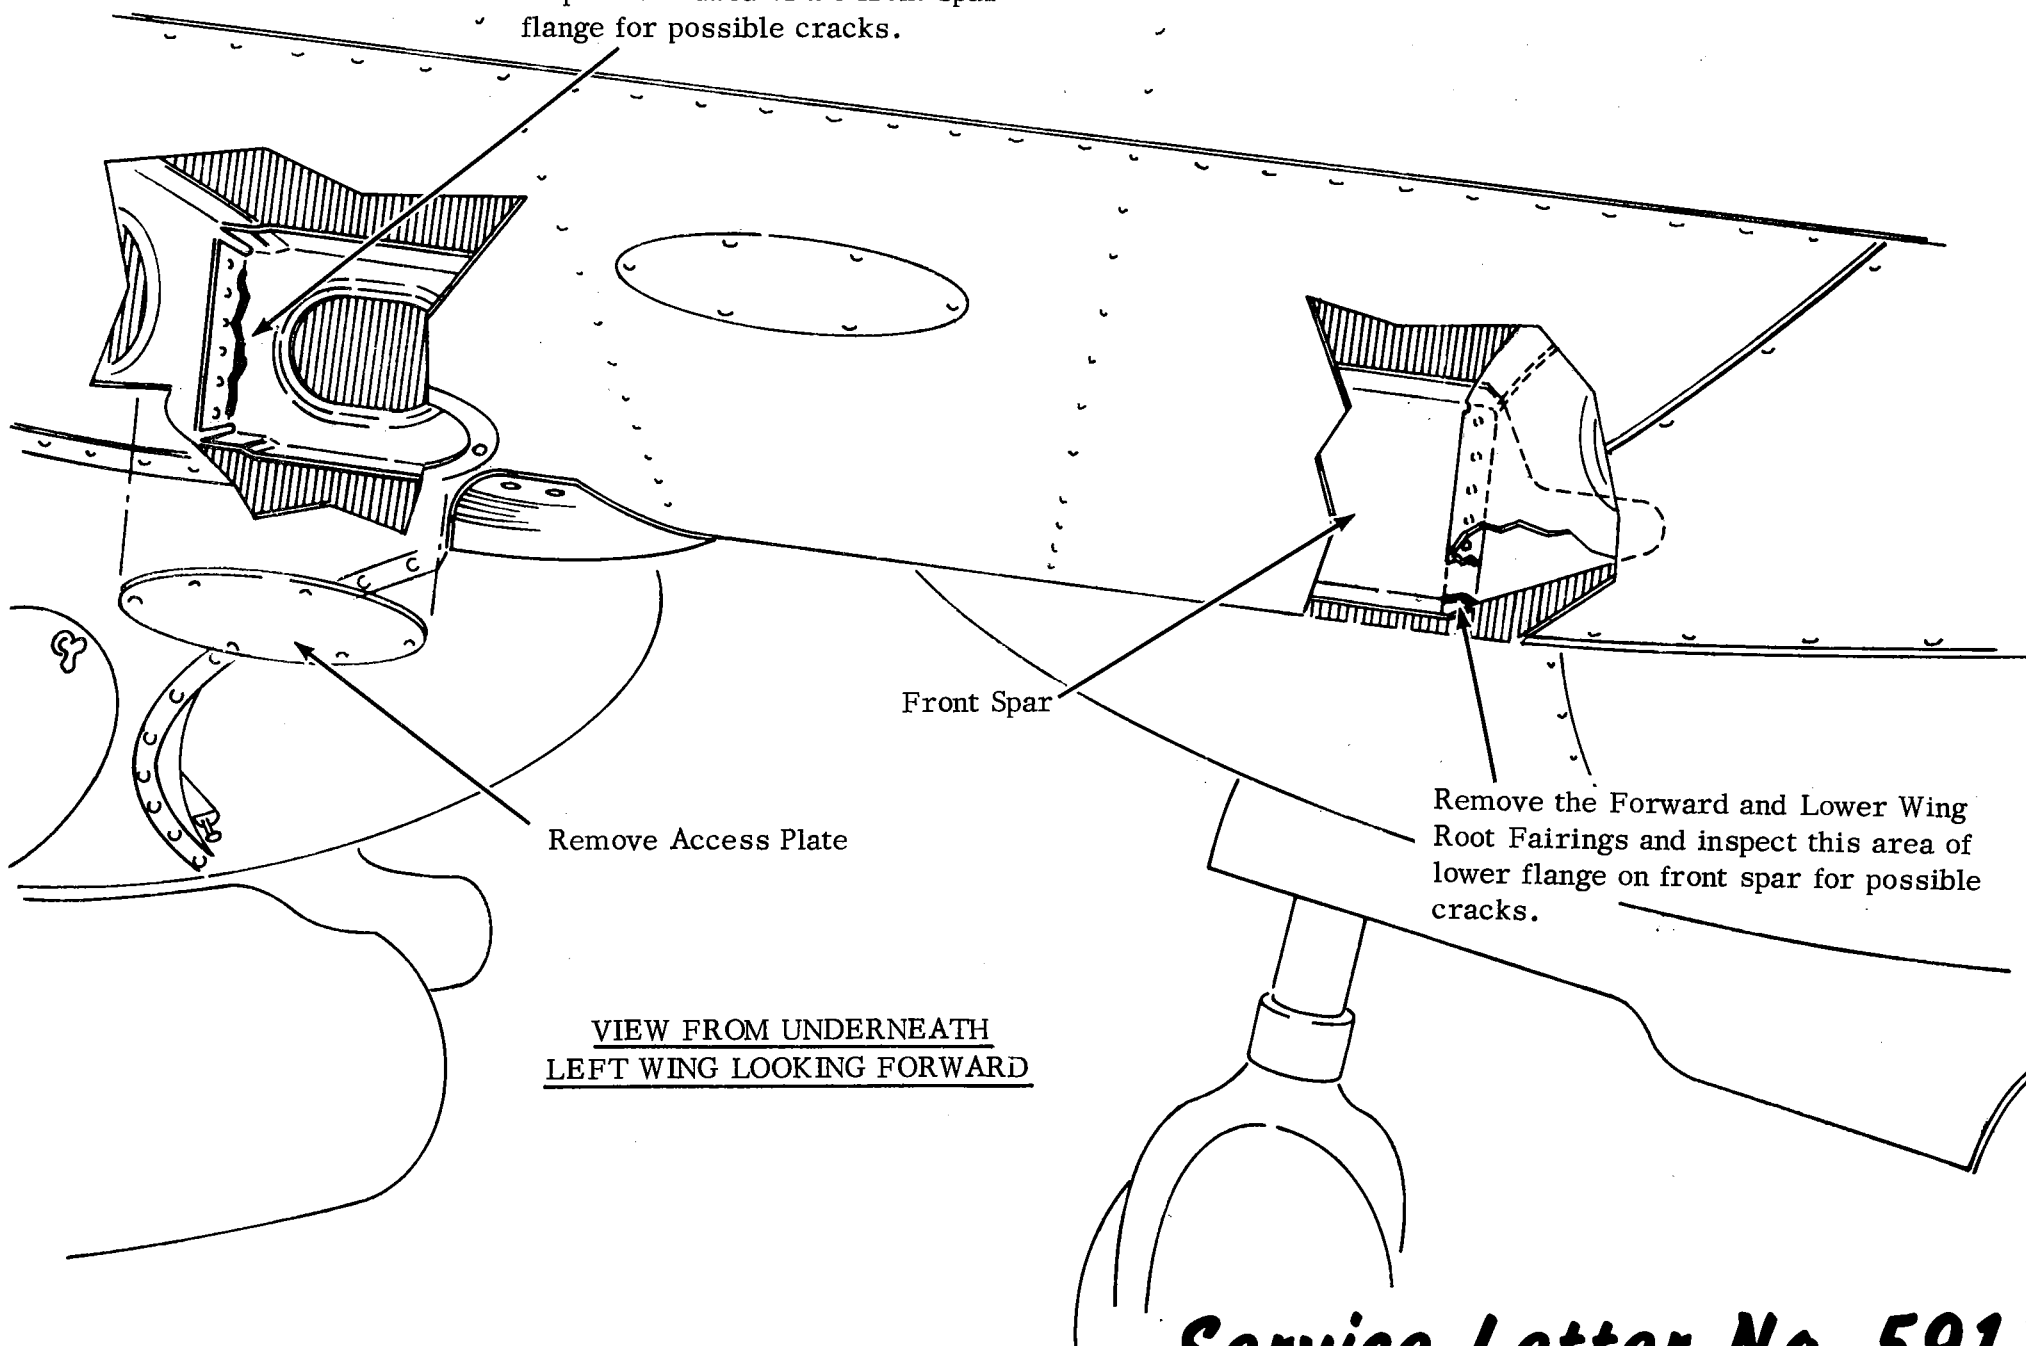
VIEW FROM UNDERNEATH
LEFT WING LOOKING FORWARD

Purpose: Several product condition reports have been received concerning the existence of cracks on the front spar (inboard and/or outboard) lower flange, as depicted on the sketch on the reverse side of this letter. These reports involved high time aircraft operated under conditions involving higher than normal stress.

Remove the Lower Access Plate and inspect this area of the front spar flange for possible cracks.

1. Inspect the wing front spars in accordance with the sketch/instruction sheet on reverse side of this letter.
2. Should cracks be detected, install the appropriate wing front spar reinforcement kit as denoted in Material Required, below.

1. Aztec Serial Numbers 27-1 to 27-4639 incl.; one (1) each (per aircraft) Wing Front Spar Inboard Reinforcement Kit, part number 760 521, as required at suggested unit retail price \$3.80A.
2. Aztec Serial Numbers 27-1 to 27-4659 incl.; one (1) each (per aircraft) Wing Front Spar Outboard Reinforcement Kit, part number 760 524, as required at suggested unit retail price \$1.85C.
