SERVICE LETTER

No. 695

Piper Aircraft Corporation

Roll Servo Inspection, Maintenance and Shear Pin Installation -- reference attached Edo-Aire Mitchell Service Letter No. ML38, dated March 18, 1974.

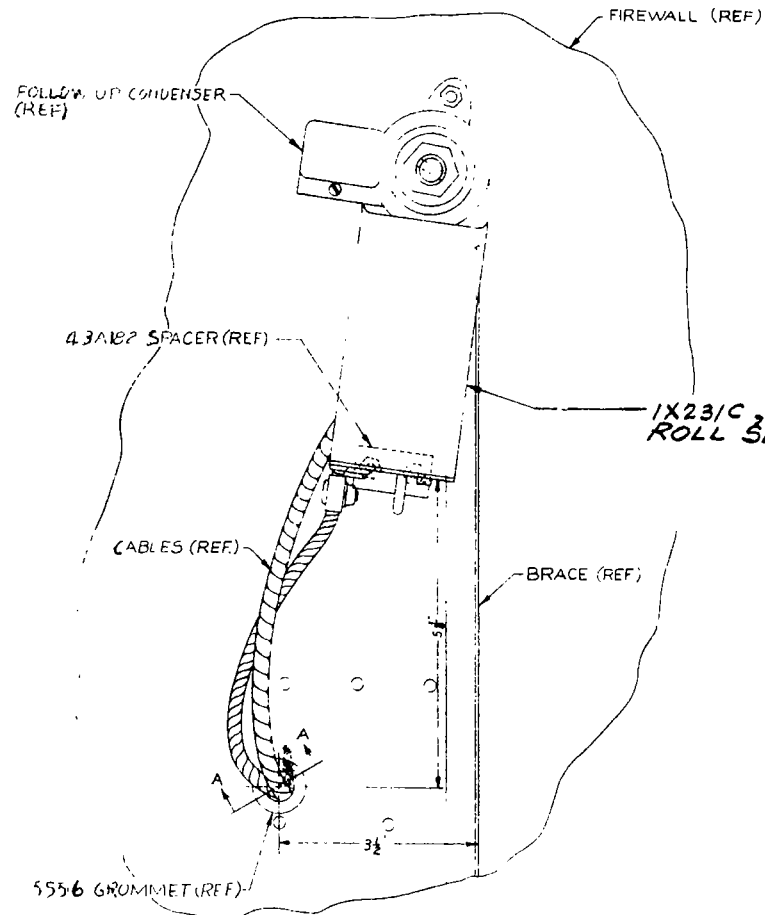
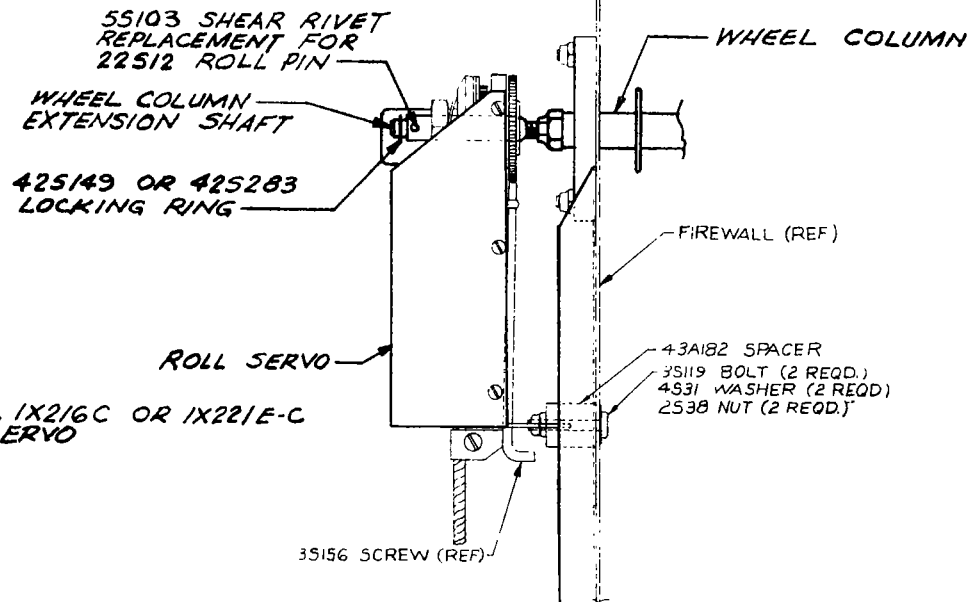
ML-38 REFERENCE DRAWING of Typical
President/Executive II/Autocontrol II/
Altimatec II Roll Servo Installation. Exact
Details Vary Slightly From Model to Model.

1. Locate the 22S12 Roll Pin (1/8 dia. x 11/16 long). Reference ML-38 Reference Drawing, Page 6. This roll pin, which secures the servo output gear and override shaft assembly to the wheel column extension shaft is to be removed after an appropriate mark is made to identify the gear and shaft orientation. When removing the roll pin support the shaft so that the shaft will not be damaged during pin removal. A suitable tool can be made from a "C" clamp to aid removal. When the servo is reassembled, the original orientation must be restored because of the preset timing of the autopilot follow up condenser. After the 22S12 roll pin is removed, the servo should be removed by sliding the unit off the wheel column extension shaft. Inspect the extension shaft and servo override shaft assembly for dirt and/or corrosion, cleaning if necessary. Also, if inspection of the roll servo indicates new lubrication is required, all traces of the old lubricant should be removed. A suitable solvent may be used, however, care is required so as not to contaminate the servo motor, clutch surfaces, or electrical components attached to the servo. Relubricate the operating surfaces of the gears and shaft assembly, and the wheel column extension shaft with a light film of the following lubricant:

2. Reassemble the roll servo on the extension shaft, noting the orientation marks previously made. Instead of the 22S12 Roll Pin, install the 5S103 Rivet (AN470AD4-10). After the rivet is installed, buck lightly to retain.

WARNING: The 5S103 Rivet is an AN rivet P/N AN470AD4-10. The material (Aluminum Alloy #2117T-4) was chosen for its shear characteristics.
DO NOT USE ANY OTHER RIVET FOR THIS APPLICATION.

3. A locking ring is to be installed over the free overhang length of the control column extension shaft on models which do not have a servo securing device, (either a castle nut with cotter pin, or a bolt and nut through the shaft in the free overhang length). The purpose of these securing devices is to secure the roll servo on the shaft following a shear pin failure.

Determine the diameter of the wheel column extension shaft. The various affected autopilot models have roll servos with two shaft sizes: .375" diameter, and .434" diameter. Use Locking Ring, P/N 42S283 (TRUARC P/N 5100-39) for a .375" diameter shaft, or a Locking Ring, P/N 42S149 (TRUARC P/N 5110-43) for a .434" diameter shaft. The locking ring is to be installed with the stamping radius on the AFT (inward) side.
