SERVICE No. 1008 BULLETIN

Date: September 30, 1997 (M)

Elevator Butt Rib Refinement

PA-31, 31-300, 31-325 Navajo
PA-31-350 Navajo Chieftain
PA-31-350 T1020
PA-31P-350 Mojave

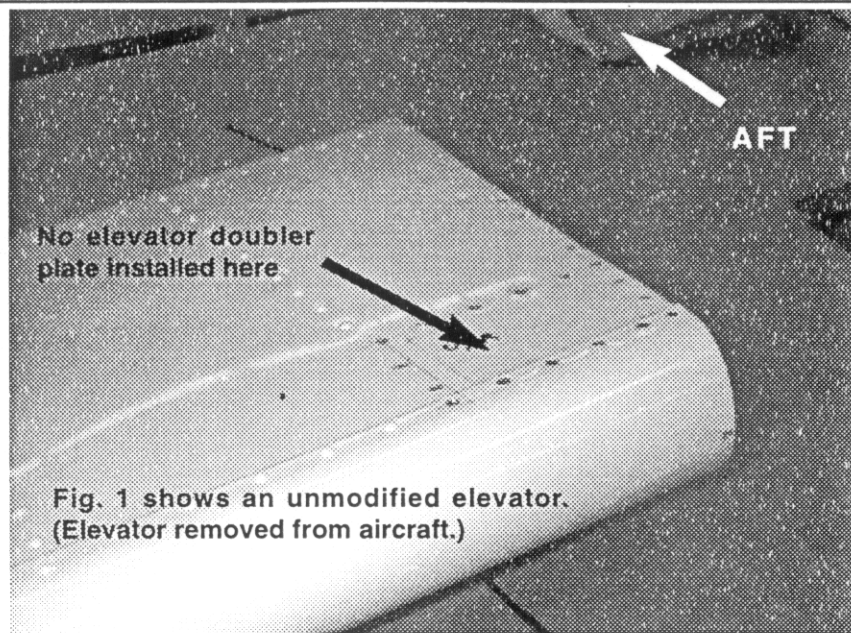
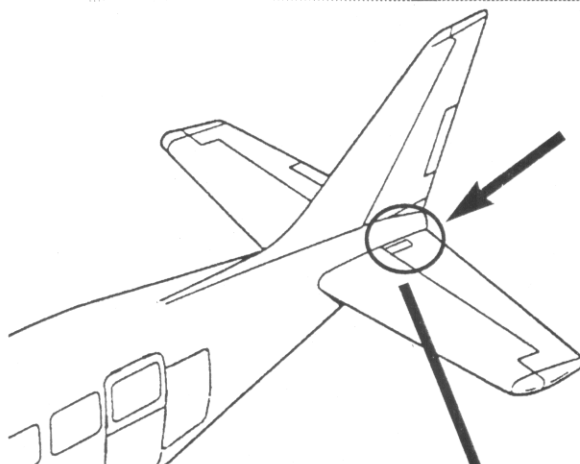
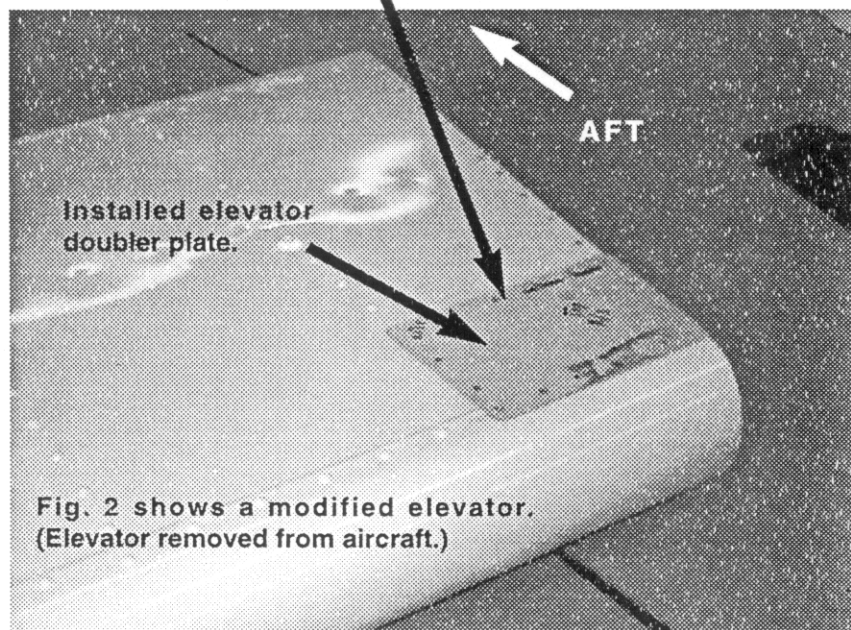
Approximate location of doubler plate on left and right elevators. Installation of doubler plate indicates the installation of the Elevator Butt Rib Refinement Kit p/n 766-642.

3. Install the Elevator Butt Rib Refinement Kit (1 per aircraft), Piper Part Number 766-642. All of the necessary instructions for installation are contained in the Elevator Butt Rib Refinement Kit.
4. Make an appropriate logbook entry of compliance with this Service Bulletin.
