# S E R V I C E *No. 1045*

Date: September 18, 2000

*Inspection of the Forward Wing Spar Attach Bracket*

PA-31, PA-31 -300 Navajo

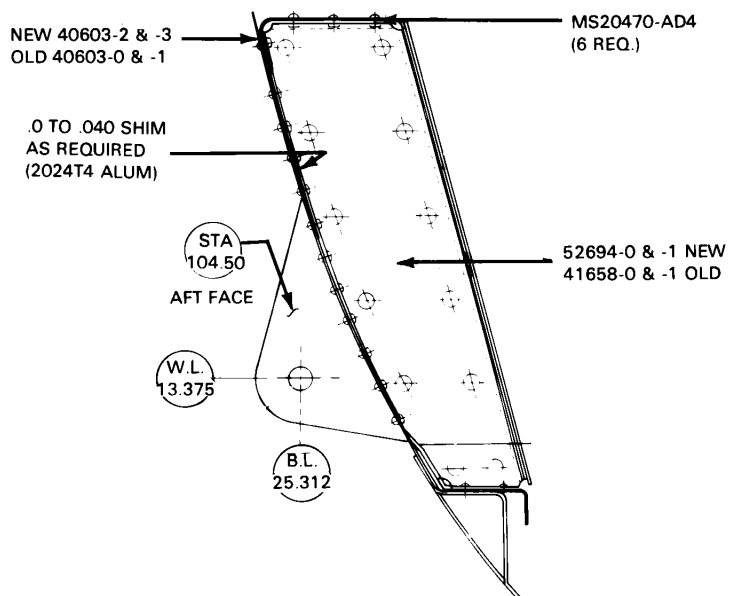
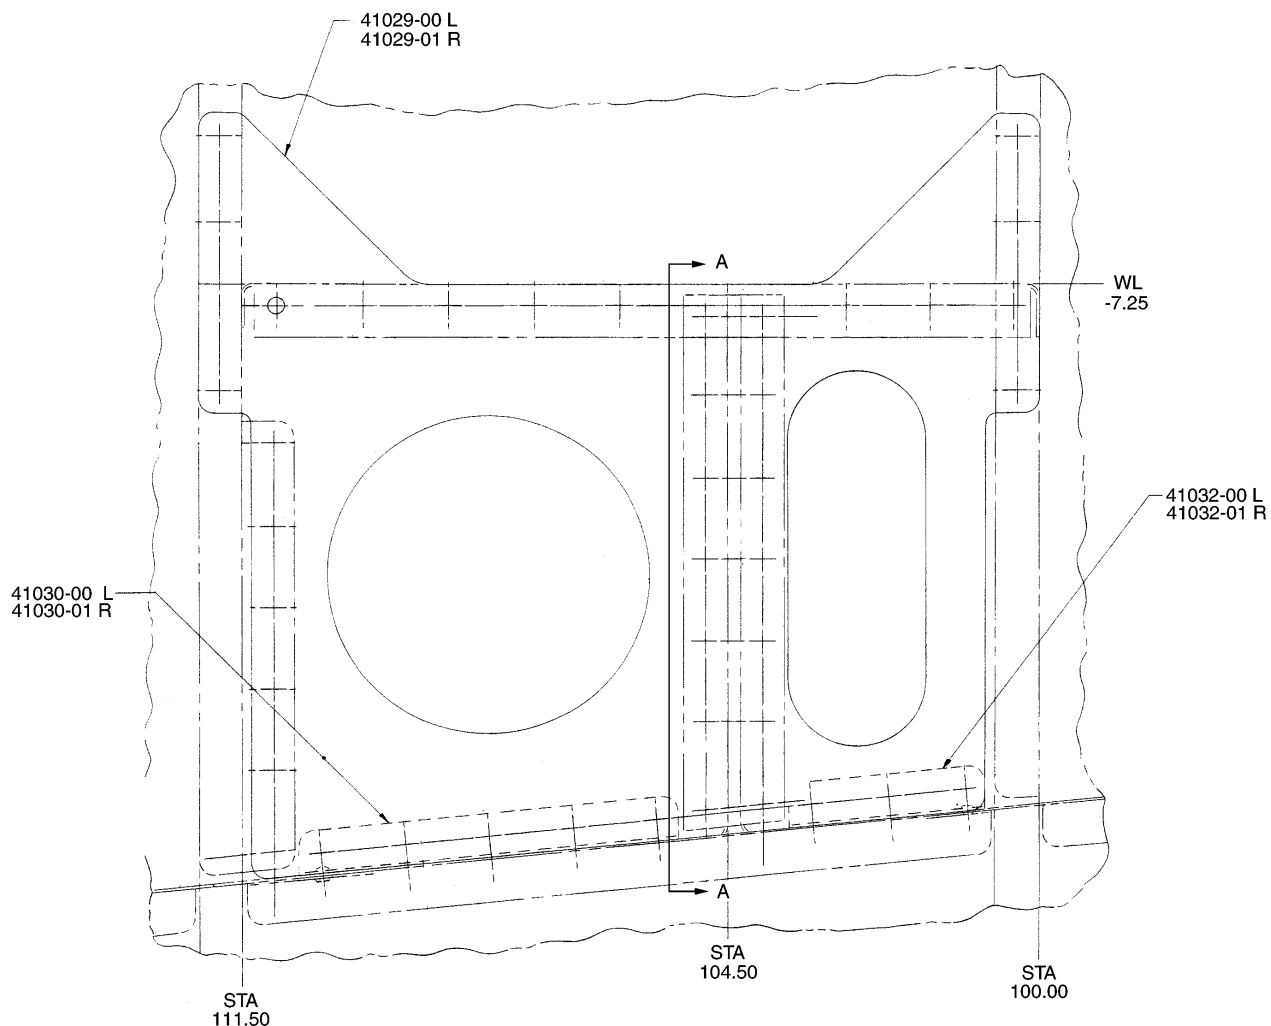
Inspection of the Forward Wing Spar Attach Bracket  
Figure 1

**PURPOSE:** It has been reported that cracks have been found in the left and right forward wing attach brackets on several of the affected aircraft. If left uncorrected, these cracks could propagate and cause a loss of structural integrity of the forward wing spar attach joint.

5. Remove the pilot and copilot seats.
6. Remove the interior side panels adjacent to the pilot and copilot seats (FS 100 to FS 135) to gain access to the Front Spar Attaching Bulkhead (FS 104.50). (It may be necessary to remove cabinetry in order to remove the side panels.)
7. Using a light and a 10 power magnifying glass, carefully examine the forward and aft faces of the Left and Right Front Spar Attachment Bulkhead Assembly for cracks, particularly in the outboard flange radius and along the edge of the rivets attaching the flange to the skin.

*The forward face of the bulkhead can be examined through the elliptical hole in the fuselage reinforcement plate, located at approximately FS 102, and the aft face can be examined through the round hole in the fuselage reinforcement plate located at FS 108.*

8. If cracks are found, it will be necessary to remove and replace the complete Left (p/n 41658-00) and/or Right (p/n 41658-01) Front Spar Attachment Bulkhead with a Left (p/n 52694-00) and/or Right (p/n 52694-01) Front Spar Attachment Bulkhead. This will also require replacement of the Left (p/n 40603-00) and/or Right (p/n 40603-01) Front Spar Attach Channel with a Left (p/n 40603-02) and/or Right (p/n 40603-03) Front Spar Attach Channel.

Also if cracks are found, it will be necessary to remove and replace the Left (p/n 41029-00) and/or Right (p/n 41029-01) Reinforcement Plate, the Left (p/n 41030-00) and/or Right (p/n 41030-01) Angle, or the Left (p/n 41032-00) and/or Right (p/n 41032-01) Angle.
