Piper Aircraft Corporation
Lock Haven, Pennsylvania, U.S.A.

SERVICE BULLETIN

No. 289

<u>Subject:</u>	Elevator Control System Friction
<u>Models Affected:</u>	PA-31 and PA-31-300 Navajo
<u>Serial Numbers Affected:</u>	31-2 to 31-326 incl., 31-328 to 31-332 incl., 31-334
<u>Compliance Time:</u>	Prior to but not later than the next 100 hours of operation
<u>Purpose:</u>	Provide instructions for checking and reducing, if necessary, the total friction in the elevator control system and the readjustment of the elevator bungee spring.
<u>Instructions:</u>	<p>Adjust the elevator bungee spring to 30 pounds \pm 1 per attached instructions.</p> <p>Using a spring scale of approximately fifty (50) pounds capacity determine that the total friction in the elevator control system does not exceed seven (7) pounds. If the frictional value exceeds seven (7) pounds, see attached sketch and instructions.</p>
<u>Material Required:</u>	Not applicable
<u>Availability of Parts:</u>	Not applicable
<u>Material Allowance:</u>	Not applicable

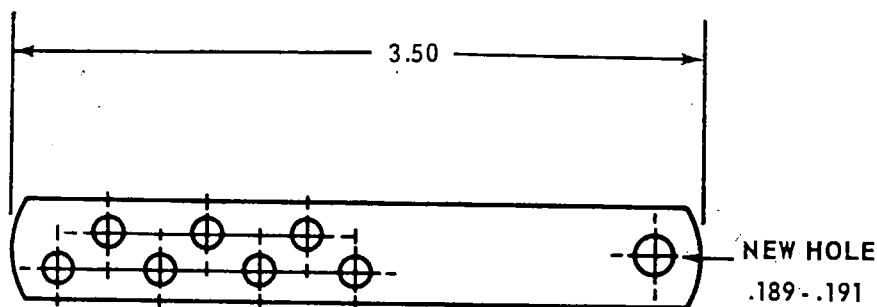
1. Remove the bottom section of the fuselage tail fairing. The top section provides a reference point and should not be removed.
 - (a) Reference PA-31 Navajo Service Manual, Page 5-20, Figure 5-5, Sketch C. Attach a 1 lb. increment spring scale to the aft end of the elevator bungee spring, Item 16, and determine the spring tension as installed. The elevators must be positioned as shown in Sketch A when measuring the spring tension.
 - (b) If the spring tension is less than 30 lbs. ± 1 , determine if 30 lbs. ± 1 can be obtained by repositioning the spring in one of the adjusting holes in the link, Item 17, part number 42376-00.
 - (c) If the proper tension cannot be obtained, proceed with the following steps:
2. Remove the link from the aircraft and modify to conform with the sketch below:

- (a) When the modification of the link is complete, reinstall the link in its original location, attaching the aft end only to the elevator control tube.
- (b) With the elevators positioned as shown in Sketch A; attach a 1 lb. increment spring scale to the aft end of the elevator bungee spring, reference Item 1 (b), and exert a force on the scale until a reading of 30 lbs. is obtained. Mark the hole in the forward

part of the link that most nearly aligns with the rearmost point of the spring while a spring scale reading of 30 lbs. is maintained. Remove the scale from the spring and install the rear loop of the spring through the hole that has been marked. This will result in an elevator bungee spring tension of 30 lbs. ± 1 when the elevators are positioned as illustrated in Sketch A.

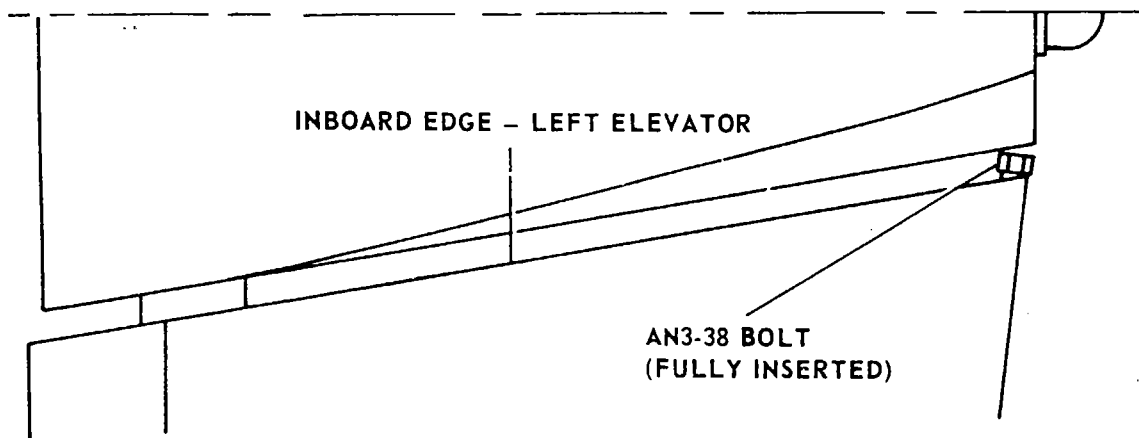
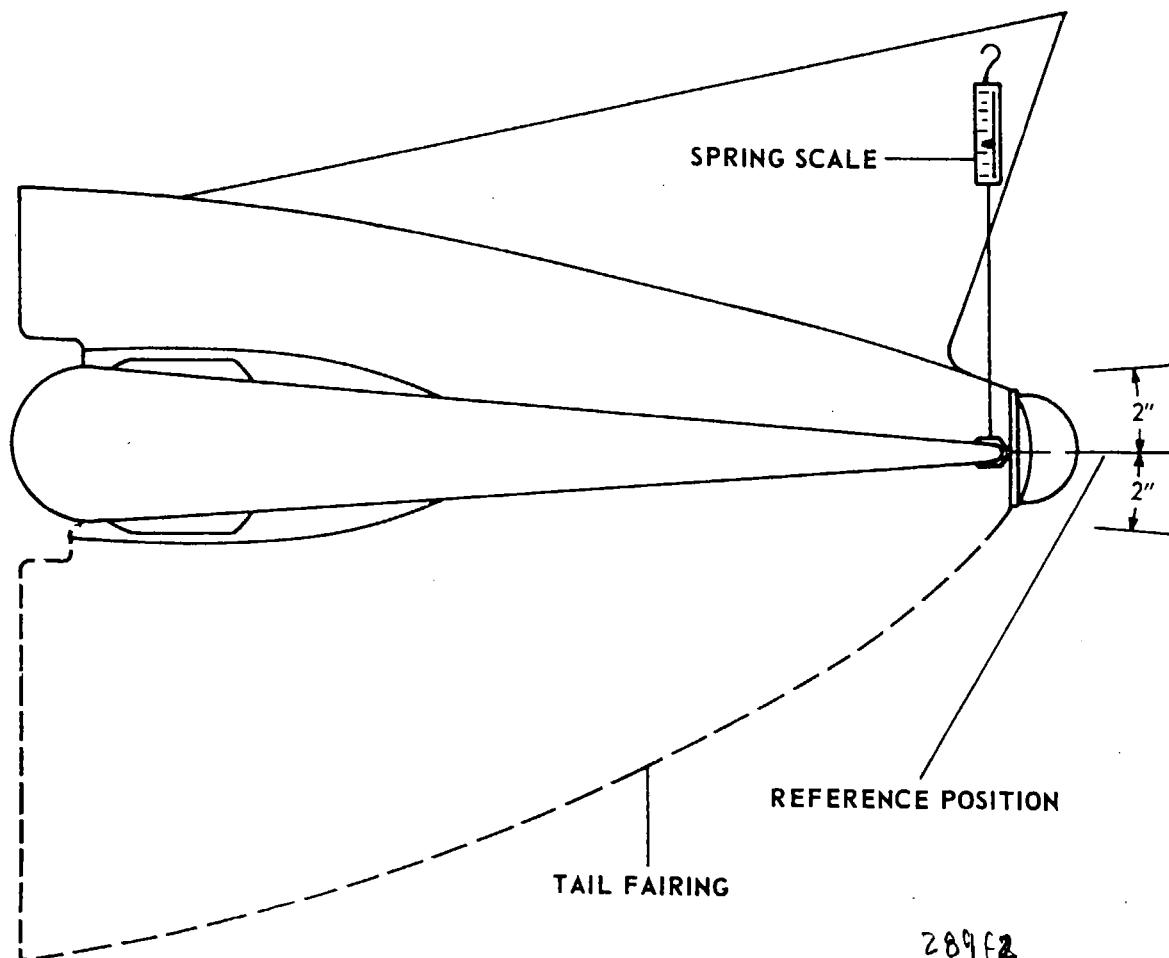
SKETCH A

- (a) Attach the spring scale to the inboard trailing edge of the elevator as shown in Sketch A.
- (b) With the spring scale attached, position the elevator trailing edge down approximately 2 inches from the reference position.
- (c) Record the force (see Note 2) required to raise the elevator through the reference position until the trailing edge is approximately 2 inches above the reference position.
EXAMPLE: 22 lbs. to raise; read at reference position.
- (d) Record the restraining force lowering the elevator from the 2 inch up position through the reference position to the original 2 inch down position.
EXAMPLE: 16 lbs. to lower; read at reference position.
- (e) Repeat the above raising and lowering process until average forces are obtained.
- (f) The "total friction" is obtained by subtracting the 2 forces.
