# SERVICE BULLETIN

No. 323

Piper Aircraft Corporation

Subject: Modification of the Rudder and Elevator Spar Assemblies

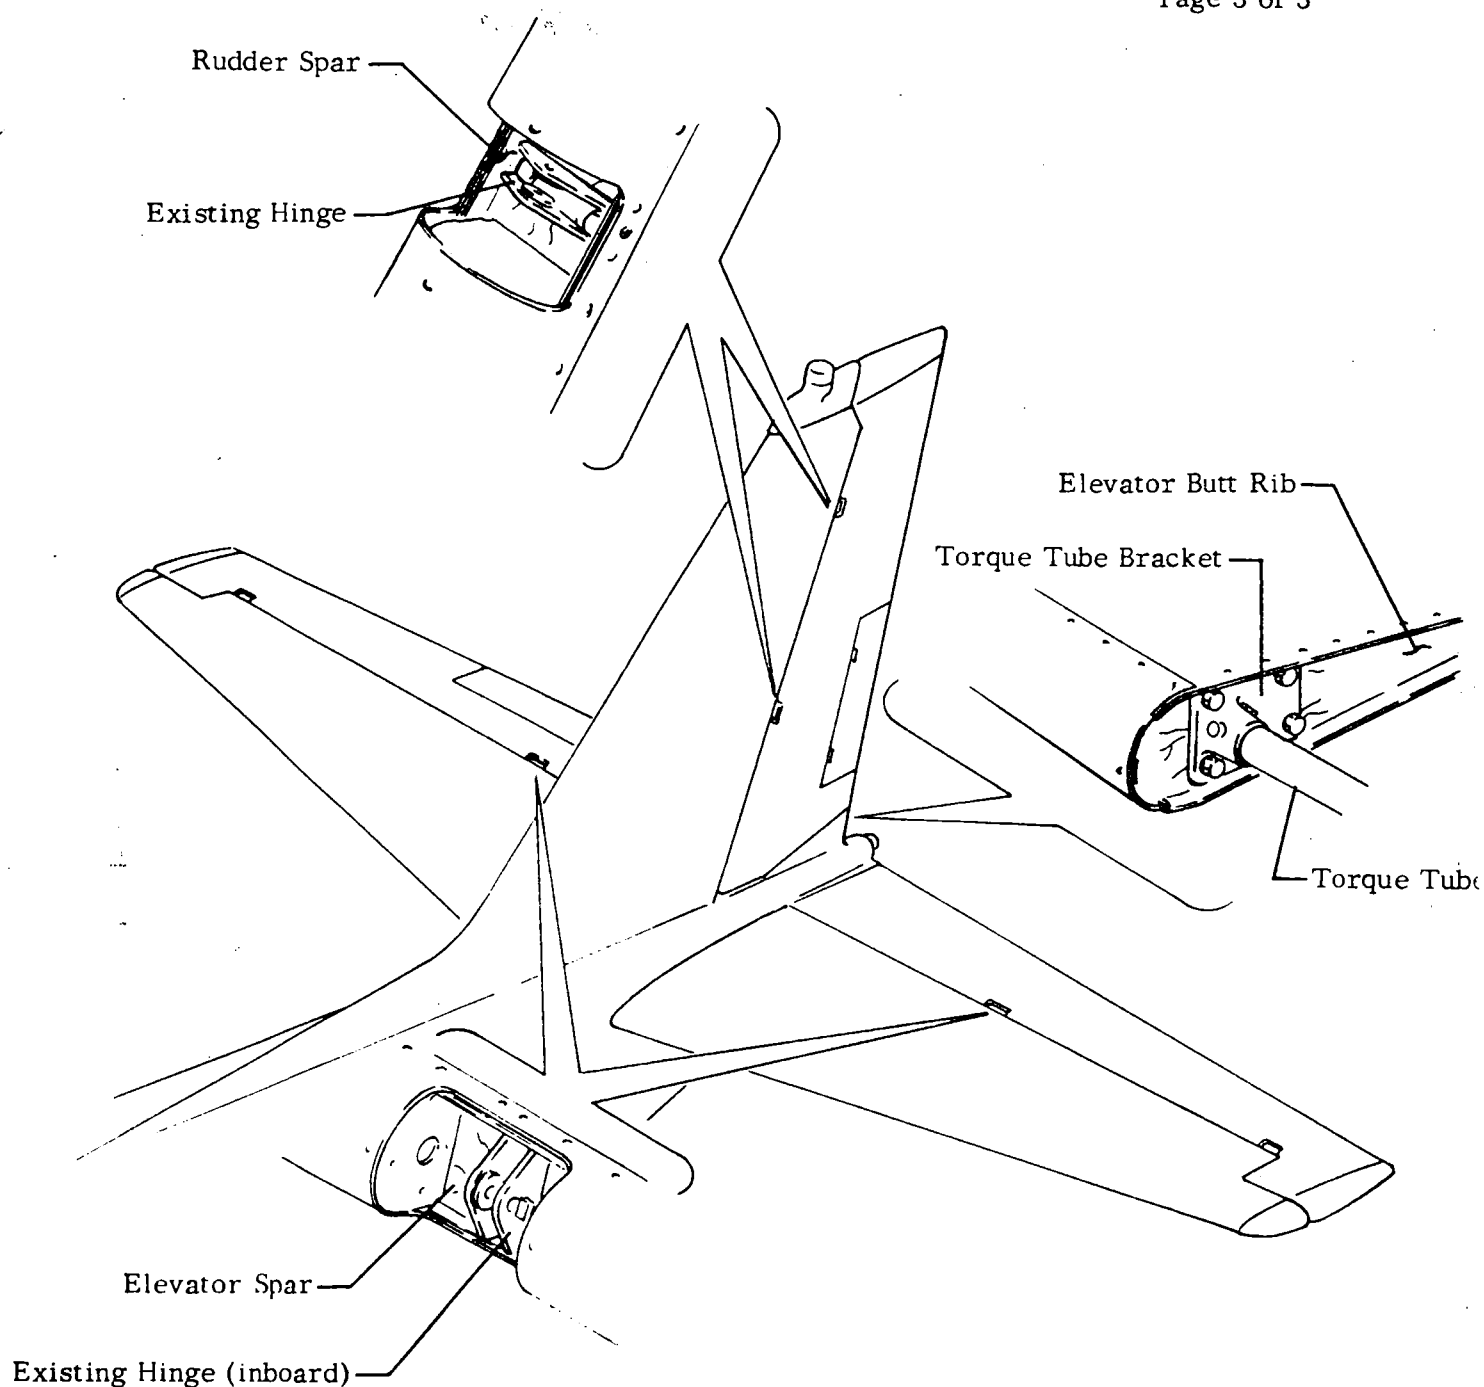
#### INSPECTION INSTRUCTIONS

Inspect the area adjacent to the hinge mounting surface on the spars for possible cracks. If cracks are evident, the affected spar must be replaced.

With elevator torque tube brackets removed, inspect the elevator butt ribs for possible cracks. If cracks are evident, the affected butt rib must be replaced.
