SERVICE BULLETIN

No. 384

Bulletin No. 94A

Subject: Inspection of Propeller Blade Shank

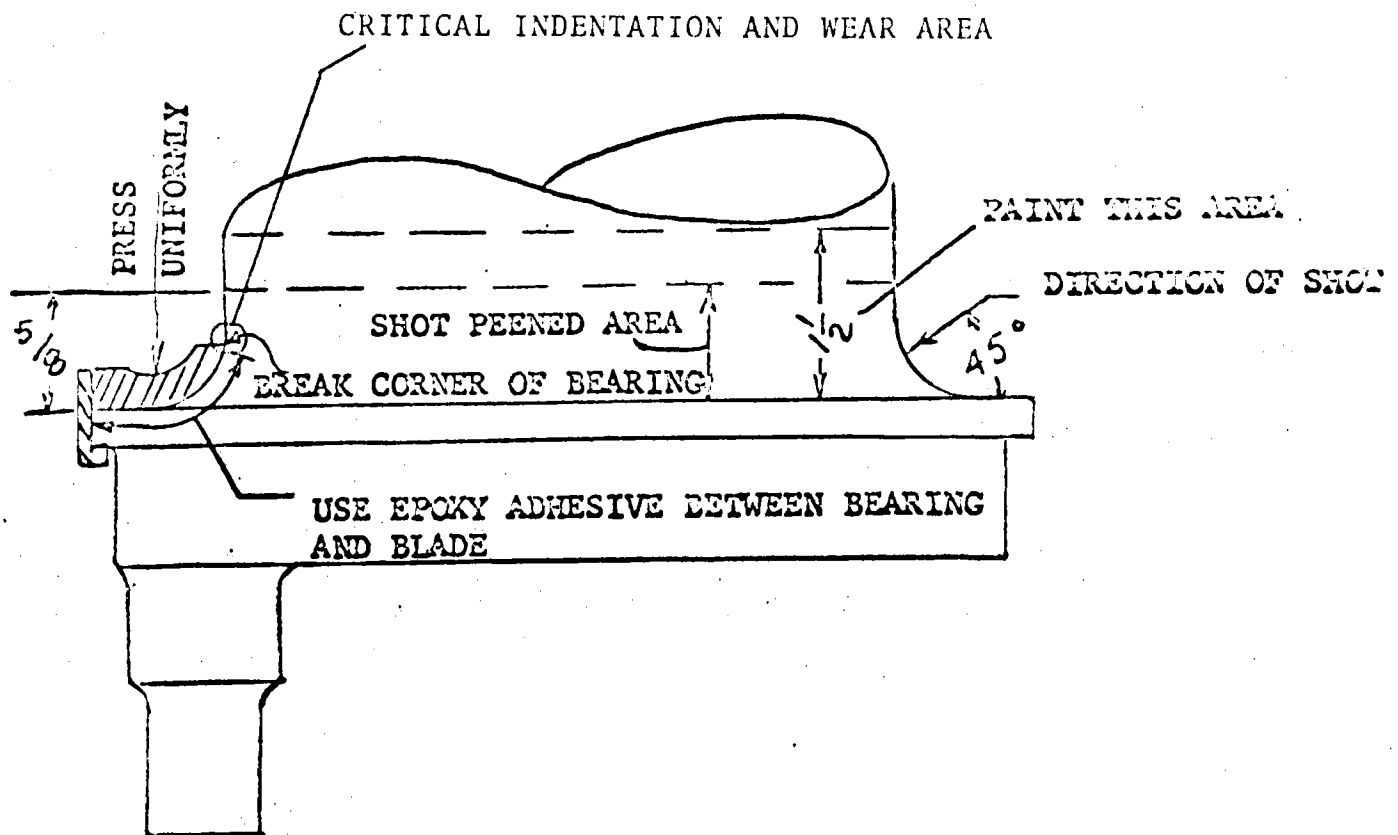
Discussion: After 1240 hours operation the cause of extreme vibration of one engine-propeller combination was found to be a cracked blade shank. This crack was due to fatigue, resulting from vibration of the system, and occurred at the outer edge of the ball bearing race which supports the blade within the hub.

- 1) For propellers which have been in service for 1000 hours or more inspect the blade shanks within the next 100 hours, by the dye penetrant method, for cracks in the radius adjacent to the retention flange.
- 2) Regardless of previous inspection, inspect for possible indentations and wear due to the sharp edge of the bearing as shown on the sketch. Blades showing wear in this critical area must be retired from service.
- 3) For those blades not rejected, inspect for chafing, fretting, or unusual wear where the A-2202 bearing race contacts the blade retention radius. If this surface is worn or marked in any way, carefully fit the A-2202 bearing race by polishing the radius area only. It is suggested that the blade be chucked in a lathe for uniform radius polishing.

- 4) Re-shot peen the radius as shown on the sketch. Use S-390. Cover 100 percent. Test the effectiveness of the peening with the C-2 Almen gage. The arc height should be .007 minimum.

- 6) Clean the blade retention shoulder with a solvent. (The polyurethane paint need not be removed.) Clean the mating surface of the A-2202 bearing race after the sharp corner is broken (see sketch).
