SERVICE BULLETIN

No. 488

Piper Aircraft Corporation

Modification of Landing Gear Selector Cable Forward Attachment Pin.

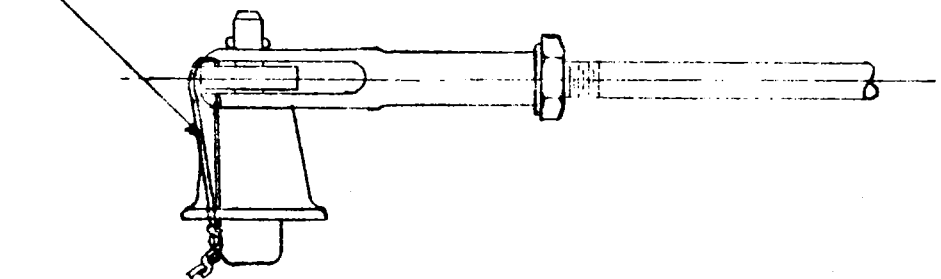
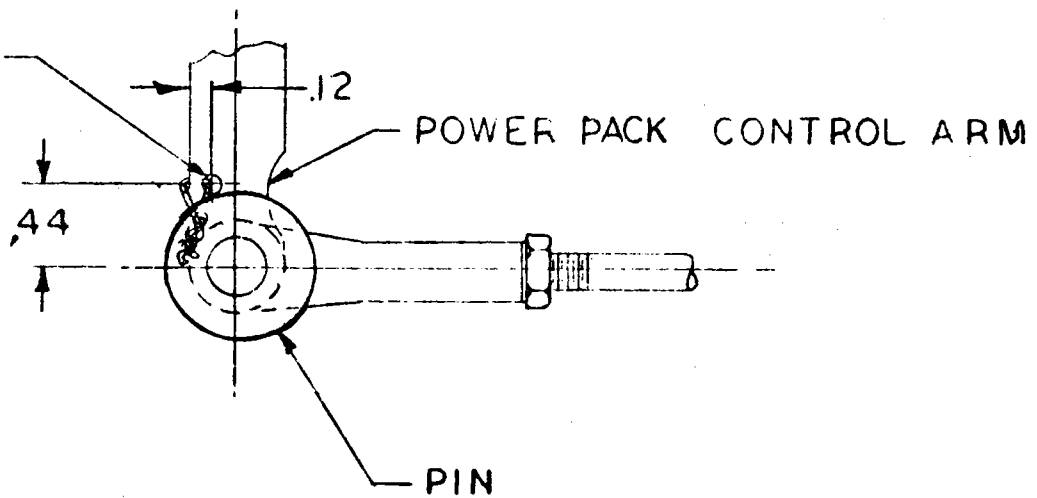
The landing gear selector flexible push-pull control cable assembly is attached to the hydraulic powerpack control arm by a cable attachment pin assembly, Piper part no. 53599-00. A recent incident at the factory indicates that this pin assembly may become disengaged, causing detachment of the landing gear selector cable from the powerpack control arm, with subsequent loss of landing gear (retraction/extension) system control.

MS20995C41 LOCK WIRE

.062 HOLE

5. Safety with approximately three inches of MS20995C41 lock wire (.041 stainless steel) through the hole in the arm and existing hole in pin knob per attached sketch.

Wrap lock wire around arm on side opposite from cable, to prevent interference with cable clevis during normal operation.
