SERVICE BULLETIN

No. 494B

Piper Aircraft Corporation

Inspection of Flap Control System

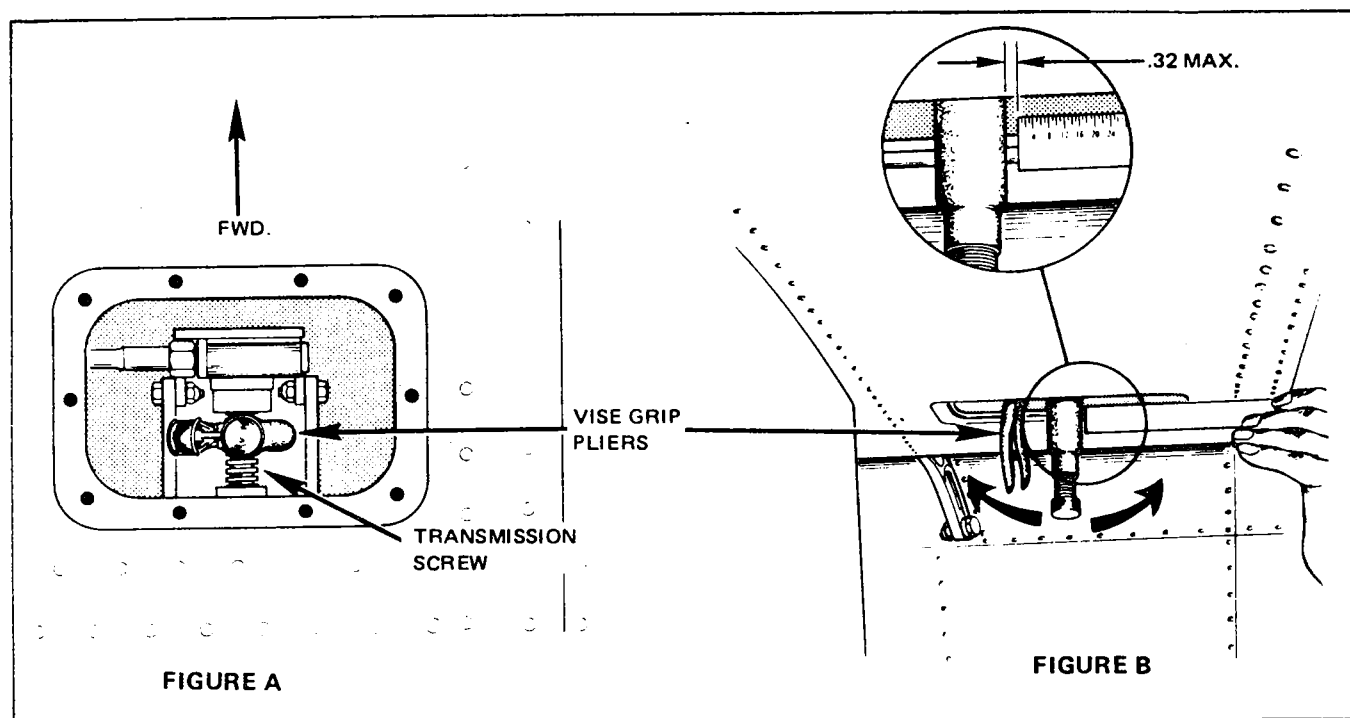
Figure 1. Wing Flap Transmission Inspection

Purpose: Piper Service Bulletin No. 494 and FAA AD 76-10-06 were issued in response to reported flap system conditions that have occurred on the above referenced aircraft. Primarily, flap system malfunctions resulted from flap transmission failures due to excessive transmission internal component (pinion and worm gear) wear - identified as excessive "play" or "lost motion" in the transmission screws. Other flap system components (reference Instructions No. 2, below) may have been a factor.

- c. With the use of vise grip pliers and exerting light pressure, grasp the exposed portion of the screw close to the transmission as shown. (Refer to Figure 1, Views A and B).

- e. Place a six inch ruler along the skin surface as shown in Figure 1, below, View B, and measure the overall distance the pliers move.
 - f. Should this dimension exceed .32 (5/16) of an inch, replace the transmission assembly or obtain Gear Transmission Overhaul Kit 755 051 for 20:1 ratio transmissions, part numbers 4268-00 and 4268-00-1, or Kit 755 050 for 40:1 ratio transmissions, part numbers 1049-00-1 and 1049-00-3. (See Parts Catalog for serial numbers affected; refer to appropriate Service Manual for transmission removal and installation.)

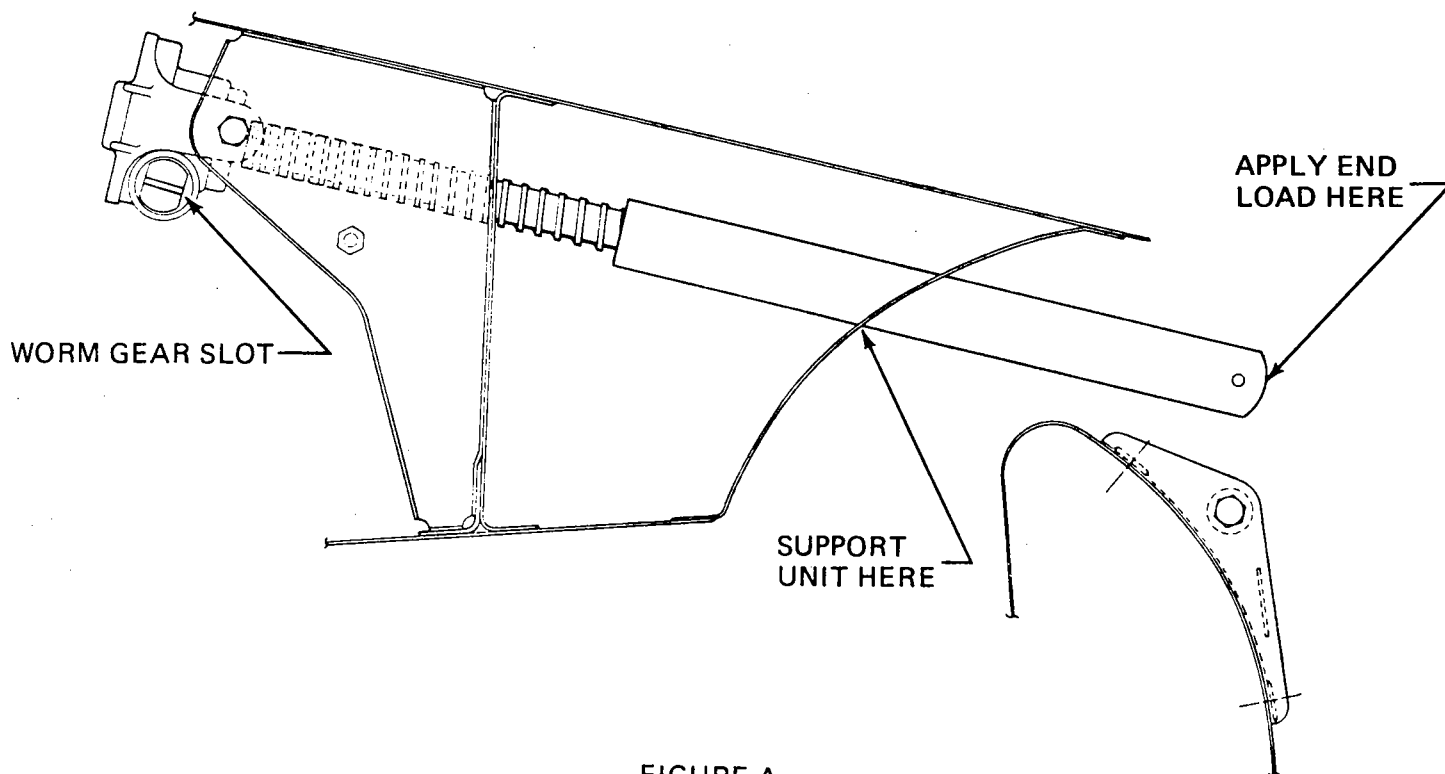
FIGURE A

1. Extend the transmission screw to the end of its travel.
2. Using a flat blade screwdriver inserted into the slot of the worm gear on the transmission (see Figure A), turn the gear 20 turns for the 4268 unit or 40 turns for the 1049 unit and note any tight or high spots as the worm gear is rotated.

The transmission should have an end load applied while turning the worm gear. (See Figure A.)
