# SERVICE BULLETIN

No. 526A

Piper Aircraft Corporation

Pilot/Copilot Microphone and Phone Jack Relay  
Modification

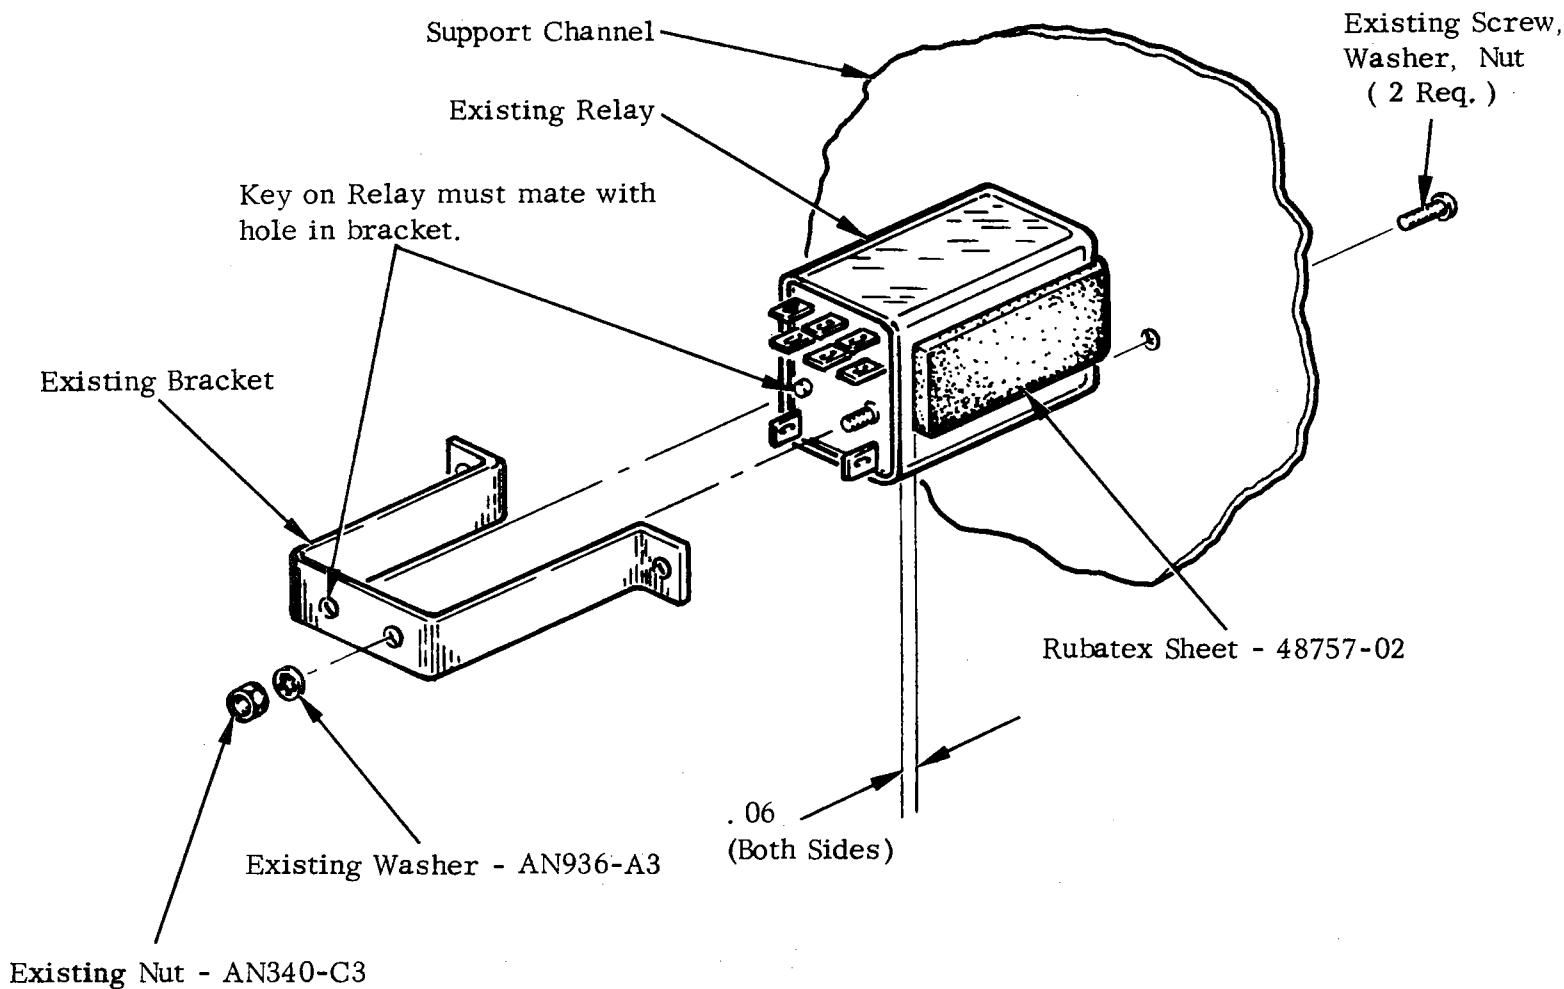
### PILOT/COPILOT MIKE AND PHONE JACK RELAY DETAIL

Purpose: Intermittent operation of the copilot's microphone was determined to have occurred as a result of the pilot/copilot's microphone and phone jack relay loosening (through vibration) from its mounting bracket. This can, in turn, cause the 28 volt pin on the relay coil to contact the mounting bracket, causing an electrical short.

This Service Release provides material and instructions for applying a rubber strip to the relay assembly, to dampen vibration and increase the rigidity of the mounting bracket.

1. Ensure master switch is off.
2. Locate pilot/copilot mike and phone jack relay, as shown in detail above. The relay will be located near the copilots mike and phone jack.
3. Remove relay and attaching bracket as one unit. Retain hardware for reinstallation.
4. Disconnect relay from bracket. Retain washer and nut for reinstallation.
5. Wrap rubatex sheet 48757-02 around relay and trim to dimension shown above. Attach existing relay, with rubatex sheet, to existing bracket as shown using existing nut and washer.
6. Reinstall switch and bracket assembly to aircraft using existing hardware.
7. Make proper logbook entry of Service Bulletin 526A Compliance .
