# SERVICE BULLETIN

No. 527

Piper Aircraft Corporation

Electric Trim Switch Modification

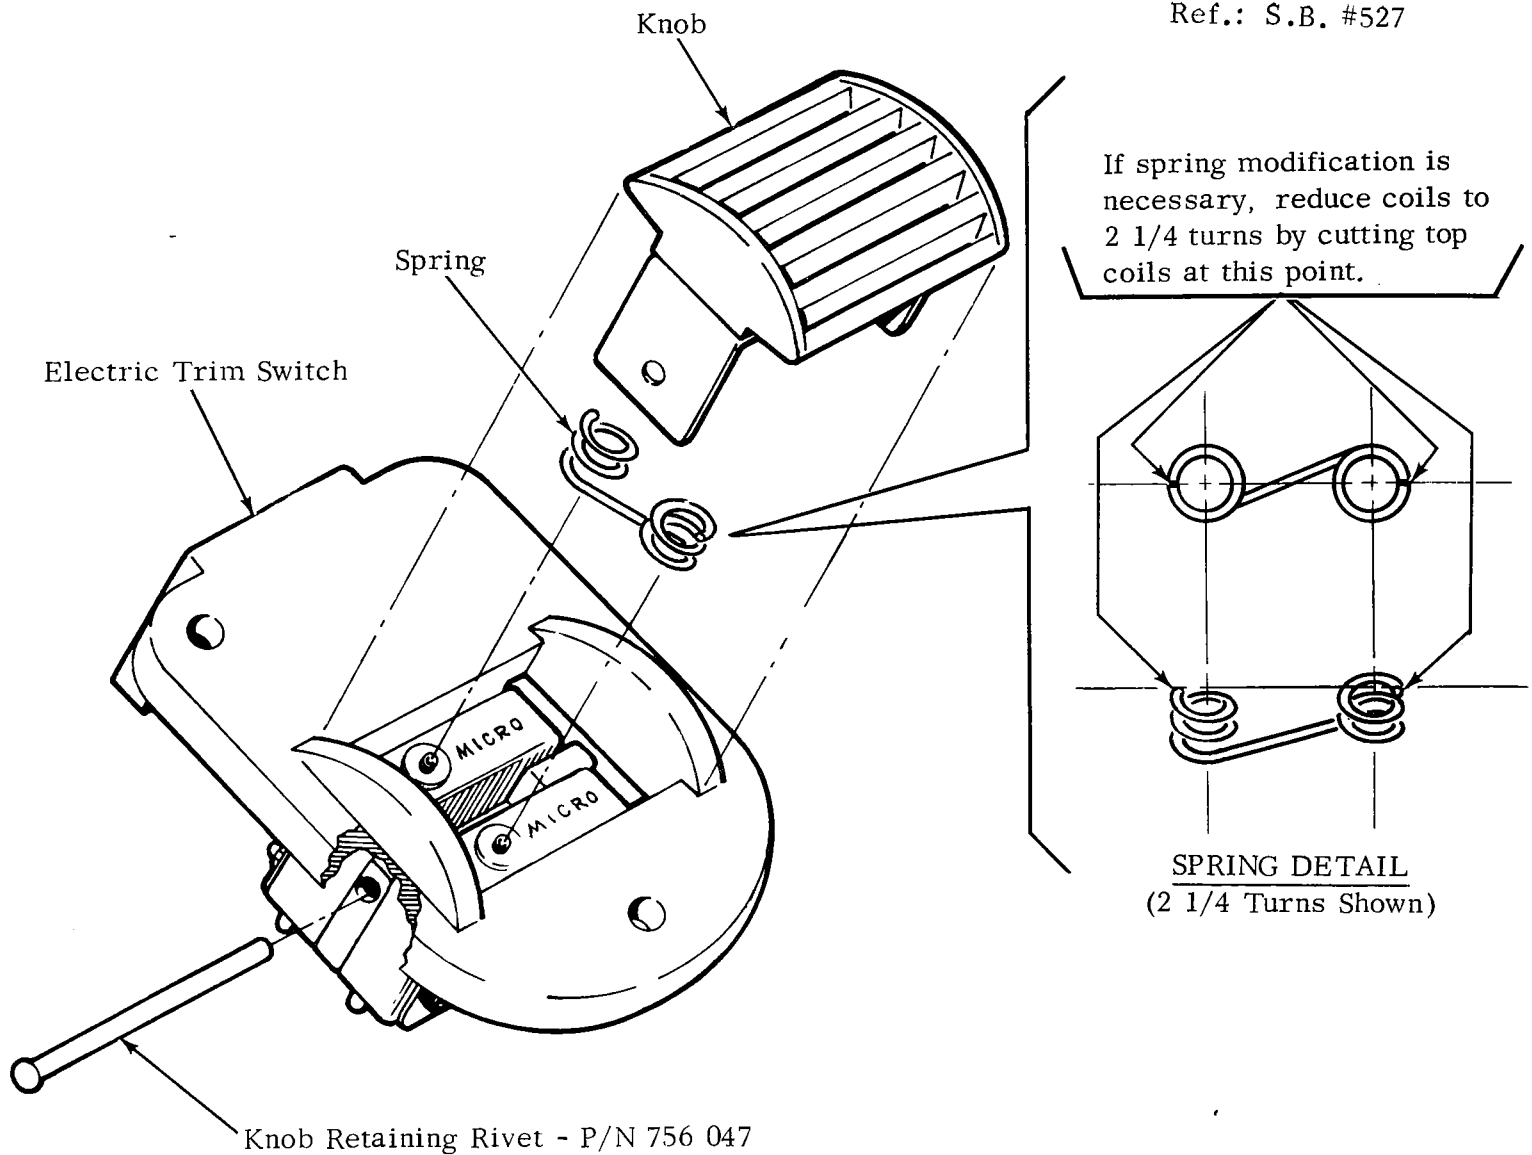
Purpose: Field reports describe a condition wherein the pilot's control wheel mounted "rocker" type electric trim switch tends to "hang up" in the "FWD"/"NOSE UP" or "AFT"/"NOSE DOWN" mode; i.e., fails to return to the "neutral" position following removal of thumb pressure. This condition occurred on some aircraft modified in accordance with Service Bulletin No. 331. Subsequent investigation revealed that the switch return coil springs supplied with Piper Kit No. 760 505 (Electric Trim Switch Modification), per Service Bulletin No. 331 and subsequent production modified models--for a period of time--had an excessive number of coils, which may cause the end of the coil spring to become caught between the switch "rocker" actuator and the micro switch body, thus preventing spring assisted return of the switch to "neutral".

To remedy--and prevent--this condition, this service release provides instructions to modify the electric trim switch return spring by reducing the number of coils (from 2 1/2 turns to 2 1/4 turns--reference attached sketch/instruction sheet for an illustrated view of this condition).

1. Carefully remove placards from electric trim switch.
2. Remove two screws which secure the switch to the control wheel and remove switch.
3. Remove knob retaining rivet by filing peened or crimped head and carefully knocking out.

4. Remove knob and spring from switch.
5. Inspect spring to determine if coils consist of 2 1/4 turns as shown in above detail or 2 1/2 turns.
  - a. If coils consist of 2 1/4 turns, proceed to Step 6.

- b. If coils consist of 2 1/2 turns, modify spring by cutting 1/4 turn from top of coils before proceeding to Step 6. Refer to spring detail above.
6. Place spring (P/N 757 685 - Scott #10004324) over micro-switch buttons with open ends of spring facing up. Spring coils must be concentric with micro-switch buttons and shoulders, and must not rest upon them.

7. Place knob in position and depress slightly so that the new retaining rivet (P/N 756 047 - Scott # 36270) can be installed. Take care not to dislodge spring from position.

8. Test switch action.
9. Crimp or peen end of retaining rivet to retain.
10. Reinstall switch on control wheel with existing screws and cement placards to switch.
