SERVICE BULLETIN

No. 546

Piper Aircraft Corporation

Inspection of Whelen Wing Tip Strobe Lights;
Reference F.A.A. Airworthiness Directive
75-05-04

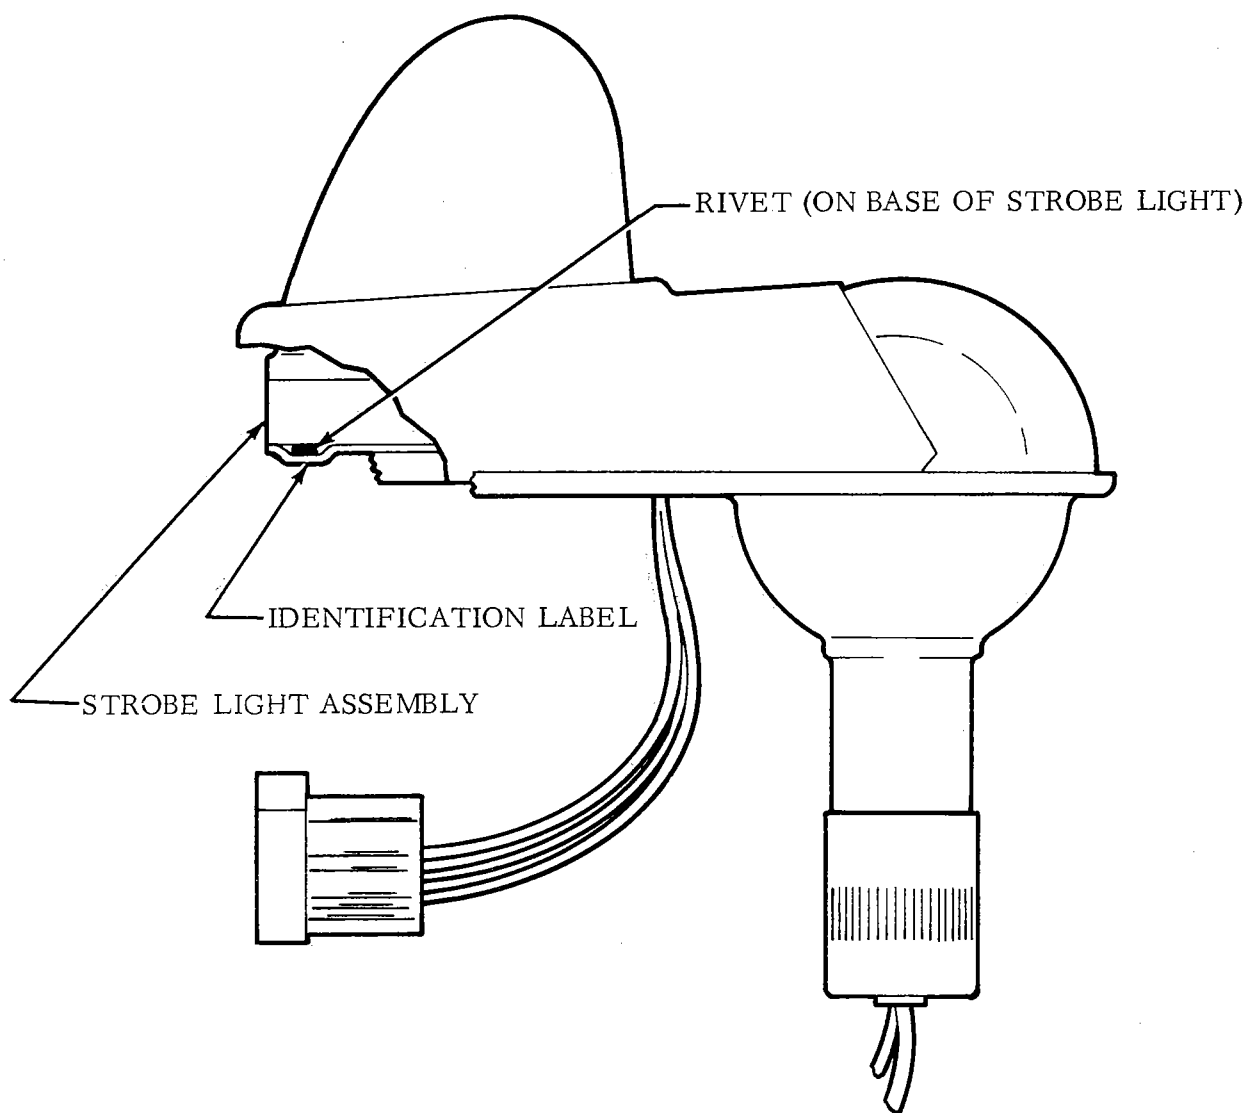
WHELEN NAVIGATION AND STROBE LIGHT ASSEMBLY

Purpose: The subject Airworthiness Directive was issued against the Whelen Engineering Company A-427 Strobe Light Assemblies "to preclude possible ignition of flammable fluids or vapors by arcing at the strobe light flash tube" (quoted from A.D. 75-05-04). The affected strobe light units may be installed as original equipment on the aircraft specified above, and it has been brought to our attention that a number of these strobe light units may not be in accordance with the subject Airworthiness Directive.

1. Expose wing tip strobe light assembly to view (refer to attached sketch for a typical strobe light assembly illustrated view).
2. If the following modification has already been accomplished, no further action is required; make appropriate entry in aircraft log book re compliance with this Service Release.

3. If the following modification has not been accomplished, proceed as follows:
 - a. Install on the base of the Whelen A-427 Flash Tube Assembly a pressure sensitive vinyl label conforming to Whelen drawing no. A-30052, Revision 1 dated October 15, 1974 or later F.A.A. approved revision.

1. Scotch Brand Type 33+ Vinyl Plastic electrical tape or equivalent tape - approved by an F.A.A. Maintenance/Avionics Inspector may be used in lieu of the vinyl label (if any plastic tape is used, it must be formed to cover the rivet at the rear of the flash tube without covering the identifying part number).

3. b. If the flash tube incorporates a label, the new label or tape may be installed directly over the old label.
- c. Install label or tape only when the label or tape and the flash tube are at a temperature above 50 degrees F.
4. Make appropriate service release compliance entry in aircraft log book.
