# SERVICE BULLETIN

No. 549

Piper Aircraft Corporation

<u>Subject:</u>	Elevator Bungee Link Modification
<u>Models Affected:</u>	<u>Serial Numbers Affected:</u>
PA-31, PA-31-325 Navajo.....	31-7612001 to 31-7612080 Inclusive; 31-7612082 to 31-7612091 Inclusive; 31-7612096; 31-7612099; 31-7612101; 31-7612102; 31-7612104; 31-7612105; 31-7612107 and 31-7612108.
PA-31-350 Navajo Chieftain.....	31-7652001 to 31-7652015 Inclusive; 31-7652017 to 31-7652162 Inclusive; and 31-7652164 to 31-7652170 Inclusive.

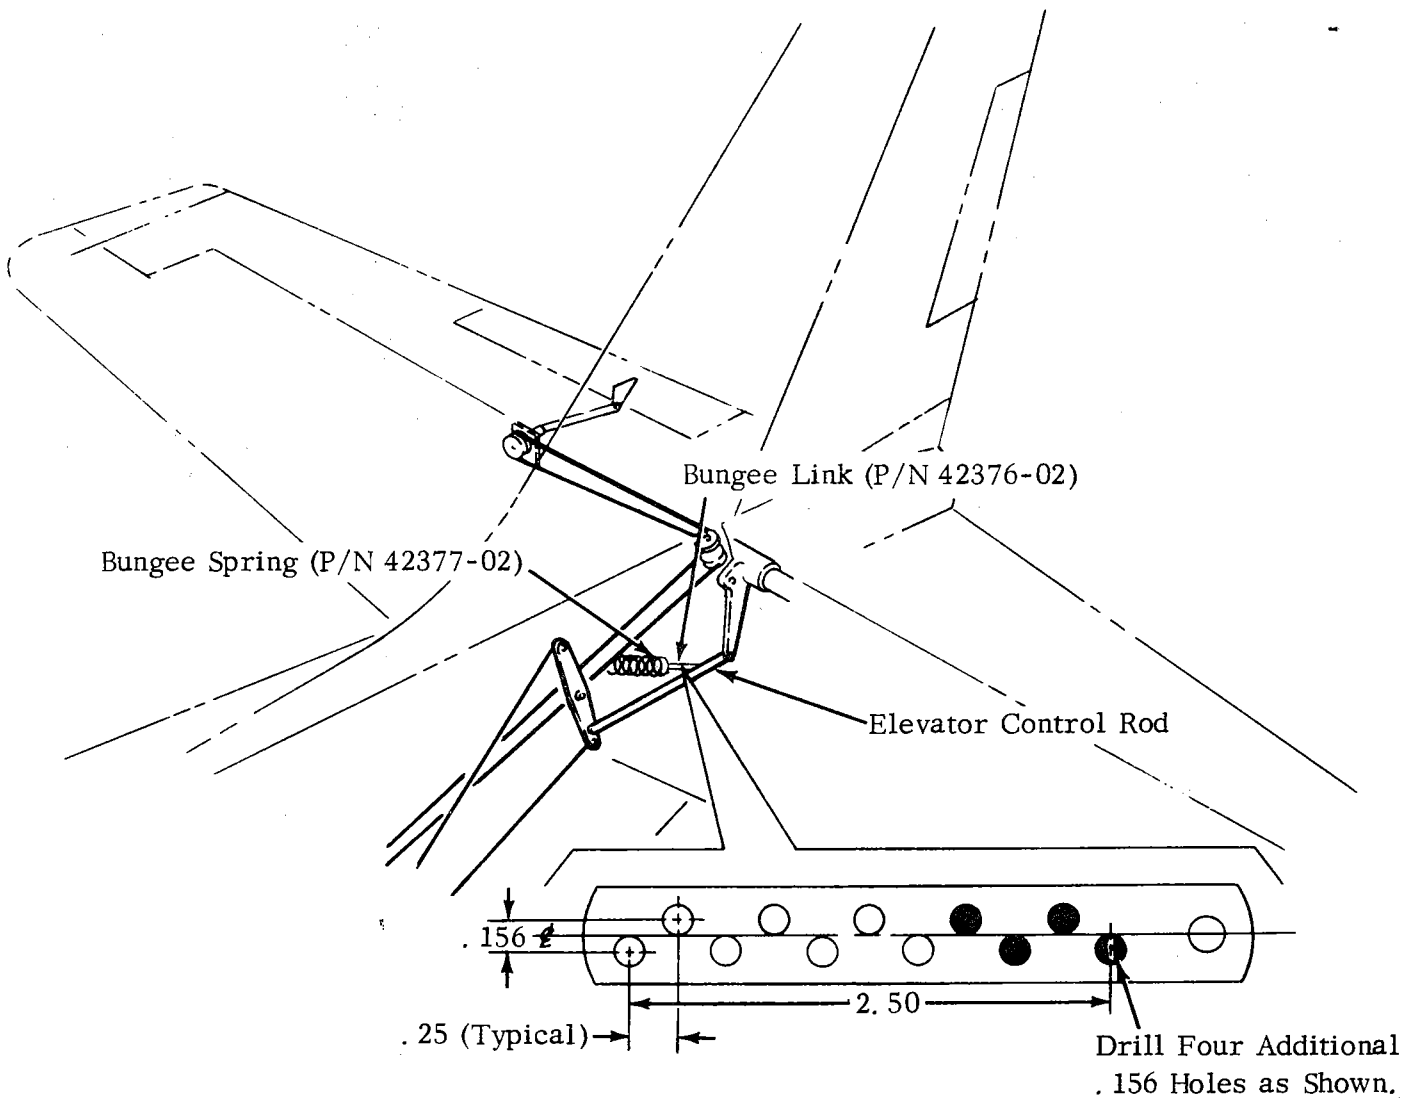
### BUNGEE LINK REWORK DETAIL

Purpose: During routine factory elevator control rigging/adjustment procedures involving the above referenced aircraft, the specified elevator bungee ("down") spring tension was, in some instances, not obtained due to insufficient adjustment at the elevator bungee link. This condition can be resolved by drilling additional spring attachment/adjustment holes, permitting additional (if necessary) spring tensioning.

1. Remove bottom half of tail cone and side access plate from aft fuselage to gain access to elevator bungee spring and link.
2. Disconnect the bungee spring from the link and remove hardware attaching the link to the elevator control rod.
3. Rework the bungee link by locating and drilling four additional .156 holes as shown in above detail.
4. Reinstall link to control rod using existing hardware.
5. Connect a spring scale to the aft end of the bungee spring and pull rearward until proper tension is obtained with the elevator in the neutral position.

Proper tension for PA-31 is 30 lbs.  $\pm$  1 lb.

Proper tension for PA-31-325 & PA-31-350 is 37 lbs. + 1 - 0 lbs.

At this point, observe which hole in the link is in line with the hook at the end of the spring and connect the spring into this hole. If necessary, cut off excess link material (.188 min. edge distance) for ease of spring attachment. (Reference "Rigging and Adjustment of Elevator Controls" in appropriate Service Manual.)

6. Reinstall access plate and bottom half of tail cone to aft fuselage.
7. Make proper Logbook entry of Service Letter compliance.
