# SERVICE BULLETIN

No. 550

Piper Aircraft Corporation

Engine Control Cable Inspection

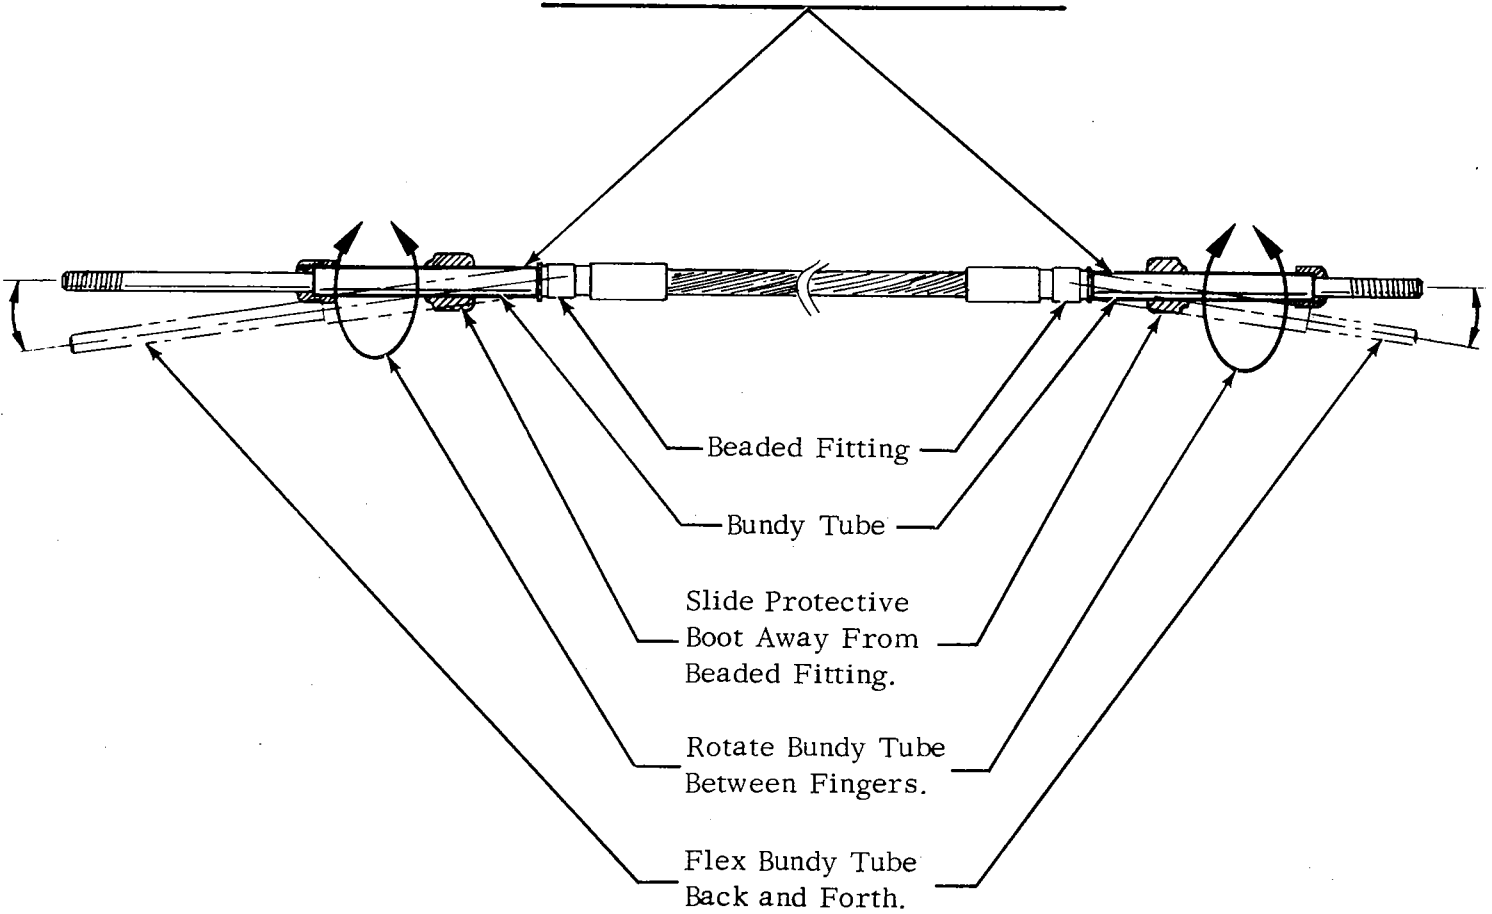
Purpose: During installation of the engine throttle and mixture control cables, in some cases, the cable Bundy Sleeve would crack or break where it enters the cable housing. Investigation revealed that the Bundy Sleeve on certain groups of cables received from the manufacturer had been improperly heat treated. This condition could result in the Bundy Sleeve becoming detached from the cable housing and thereby limiting throttle and/or mixture control cable travel.

Inspect Bundy Tube and Beaded Fitting for Cracks or Other Damage.

5. Visually inspect the Bundy Sleeve in the area of the beaded fitting for cracks or other damage; also, inspect the end of the housing for any damage.
6. If no sleeve cracks are present and there is no damage to the housing, reinstall rubber boot and reconnect cable; insure proper cable/control function.
7. If the Bundy Sleeve is cracked or broken and/or the housing is damaged, replace applicable cable (see Material Required, below).
8. Enter service bulletin compliance data in aircraft log book.
