SERVICE BULLETIN

No. 574

Piper Aircraft Corporation

Subject: Fuel Crossfeed Control Shaft Security

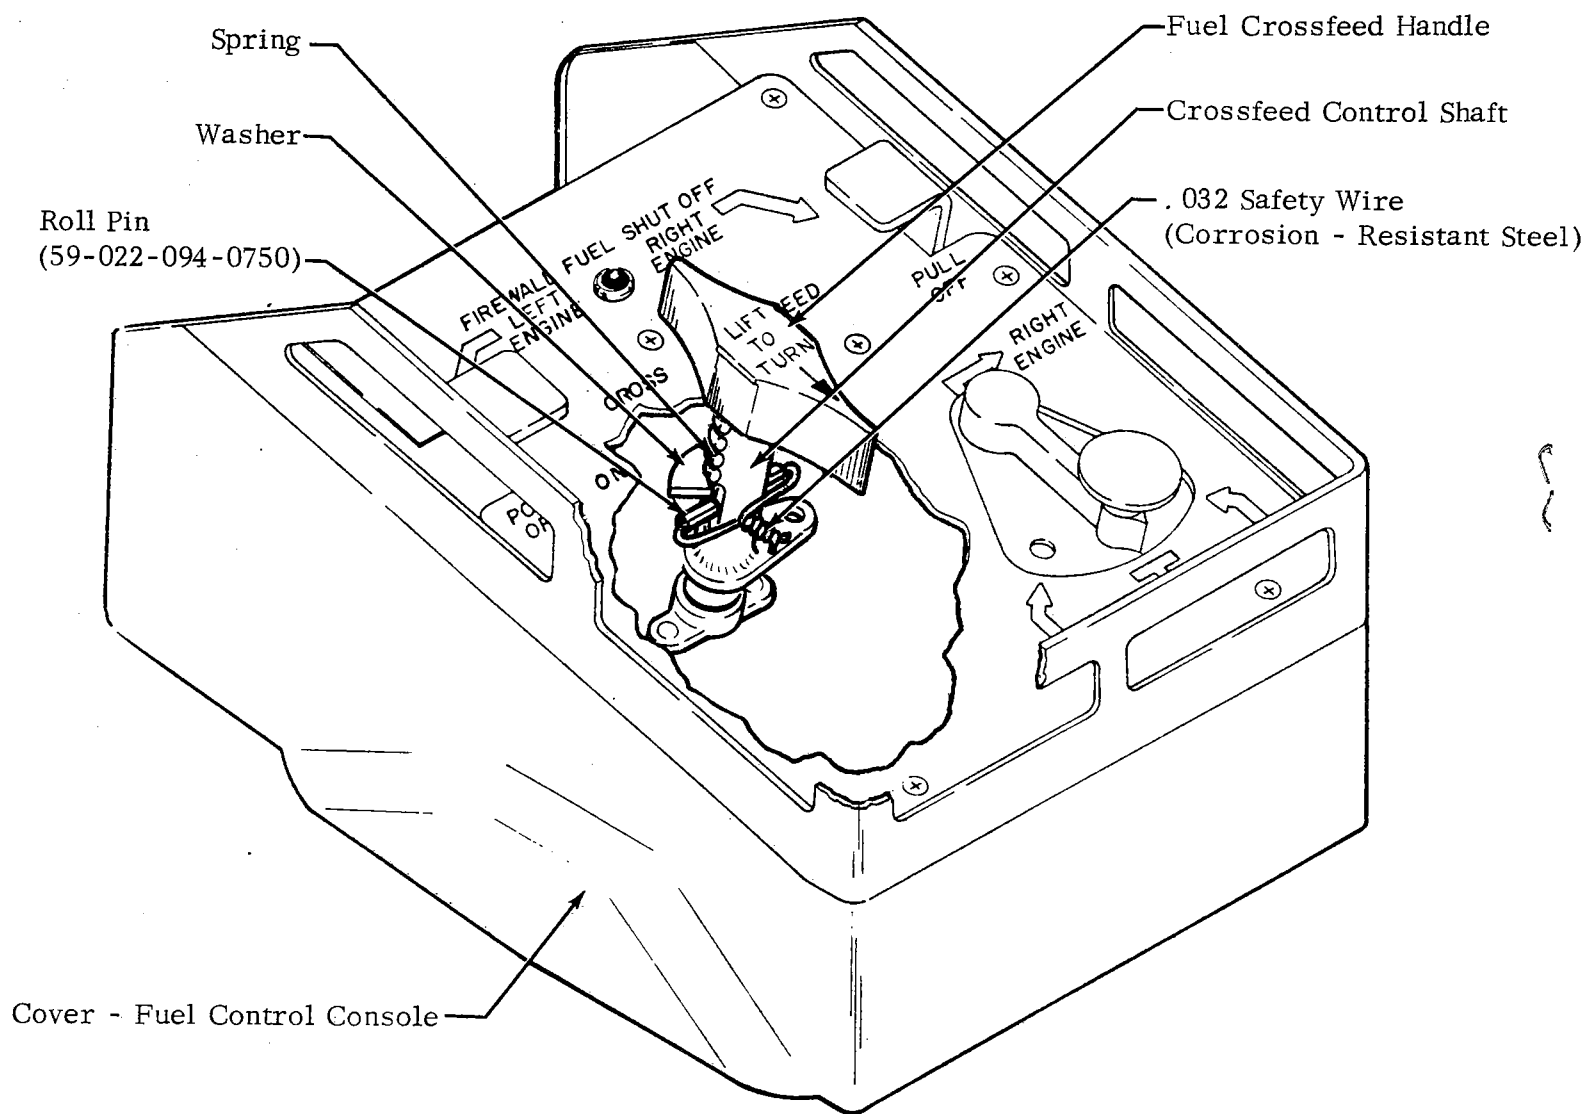
Purpose: It has been noted that the roll pin attaching the fuel crossfeed handle to the crossfeed control shaft may "shift" from its proper installation location. If left unattended, this condition could cause eventual loss of fuel crossfeed function due to jamming of the crossfeed handle.

1. Remove cover from fuel control console in cockpit area.
2. Inspect roll pin (59-022-094-0750) to insure that it is equally spaced in cross-feed control shaft.
3. Install .032 safety wire through roll pin and around crossfeed control shaft as shown above.
4. Turn fuel crossfeed handle to insure there is no binding from the safety wire.
5. Reinstall cover to fuel control console.
6. Make proper logbook entry of Service Bulletin compliance.
