# SERVICE BULLETIN

No. 575

Piper Aircraft Corporation

Inspection of Horizontal Stabilizer and Vertical  
Fin Stringer Attachment Rivets

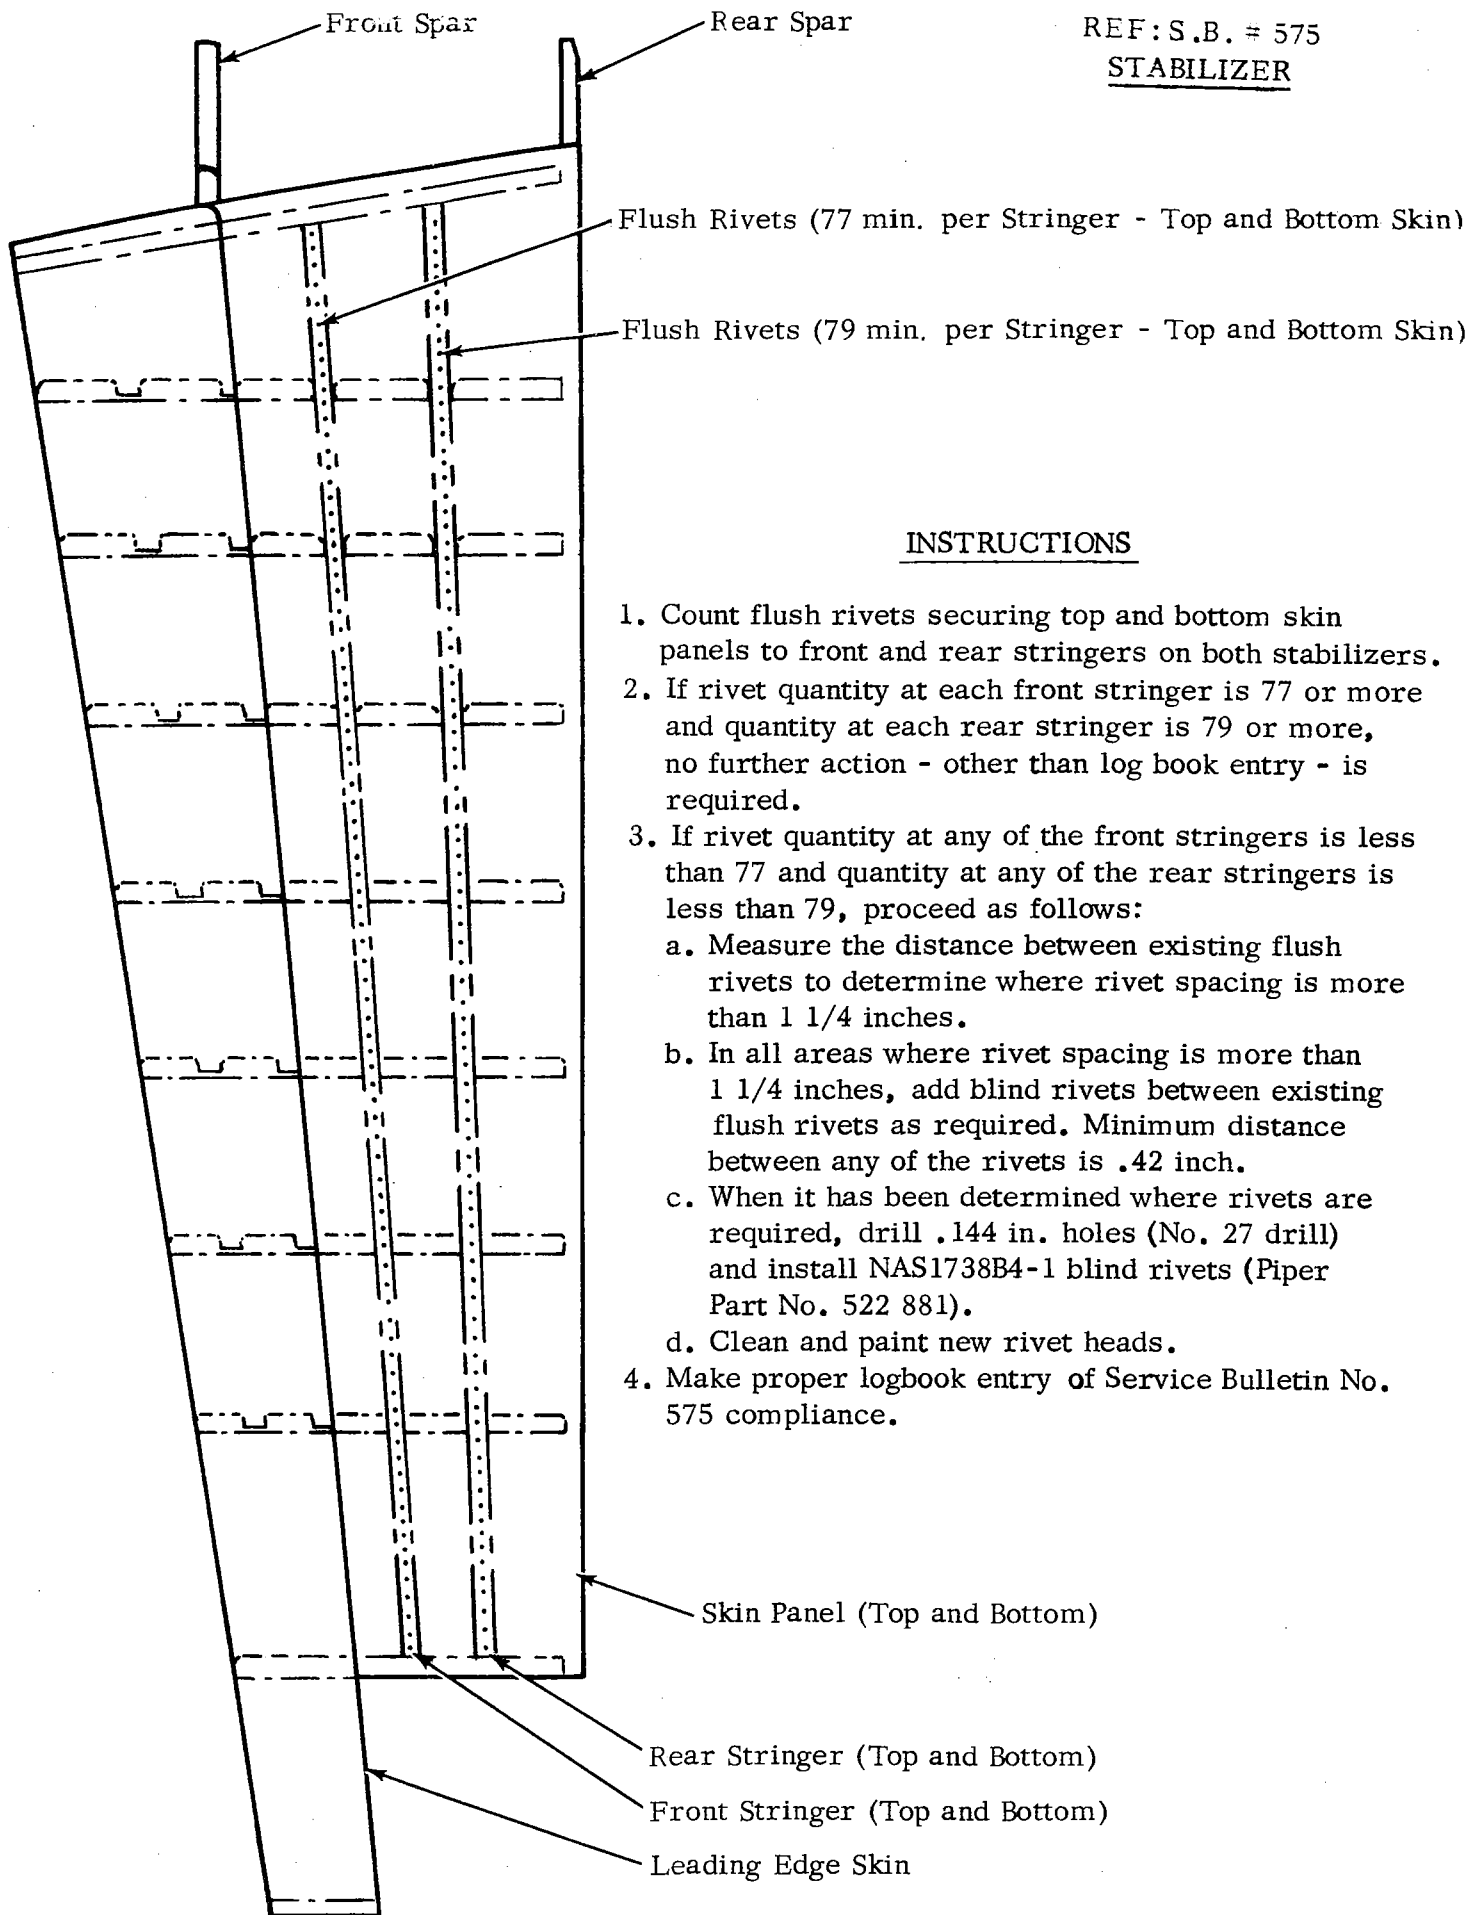
TOP VIEW OF LEFT STABILIZER SHOWN - RIGHT OPPOSITE

It has been determined that an improper number of rivets may have been used to attach stringers to skin panels in the areas referenced above. An inadequate number of rivet in the above locations may permit local buckling of the skin between rivets. The attached sketch/instruction data visually defines affected areas.

1. Count flush rivets securing top and bottom skin panels to front and rear stringers on both stabilizers.
2. If rivet quantity at each front stringer is 77 or more and quantity at each rear stringer is 79 or more, no further action - other than log book entry - is required.

3. If rivet quantity at any of the front stringers is less than 77 and quantity at any of the rear stringers is less than 79, proceed as follows:
  - a. Measure the distance between existing flush rivets to determine where rivet spacing is more than 1 1/4 inches.

- b. In all areas where rivet spacing is more than 1 1/4 inches, add blind rivets between existing flush rivets as required. Minimum distance between any of the rivets is .42 inch.

- c. When it has been determined where rivets are required, drill .144 in. holes (No. 27 drill) and install NAS1738B4-1 blind rivets (Piper Part No. 522 881).

- d. Clean and paint new rivet heads.
4. Make proper logbook entry of Service Bulletin No. 575 compliance.

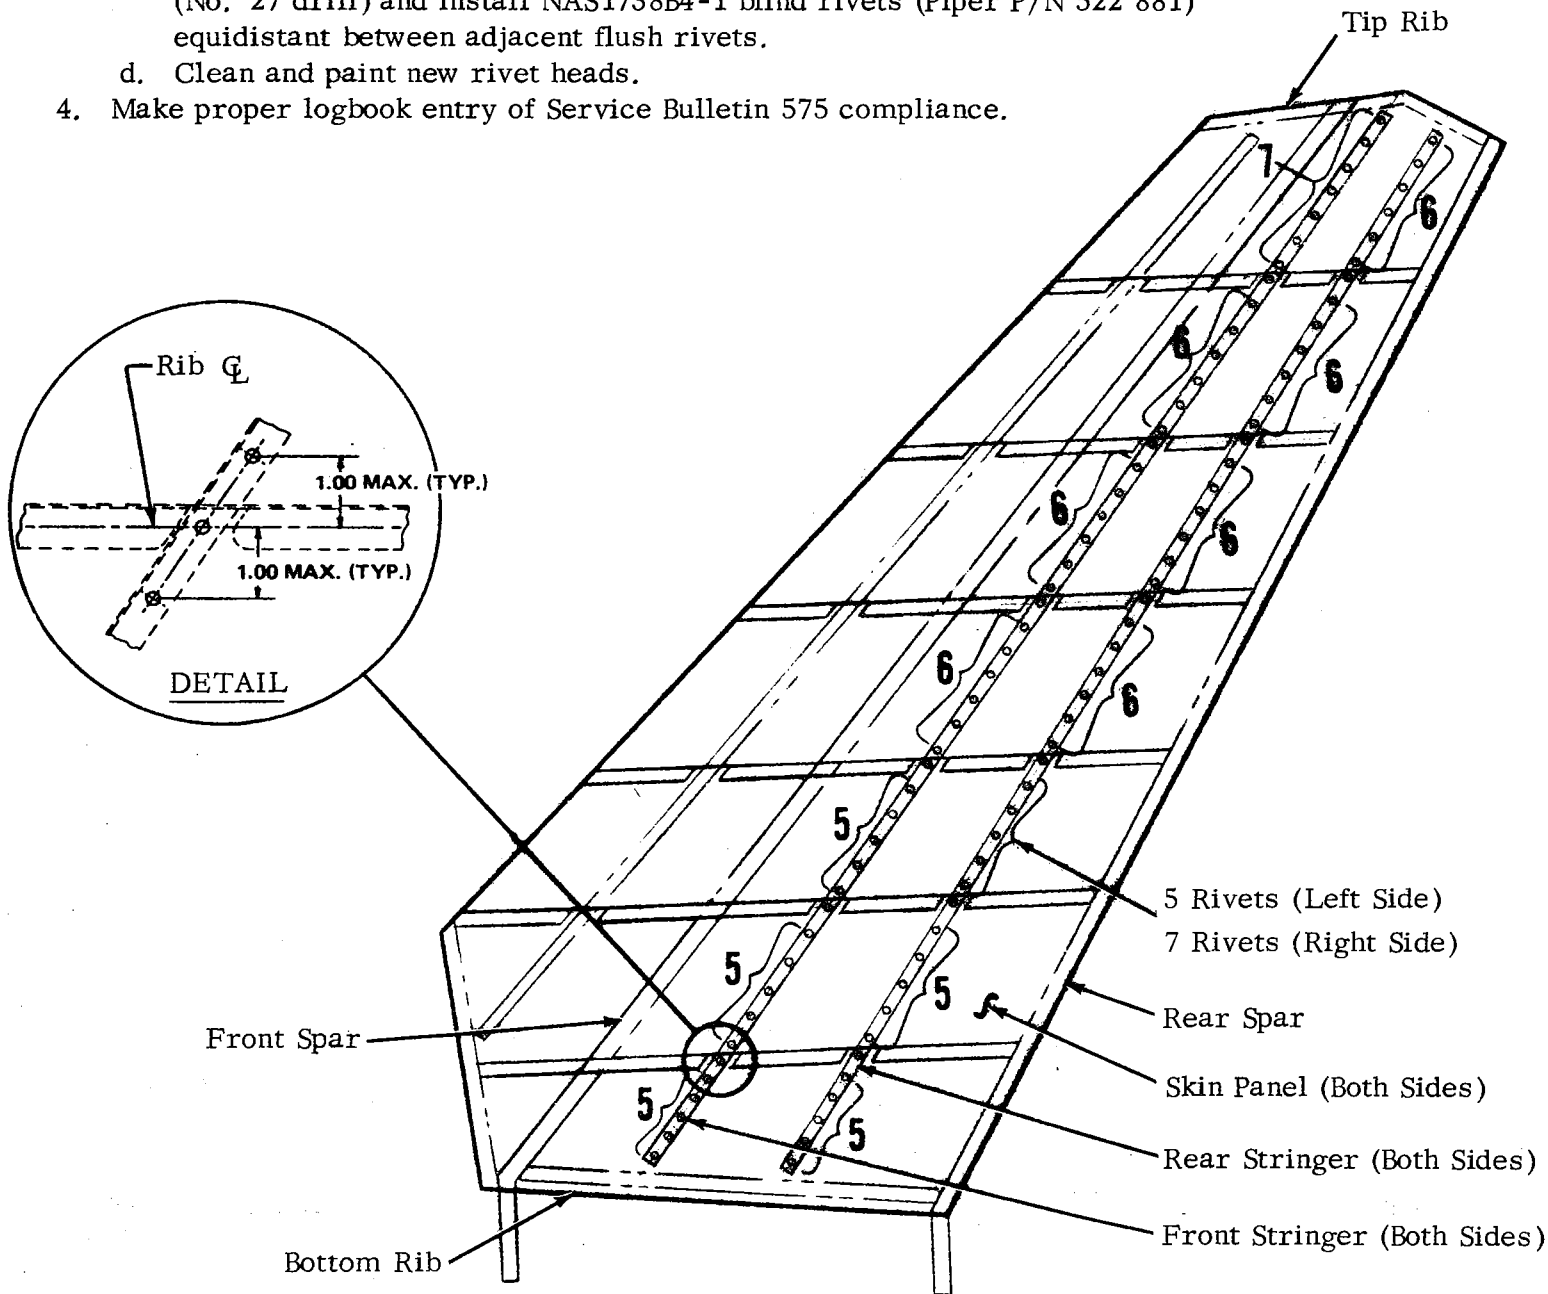
REF: S. B. #575  
FIN

LEFT SIDE VIEW OF VERTICAL FIN SHOWN - RIGHT OPPOSITE

1. Count flush rivets attaching front and rear stringers to skin panels on vertical fin (both sides).
  2. If rivet quantity at front stringer is 46 or more on each side, and rivet quantity at rear stringer is 44 or more on left side and 46 or more on right side, no further action is required.

3. If count reveals less rivets than specified above on any stringer, either side, proceed as follows:
    - a. Refer to sketch for minimum number of rivets in each bay (area between ribs).  
In any bay with less than minimum number of rivets, add a NAS1738B4-1 blind rivet between each existing rivet.

- b. The first rivet above and below each rib should be spaced 1" maximum, measured from the rib centerline. See detail.  
In any area where this spacing exceeds 1", add a NAS1738B4-1 blind rivet between rib and first stringer rivet.

- c. When it has been determined where rivets are required, drill .144 holes (No. 27 drill) and install NAS1738B4-1 blind rivets (Piper P/N 522 881) equidistant between adjacent flush rivets.

- d. Clean and paint new rivet heads.
  4. Make proper logbook entry of Service Bulletin 575 compliance.
-
