# SERVICE BULLETIN

No. 591

Piper Aircraft Corporation

Subject: Inspection of Goodyear BTC-39 Fuel Cells

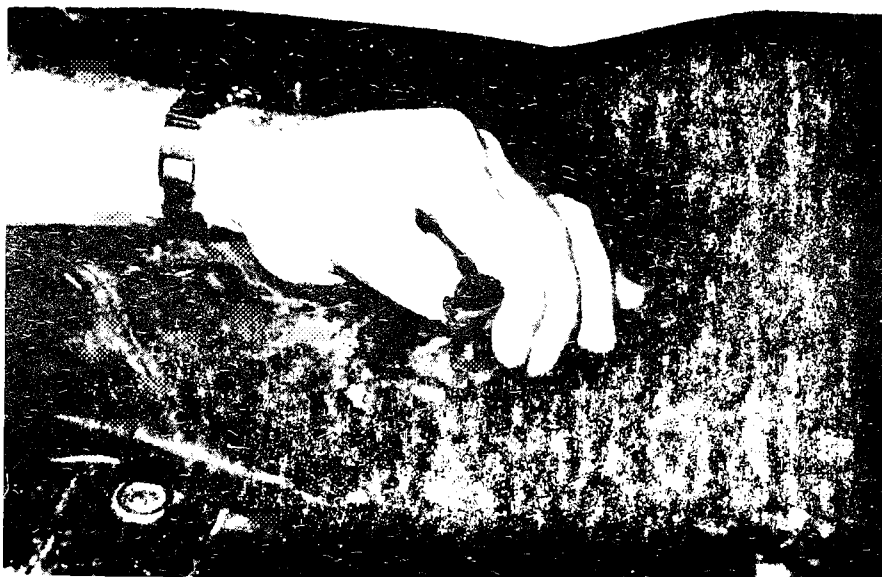
FIGURE 1

The fingernail test consists of using the fingernail to attempt to scrape the rubber off the nipple fitting (see Figure 1). If the rubber has not degraded, the fingernail will glide across the rubber without damage to the rubber. If an unsatisfactory condition exists, the fingernail will dig into the rubber. The rubber will have a consistency of either art gum or chewing gum.

4. Any fuel tank found seeping or with soft nipples should be replaced.
5. Replacement fuel tanks should be installed in accordance with aircraft manufacturers instructions.
