SERVICE BULLETIN

No. 636A

Piper Aircraft Corporation

<u>Subject:</u>	Bulkhead Reinforcement at STA .317.75
<u>Reason for Revision:</u>	Change <u>Compliance Time</u> , and <u>Purpose</u> .
<u>Models Affected:</u>	<u>Serial Numbers Affected:</u>
PA-31/31-300/31-325 Navajo	31-2 through 31-7912039
PA-31-350 Chieftain	31-5001 through 31-7952071
<u>Compliance Time:</u>	Within the next one hundred (100) hours of operation or at the next regularly scheduled inspection event, whichever occurs first, and every one hundred (100) hours of operation thereafter unless/until Kit 763 917 or Kit 764 028 is installed or if cracks are found, in which case Kit 764 028 <u>must</u> be installed.

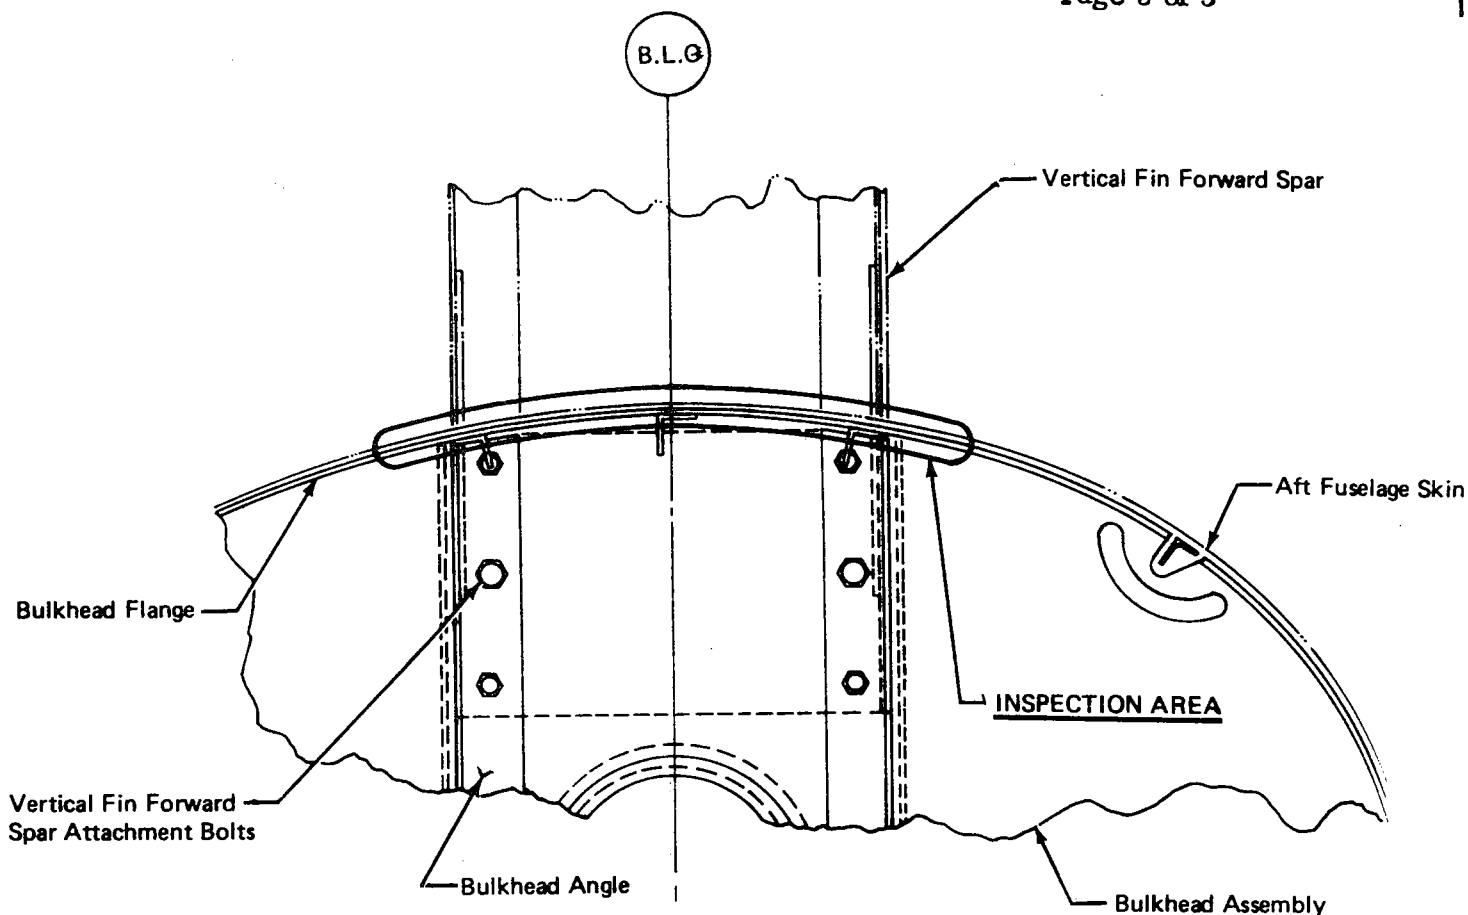
VIEW LOOKING AFT AT STA. 317.75 AFT FUSELAGE BULKHEAD

In several of the above listed aircraft, instances have occurred of cracks developing in the bulkhead flange area of STA. 317.75 at the attachment point for the vertical fin forward spar. If left unattended, this condition could eventually result in the loss of structural integrity of the vertical fin forward attachment. This condition has been limited to aircraft with two thousand (2000) or more hours of operating time.

1. Gain access to the forward side of Sta. 317.75 aft fuselage bulkhead by removing the right side access panel (aft of Sta. 274 bulkhead on aircraft so equipped) or by removing the interior closeout panel at Sta. 274.
2. Inspect the upper section of Sta. 317.75 bulkhead for evidence of cracks in the bulkhead flange area. Refer to sketch for inspection area. Use a 10X magnifying glass.
 - a. If no cracks are found, the bulkhead must be inspected at each 100 hours of operation unless Bulkhead Reinforcement and Drag Angle Installation Kit P/N 763 917 is installed.
 - b. If cracks are found, Bulkhead Reinforcement and Drag Angle Installation Kit P/N 764 028 must be installed prior to further flight.
3. Reinstall exterior and/or interior access panel(s).
4. Make proper Logbook entry of compliance with this Service Bulletin.
