Piper Aircraft Corporation
Vero Beach, Florida, U.S.A.

SERVICE No. 644D BULLETIN

Date May 29, 1986 M

Turbocharger Exhaust Coupling
Inspection/Replacement

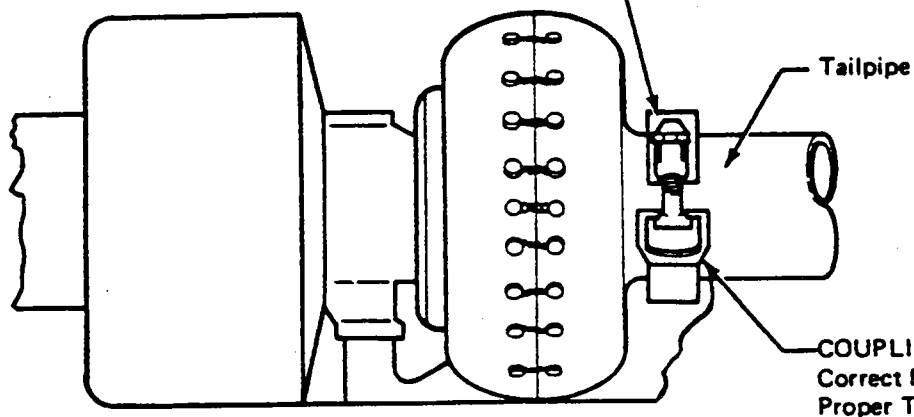
SKETCH "A"

1. Within the next ten (10) hours of operation, determine type of turbocharger exhaust coupling installed:
 - a. If single-piece type, Piper Part Number 556-962 (PA-31/31-325) or 556-053 (PA-31-350), replacement is required prior to further flight.
 - B. If segmented type, Piper Part Number 555-511 (PA-31/31-325) or 555-366 (PA-31-350), proceed to Instruction 2 below, in accordance with Compliance Time, PART I.
2. Remove upper engine cowlings.
3. Remove turbocharger exhaust couplings. Inspect couplings for cracks, spreading of sides, and indication of exhaust pipe flanges bottoming in coupling. (Refer to Sketch "A" attached). Inspect coupling clamp bolt for bending, overstress and cracks. (Refer to Sketch "A").

Inspect Tailpipe And Turbocharger
Flanges For Proper Mating.

Inspect Turbocharger Flange For
Carbon Deposits, Cracks And Distortion.

Inspect Coupling Strap For
Cracks, Separation And Distortion.

Inspect Coupling V Bands For
Cracks, Separation From Strap
And Distortion.

Inspect Coupling Bolt For Bends,
Distortion, Cracks And Thread Damage.

Inspect Tailpipe Flange For Carbon
Deposits, Cracks And Distortion.

7. Install coupling on exhaust flange and torque nut in accordance with Sketch "A" while tapping gently around the periphery with a soft mallet to distribute band tension.
8. Turbocharger to tailpipe coupling with one-thousand (1000) hours or more time in service must be replaced. (See MATERIAL REQUIRED, below).

Torque The Coupling Nut In Accordance With This Chart

Model	Clamp Part Number	Torque
PA-31-350	555 366 (MVT68049-450M)	45-55 in. lbs.
PA-31/PA-31-325	555 511 (MVT69861-377M)	40-50 in. lbs.

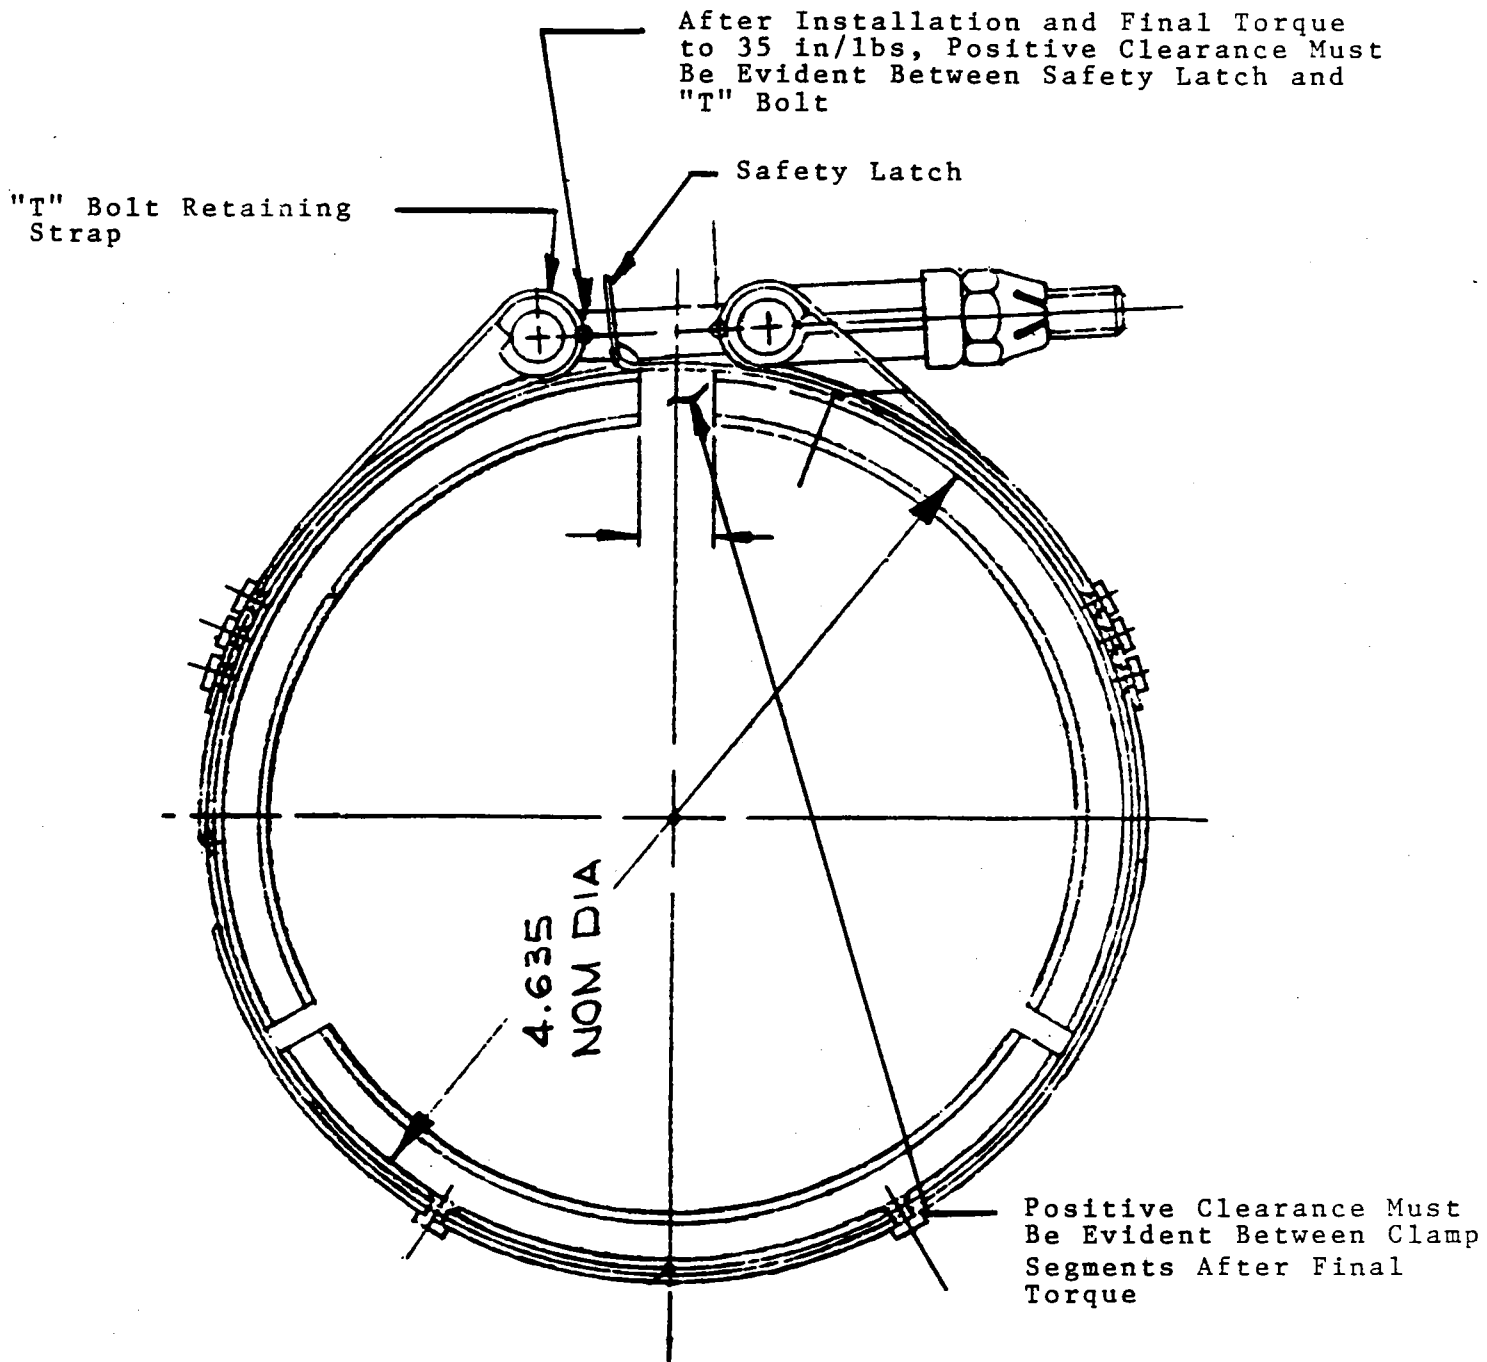
V BAND CLAMPING DETAILS

5. Tighten couplings to torque value of 30 inch/pounds minimum, 35 inch/pounds maximum.
6. Secure and tighten waste gate exhaust clamps previously loosened per note above.
7. Inspect couplings for positive clearance between safety latch and "T" bolt, and between coupling segments after final torque. See Sketch "B" attached.
8. Reinstall upper engine cowlings.
9. Make appropriate logbook entry of compliance with PART II of this Service Bulletin.

1. If couplings, Piper Part Number 557-584 and 557-369 have been installed prior to the date of this publication, comply with following instructions.
2. Remove upper cowlings on left and right engines.
3. Inspect couplings for positive clearance between safety latch and "T" bolt, and between coupling segments, after final torque. See Sketch "B" attached.
4. Inspect couplings for security and that "T" bolt is not bottomed out.
5. If couplings are found to be distorted and/or bottomed out, replacement is required. (See MATERIAL REQUIRED, below).
6. Reinstall upper cowlings on left and right engines.
7. Make appropriate logbook entry of compliance with PART III of this Service Bulletin.

Torque The Coupling Nut In Accordance With This Chart

Model	Clamp Part Number	Torque
PA-31-350	557-369 (NH1005798-10)	30-35 in.lbs.
PA-31/PA-31-325	557-584 (NH1005834-10)	30-35 in.lbs.
