Piper Aircraft Corporation
Vero Beach, Florida, U.S.A.

SERVICE *No. 860* BULLETIN

Date April 14, 1987

Main Landing Gear Downlock Cable
Anti-Rotation Stop Replacement

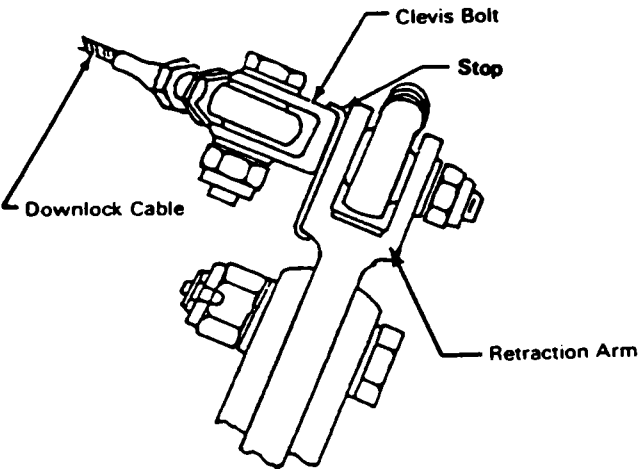
Old Configuration

It has been determined that the existing anti-rotation stop used in conjunction with the main landing gear downlock cable, as installed on certain aircraft as a field retrofit or original factory installation, can allow the cable attach clevis bolt to rotate. This in effect shortens the length of the downlock cable, preventing full engagement of the downlock hook assembly. If this condition exists and is left uncorrected, a gear unsafe condition could occur.

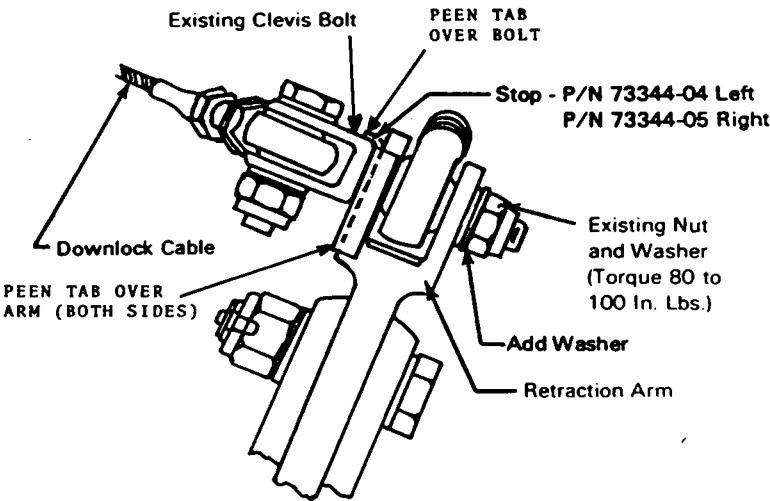
New Configuration

This Service Bulletin announces the availability of an improved anti-rotation stop which, when installed, will prevent the above described condition.

1. Place aircraft on jacks.
2. Remove nut and washer from the clevis bolt connecting the downlock cable to the retraction arm. See Sketch "A" attached.
3. Pull out the clevis bolt, remove and discard the existing anti-rotation stop, if installed.
4. Install new anti-rotation stop, Piper Part Number 73344-04 (left gear) and 73344-05 (right gear) over the bolt and reinsert bolt through the retraction arm.

5. Install an additional AN960-416 washer as well as existing washer and nut. Torque nut 80 to 100 inch pounds. See Sketch "A".
 6. Insure that tab on anti-rotation stop secures clevis bolt. See Sketch "A".
 7. Repeat procedure on opposite gear.
 8. Perform a gear function check.
 9. Remove aircraft from jacks.
 10. Make a logbook entry of compliance with PART II of this Service Bulletin.
-
