# SERVICE *No. 974* BULLETIN

DATE: October 19, 1994

Aileron Hinge Inspection and Replacement

PA-31, 31-300, 31-325 Navajo  
PA-31-350 Navajo Chieftain  
PA-31-350 T1020  
PA-31P-350 Mojave  
PA-31T3 T1040

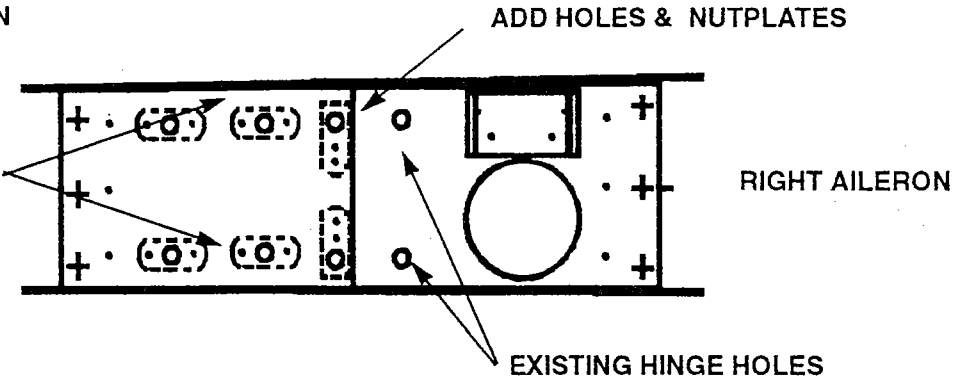
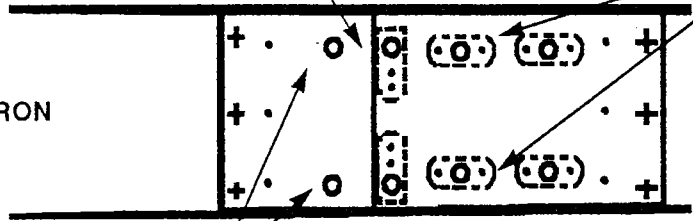
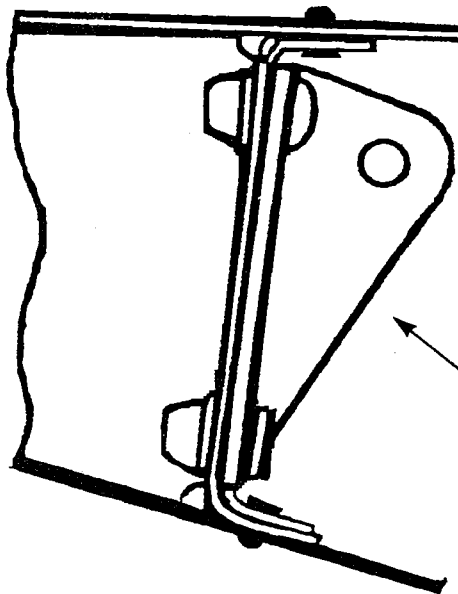
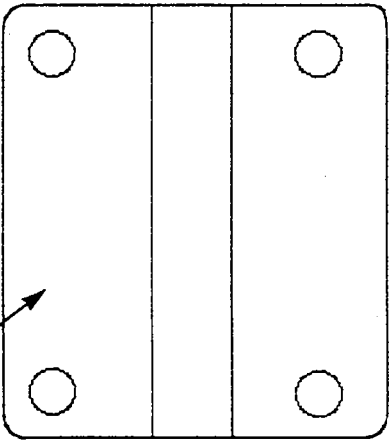
SKETCH A

Reports have been received of small cracks developing in the aileron spar and reinforcement doubler beneath the inboard aileron hinge attachment point.

INSPECT:  
CRACKS WILL  
APPEAR ALONG  
SPAR FLANGE  
AND AT ATTACH  
HOLES.

ADD HOLES & NUTPLATES

INSTALL NEW HINGE  
P/N'S 74461-02 (LEFT)  
AND 74461-03 (RIGHT)
