Service Letter No. 505A
(Supersedes Service Letter No. 505)

May 2, 1968

Fuselage Drain Holes

PA-31 Navajo

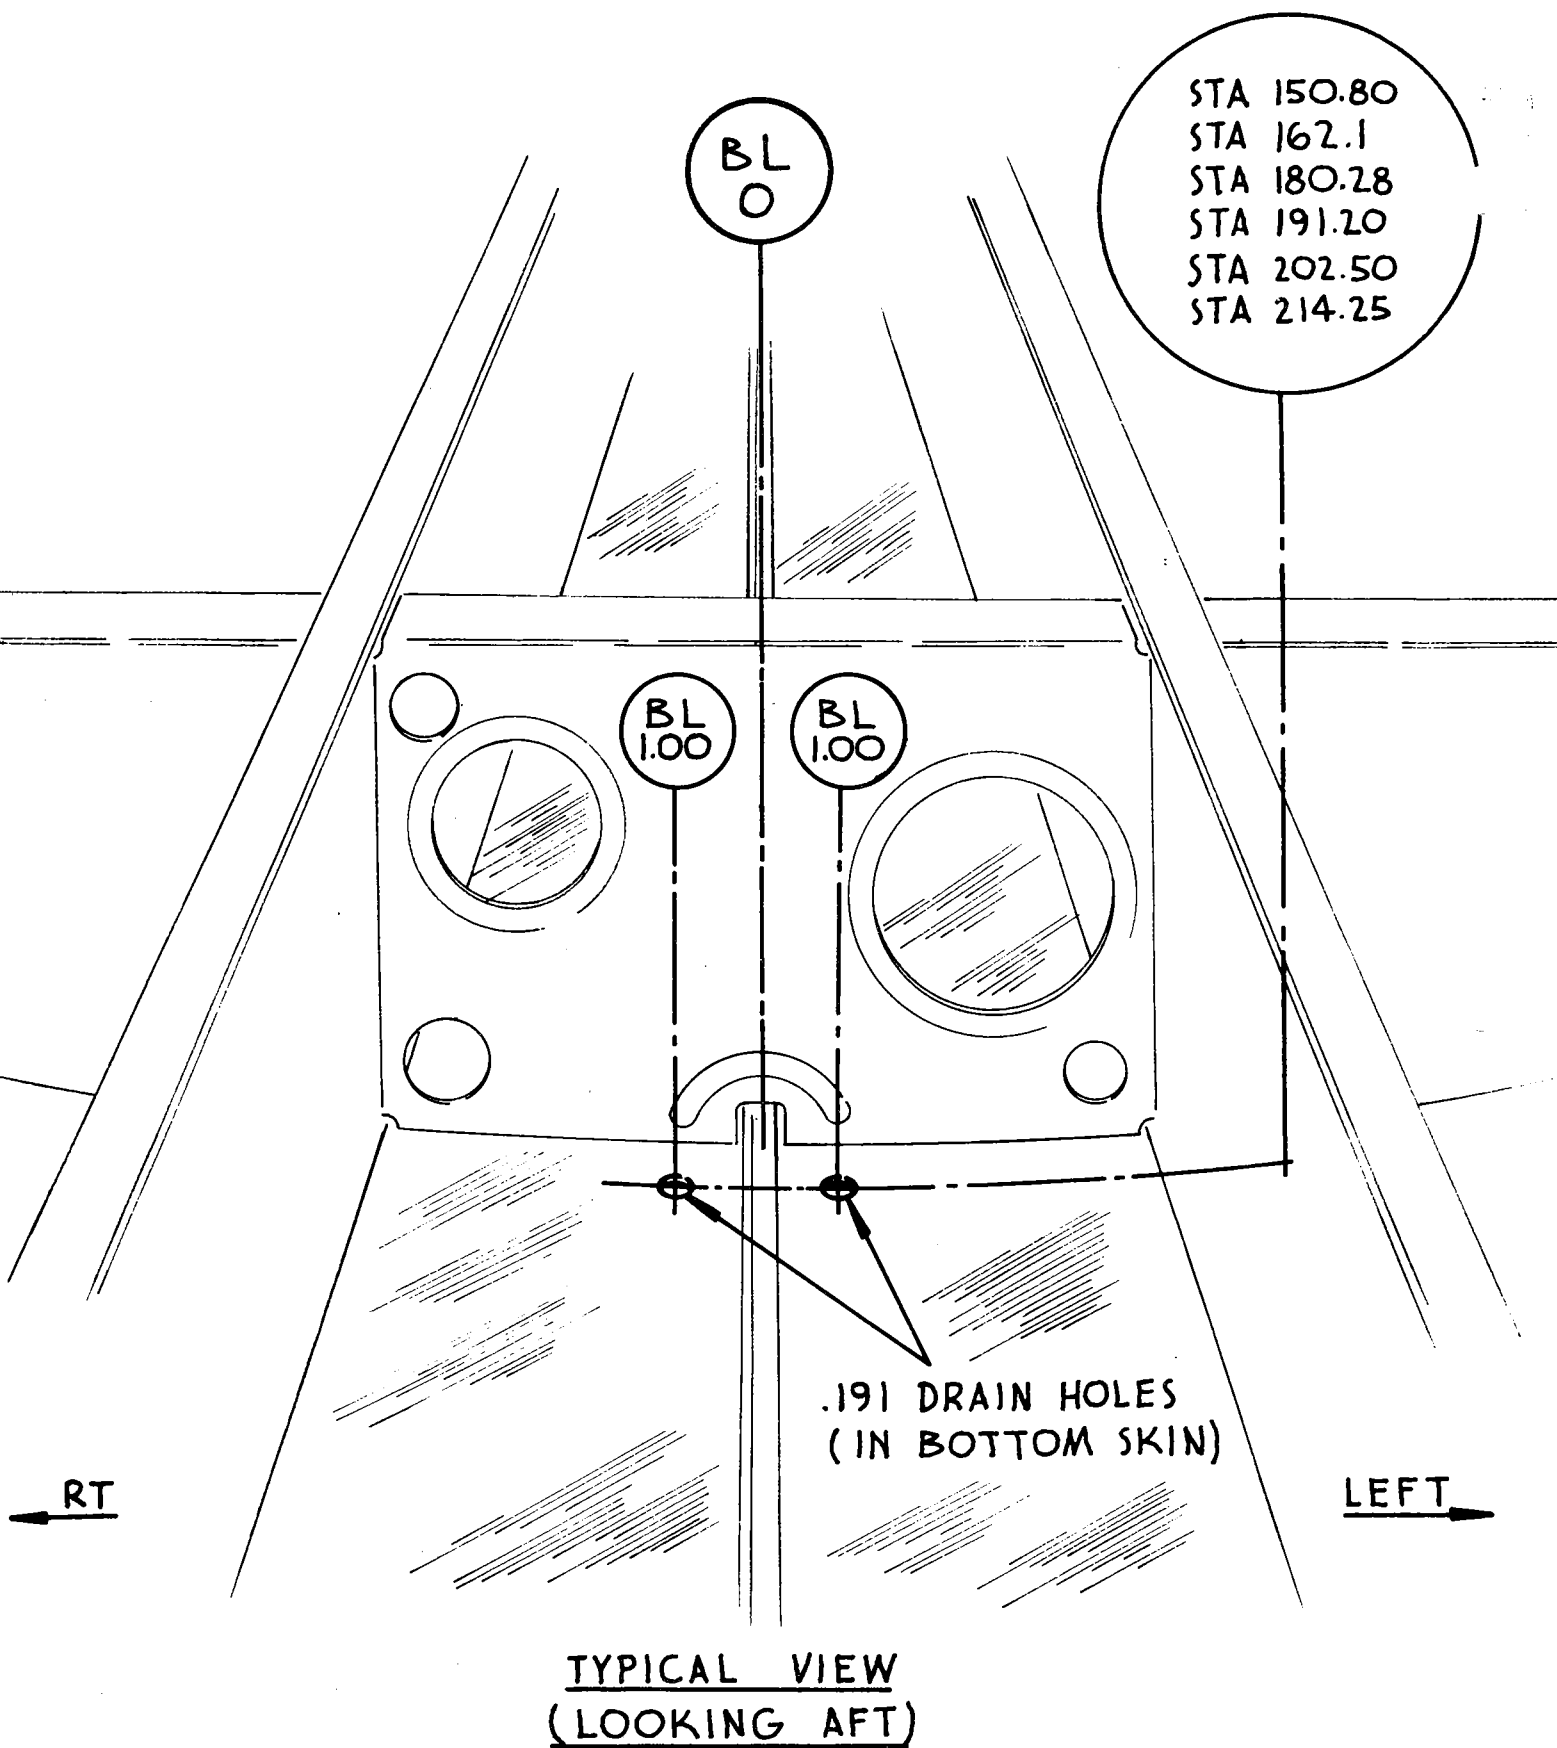
To provide drain holes at various fuselage locations.

Each hole must be drilled .191 inches in size. The proper hole locations are depicted on the reverse side of this letter.

It is recommended that this modification be accomplished at the next one-hundred (100) hour inspection, when the floorboards are removed, to insure that airframe members are not damaged during the drilling process.
