Service Letter No. 508

Subject: Propeller Counterweight Attachment Bolt Clearance

Models Affected: PA-31, PA-31-300 Navajos

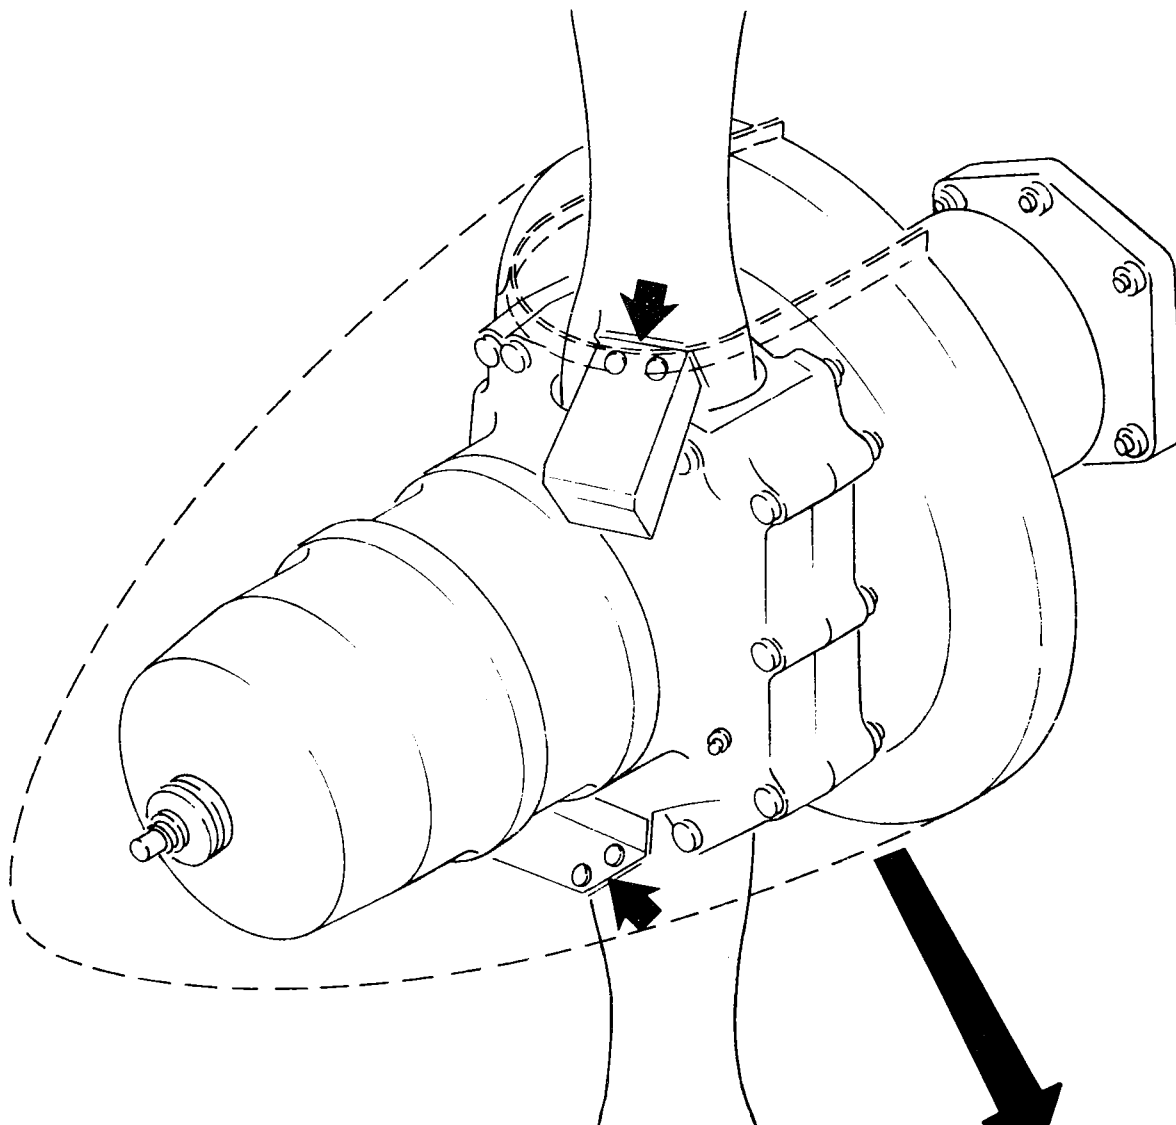
Purpose: An inspection of the propeller counterweight attachment bolt and propeller spinner assembly will be necessary to assure that adequate clearance exists between the bolt and the spinner in all propeller blade pitch positions.

The maximum allowable depth of scoring by the propeller counterweight attachment bolt in the propeller spinner shall not exceed .010 inch. If this dimension is exceeded, the spinner must be replaced. Propeller spinner scoring of .010 inch or less must be dressed out to relieve any stress concentration areas.

Instructions: If evidence of bolt scoring in the spinner is detected, the bolt head must be reworked per the Hartzell approved rework procedure as illustrated on the sketch on the reverse side of this letter.

Remove this amount of material from bolt head if necessary.
Paint surface with metal primer or equivalent protective paint.
