SERVICE LETTER

No. 523

Subject: Modification to the Fuselage Bulkhead

Models Affected: PA-31 and PA-31-300 Navajo

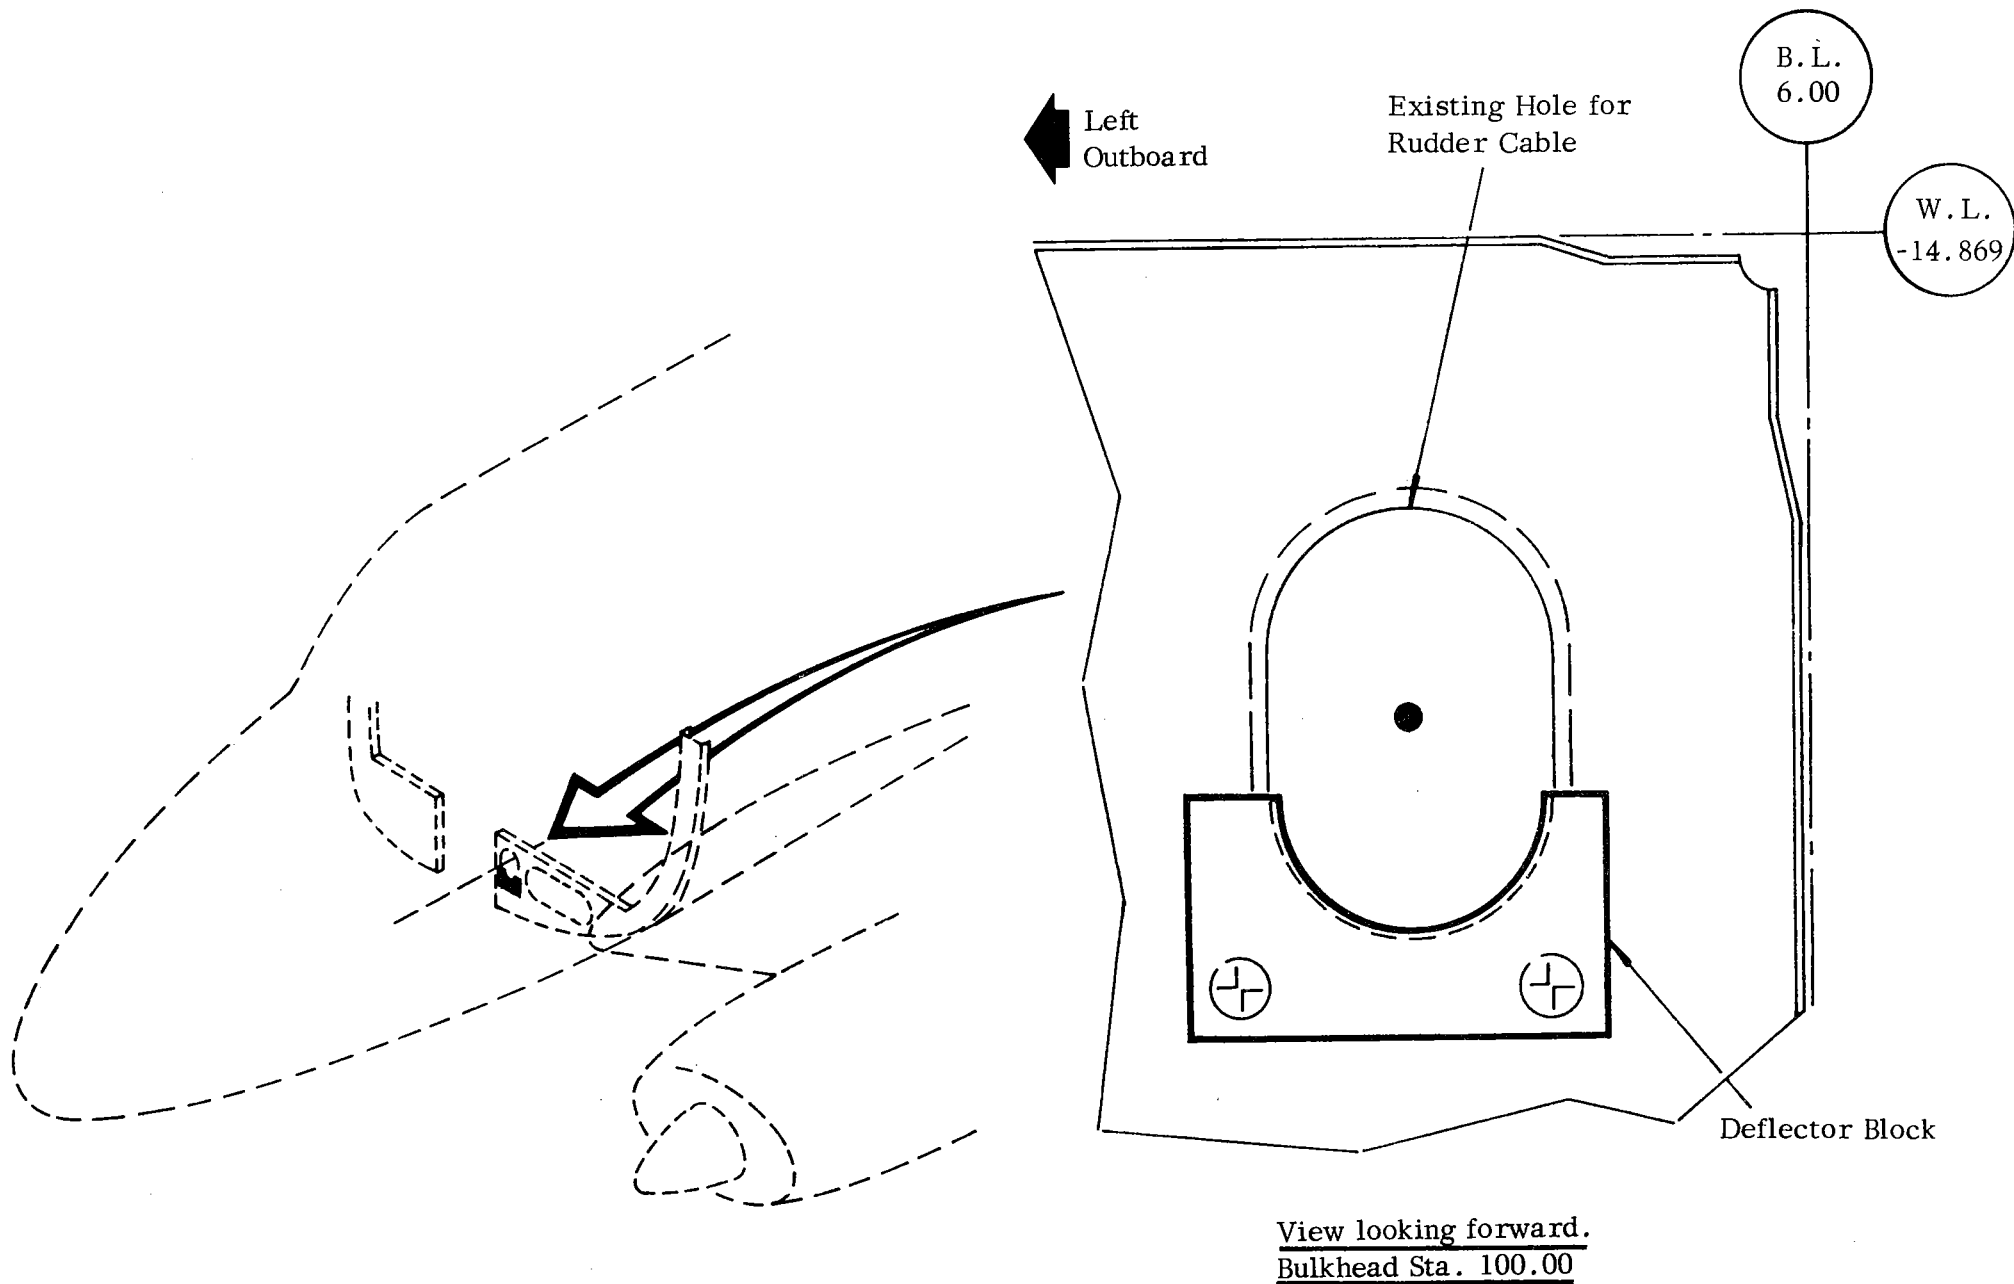
Installation of the phenolic guard block device contained in Kit No. 760 295 will preclude the possibility of the rudder cable chafing the bulkhead cutout at fuselage bulkhead station 100. (See sketch on reverse side of this letter for more descriptive information.)

Purpose: To provide materials and instructions necessary to install a phenolic guard block at fuselage bulkhead station 100.

Instructions: Contained in Kit No. 760 295; Fuselage Bulkhead Modification
