# SERVICE LETTER

**No. 578A**

Fuel Line Inspection and Support Clamp Installation (Reference attached Lycoming Service Bulletin No. 335A, dated April 14, 1972).

Service Bulletin No. 335A  
(Supersedes Service Bulletin No. 335)  
Engineering Aspects are  
FAA (DEER) Approved

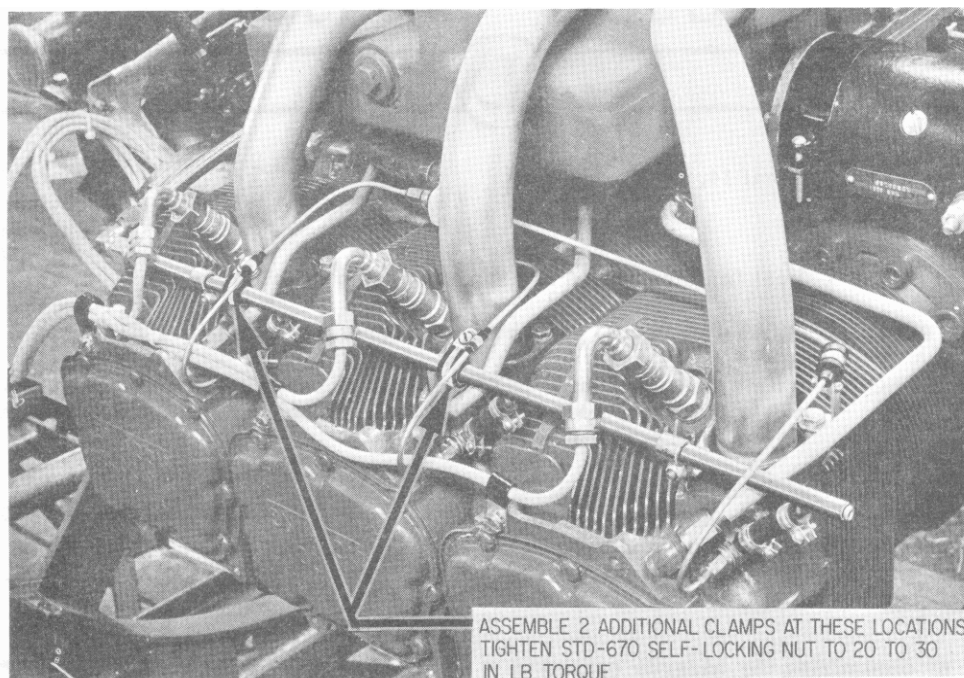
Left, Underside View of Engine Showing Location of Fuel Line Clamps

3. Examine the location of the clamps that secure the lines to the engine and compare them with the illustrations shown here. If any clamp **is not** located exactly as shown, correct it before proceeding to the next step. Also, examine the line at the clamp location for chafing. Replace any line that is chafed at the clamp location.
