SERVICE LETTER

No. 631A

Alternator Switch and Circuit Breaker Panel Wiring Inspection

PA-31 and PA-31-300 Navajo

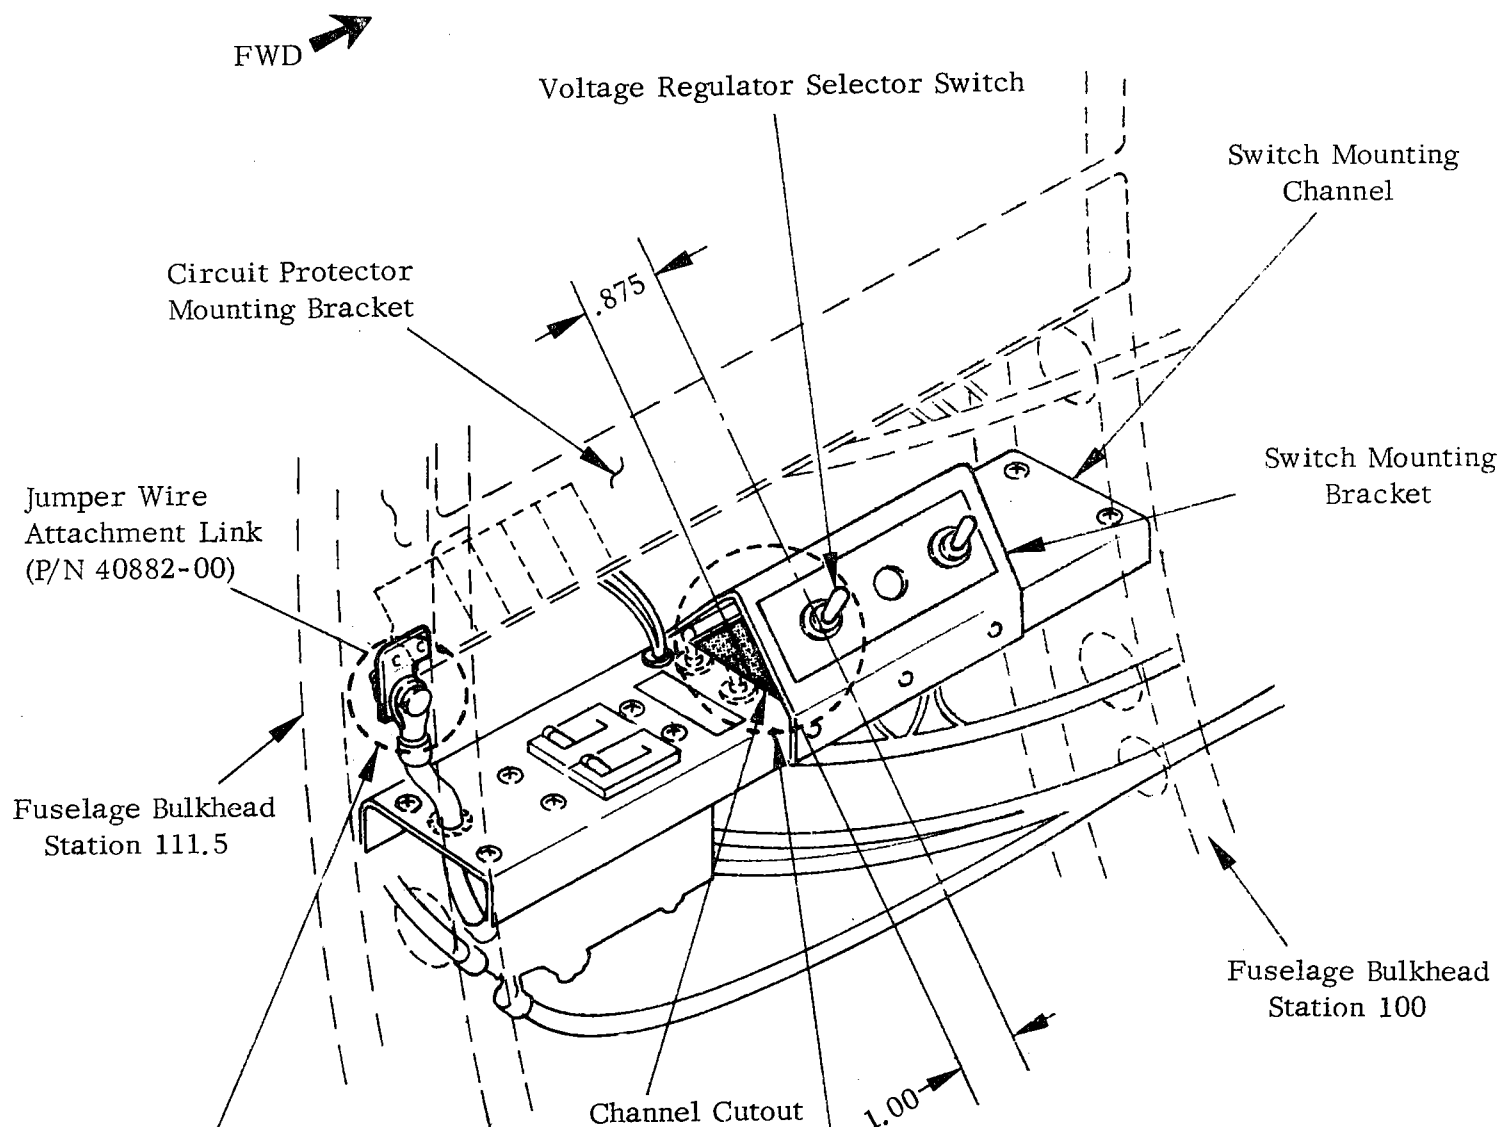
Service Letter 631A

Inspect to make certain that the jumper wire attachment link is installed. Inspect jumper wire attachment hardware to assure that only AN4-4A Bolt and MS20365-428C Nut are used to attach the jumper wire to the link. The torque of hardware must be of sufficient tension to provide a tight electrical connection.

Inspect to make certain there is a distance of 1 inch between the edge of the switch mounting bracket and the center of the voltage regulator selector switch. If the 1 inch distance has not been maintained, enlarge the channel cutout to obtain a distance of .875 between the center of the voltage regulator selector switch and the edge of the channel cutout.
