SERVICE LETTER

No. 635

SUBJECT: Addition of Alternator Bracket Support

MODELS AFFECTED: All Avco Lycoming TIO-540-A2C series aircraft engines equipped with freon compressors.

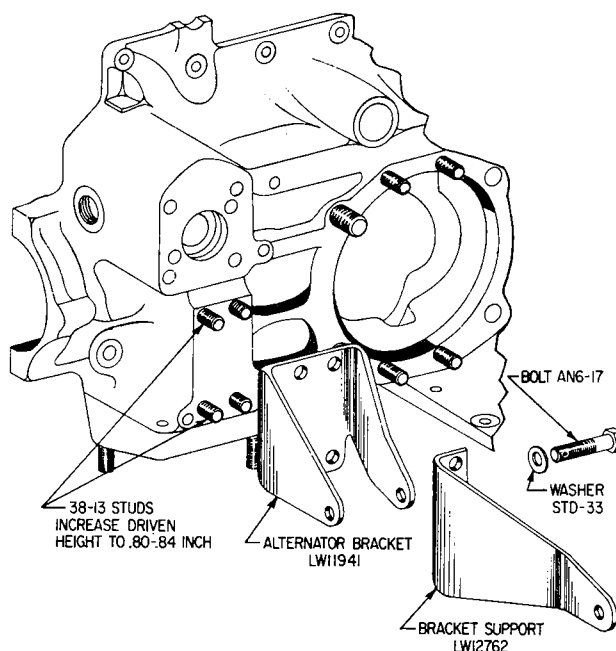
Installation of Alternator Bracket Support

To strengthen the alternator bracket (LW11941) it is recommended that the bracket support (LW12762) be installed as soon as possible. The following changes are necessary when installing the bracket support. The driven height of the two studs, indicated on the accompanying illustration, must be increased from the present height of .74 - .78 inch to .80 - .84 inch. Two nuts may be jammed on the 3/8 studs to turn them outward; turn slightly beyond the specified height and check the torque required to drive them to the correct height. The required torque should not be less than 160 inch pounds; if it is, an oversize stud should be installed.

The bolt indicated on the accompanying illustration must be changed from the present AN6-16 to an AN6-17 bolt and a flat washer (STD-33) installed under the bolt head at assembly.

1. Refer to Avco Lycoming Service Bulletin No. 356 (on reverse side).
2. Prior to installing the alternator bracket support, Avco Lycoming Part No. LW12762, inspect the alternator bracket, Avco Lycoming Part No. LW11941, shown on Avco Lycoming Service Bulletin No. 356 sketch; if evidence of cracks is noted, replace alternator bracket.

Kit LW13017 containing material for this modification is available free of charge through your Avco Lycoming Distributor. At the time the bracket support is installed the alternator belt should be replaced as described in Service Instruction No. 1254.
