SERVICE LETTER

No. 665A

Piper Aircraft Corporation

Rotator Type Intake Valves -- reference Lycoming Service Instruction No. 1280A dated September 28, 1973, reproduced on reverse side.

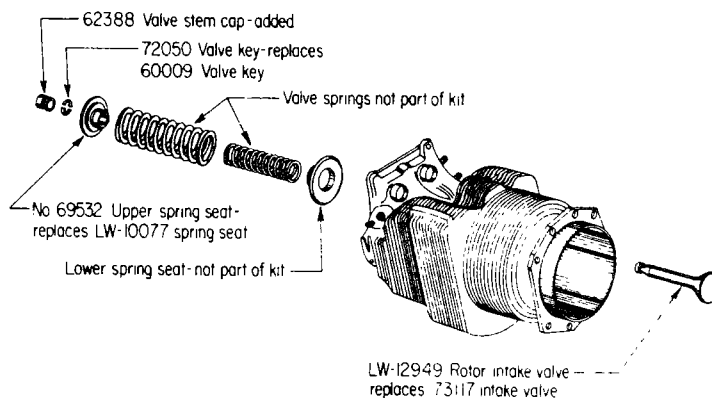
Rotator Intake Valve Components

In order to improve valve seating and minimize compression loss at the intake valve seat, a new intake valve, incorporating a rotator cap is available for installation in applicable aircraft engines now in service. This rotator valve, LW-12949 and its associated parts replace the conventional intake valve, 73117 that has been used in these engines.

Kit No. LW-13292, Rotator Valve Replacement for one cylinder consists of:
