SERVICE LETTER

No. 697

Piper Aircraft Corporation

Addition of Fuselage Drain Holes

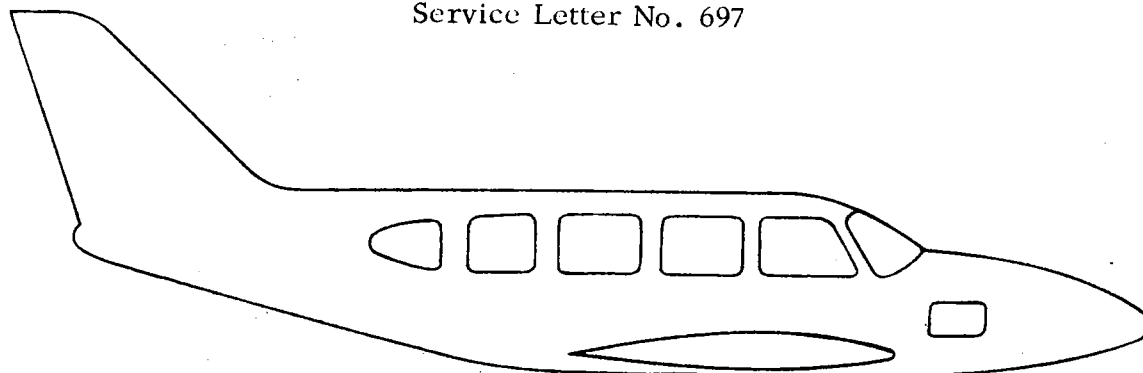
Fuselage Bottom View A-A

A report has been received from the field describing the presence of accumulated moisture in the lower forward fuselage area on one of the above referenced aircraft. This condition was noted after the aircraft had been flying through extremely heavy precipitation, and the moisture is believed to have entered through the ventilation air inlet. Although subsequent investigation revealed that moisture does not normally accumulate in this section, as a preventative measure it is recommended that drain holes be added in this area.

Locate and Drill Four
.191 Drain Holes in
Bottom Skin (See Notes)

1. Drill no deeper than necessary to achieve skin penetration.
2. Remove metal drillings
