SERVICE LETTER

No. 707

Modified Flyball Assembly to Improve RPM Control
-- reference attached Hartzell Service Letter No. 75,
dated November 16, 1973.

SERVICE LETTER NO. 75

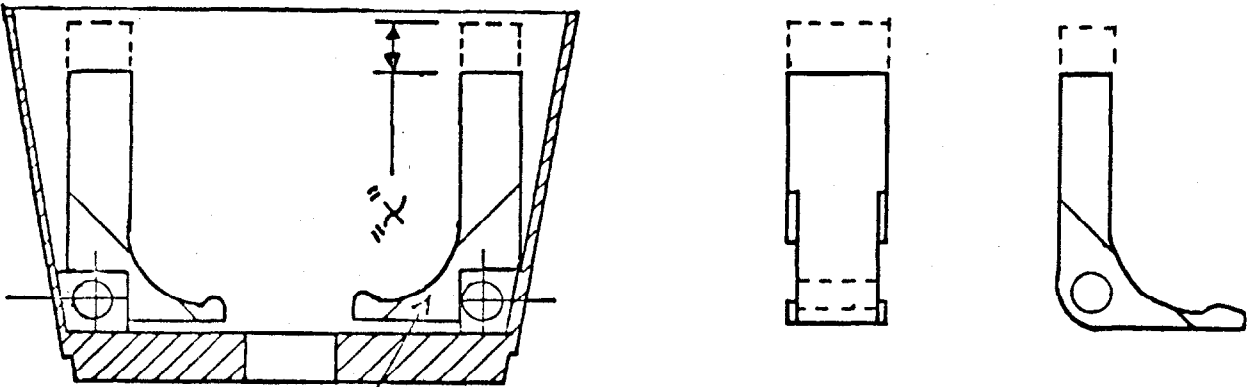
Discussion: To effect an improved RPM control on aircraft with the Hartzell governors, a modified flyweight assembly designed to absorb the torsional motions of the drive gear are being installed in all Hartzell production governors.

A-153(A)-(C) FLYWEIGHT (SEE CHART)
(MATERIAL GROUND FROM
SIDES ON "A" MODIFICATION)

- 1) Determine flyweight assembly needed using parts listed in this letter.
- 2) The flyweight assembly can be changed by:
 - a) removing cover assembly
 - b) removing flyweight assembly locking ring
 - c) removing flyweight assembly
 - d) placing new flyweight assembly in place
 - e) replacing lock ring, making sure it is in place
 - f) replacing cover gasket 50672, and
 - g) installing cover assembly
