# SERVICE LETTER

No. 755C

Piper Aircraft Corporation

Landing Gear Lock Actuator Rod  
and Rod End Bearing Inspection/  
Replacement.

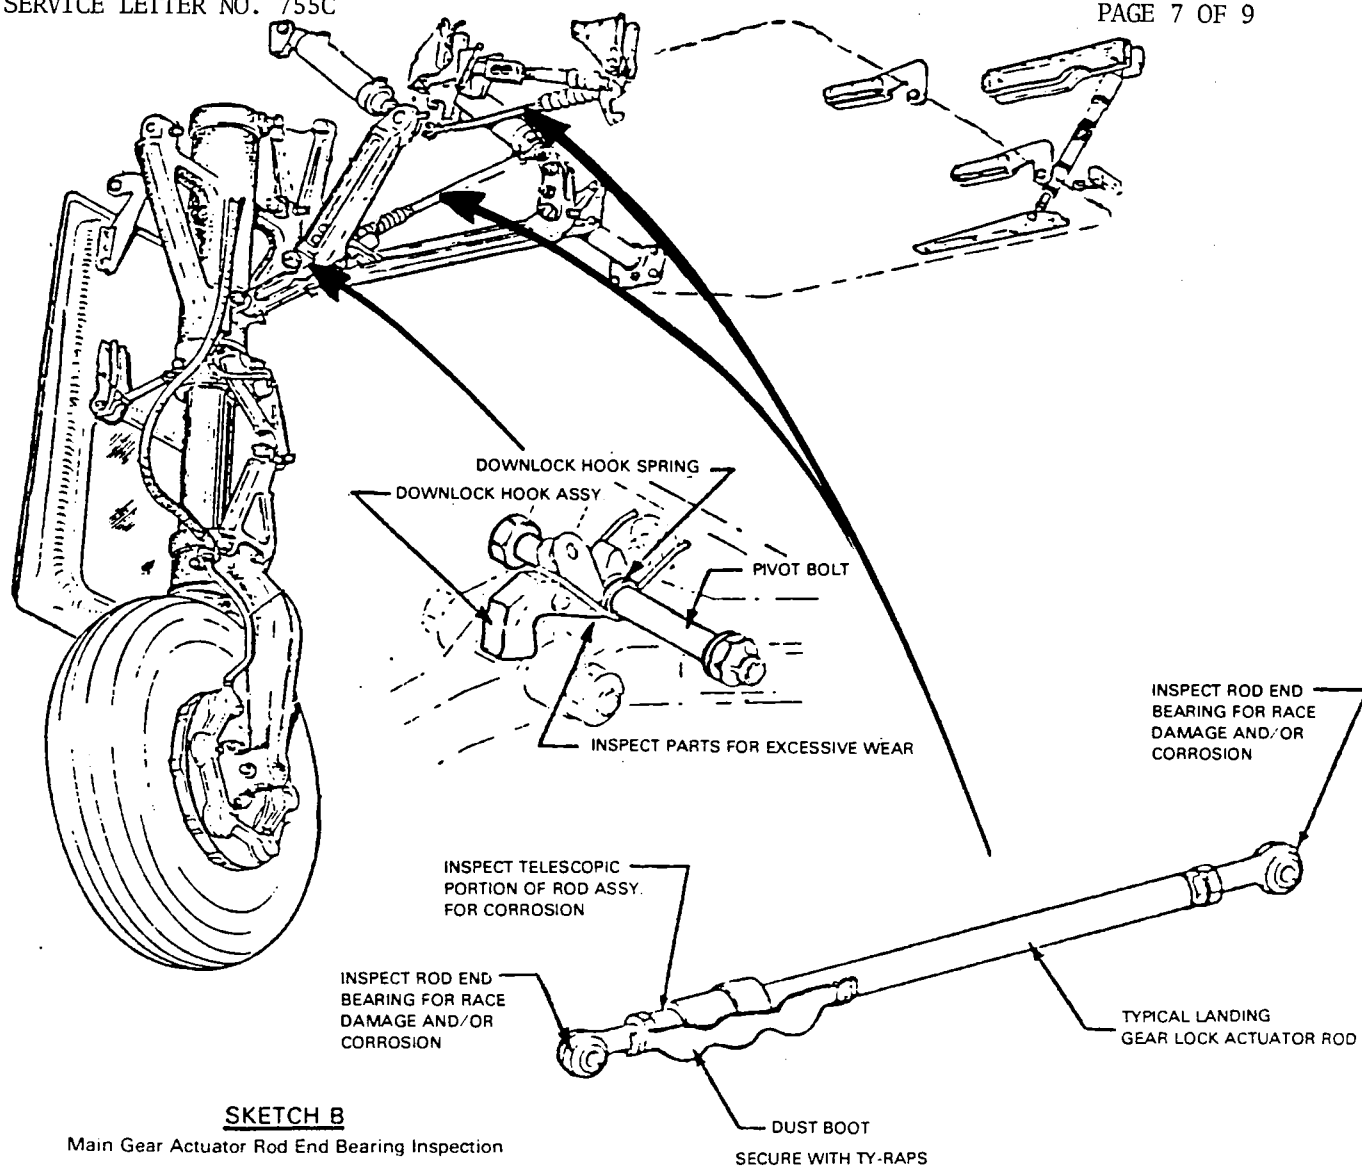
**SKETCH B**

Main Gear Actuator Rod End Bearing Inspection

3. Inspect the telescopic portion of each landing gear lock actuator rod assembly for evidence of corrosion.
  - a. If corrosion is evident, the landing gear lock actuator rod assembly should be replaced.

5. Inspect each rod end bearing for evidence of race damage and/or corrosion.
  - a. If corrosion is evident and/or ball and race of bearing shows evidence of damage (ball must rotate freely in race), it will be necessary to replace that bearing.

7. Remove the main gear downlock hook assembly. Thoroughly clean the downlock hook assembly, downlock hook spring and pivot bolt and inspect each part for evidence of excessive wear. If any part or parts show excessive wear, those parts should be replaced.

1. Locate and remove the main gear lock actuator rod assemblies from aircraft as shown. Accomplish on left and right main gear assemblies.
2. Loosen the clamp attaching the dust boot to the landing gear lock actuator rod assembly. Slide the dust boot back to expose the telescopic portion of the actuator rod assembly.

- b. If no corrosion exists, lubricate the telescopic portion with MIL-G-81322, 81827 or MIL-G-21164C lubricant.
4. Reposition and secure the dust boot on each landing gear lock actuating rod assembly.

- b. If existing bearings show no evidence of corrosion or damage, lubricate bearings with MIL-L-7870 lubricant.
6. If a new main gear lock actuator rod assembly (assemblies) is being installed, lubricate the telescopic portion as described in 3b above, and the rod end bearings with MIL-L-7870 lubricant. Install existing dust boot on actuator rod assembly as shown.

8. Reinstall the downlock hook assembly, spring and pivot bolt on aircraft. Lubricate pivot bolt and hook with MIL-G-81322, 81827 or MIL-G-21164C Lubricant.

9. Reinstall the main gear lock actuator rod assemblies on aircraft. Check system function and rigging; adjust as necessary using the appropriate Navajo Service Manual. Refer to Sketch "C" for the correct method of adjusting rod end bearings.
