# SERVICE LETTER

No. 766

Piper Aircraft Corporation

Inspection of Cleveland Brake Discs; reference attached Cleveland Engineering Service Letter 7006 dated October 1, 1976.

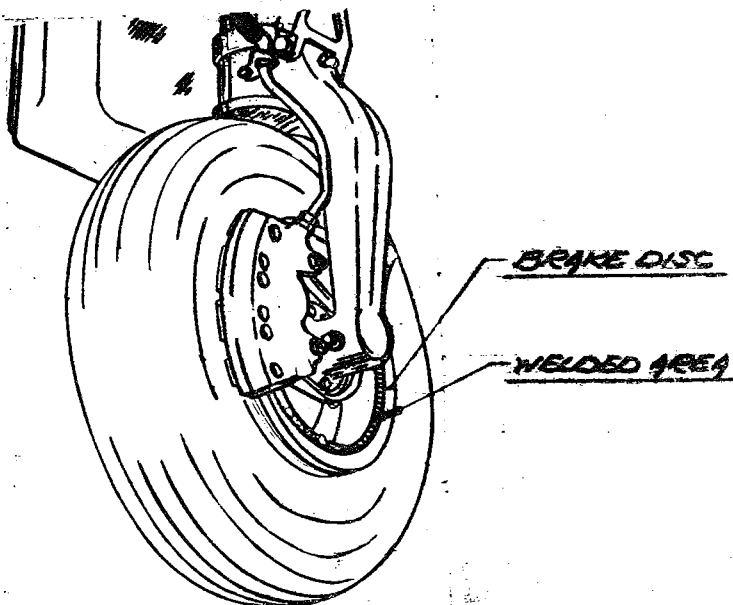
SKETCH #1

Purpose: It has been determined that the brake discs installed on the above referenced aircraft may be prone to circumferential cracking in the welded area of the disc radius. Continued use of flawed discs may lead to progressive cracking and eventual separation of the discs (see attached Cleveland E.S.L. 7006 for an illustrated view of this area).

Visually inspect the welded area (see sketch #1) for evidence of circumferential cracks. This type of crack will split the paint, and is readily visible to the naked eye. If cracks are found, replace with a new brake disc of the corresponding part number.

1. Expose brake discs to view in accordance with airframe service manual Landing Gear and Brake System section, Removal and Disassembly of Main Wheel sub-section.
2. Inspect discs per attached Cleveland E.S.L. 7006 Instructions.
3. If evidence of above described cracks is found, replace affected disc(s).
4. If no cracks are found, disc replacement is not required.
5. Prepare aircraft for return to service and make appropriate log book entry.

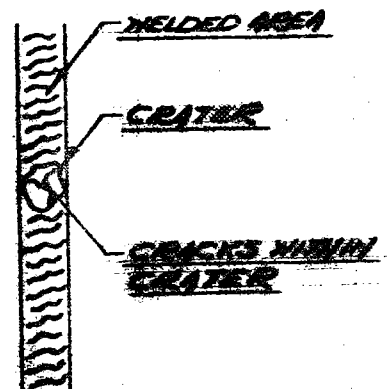
SKETCH #2

A slight impression or crater may be found in the weld bead (see sketch #2). This crater is caused by electrode removal at the end of the welding cycle. Small cracks contained within this crater are not detrimental and does not necessitate brake disc replacement.
