SERVICE LETTER

No. 789

Piper Aircraft Corporation

Inspection of Elevator Bellcrank and Elevator Control Rod

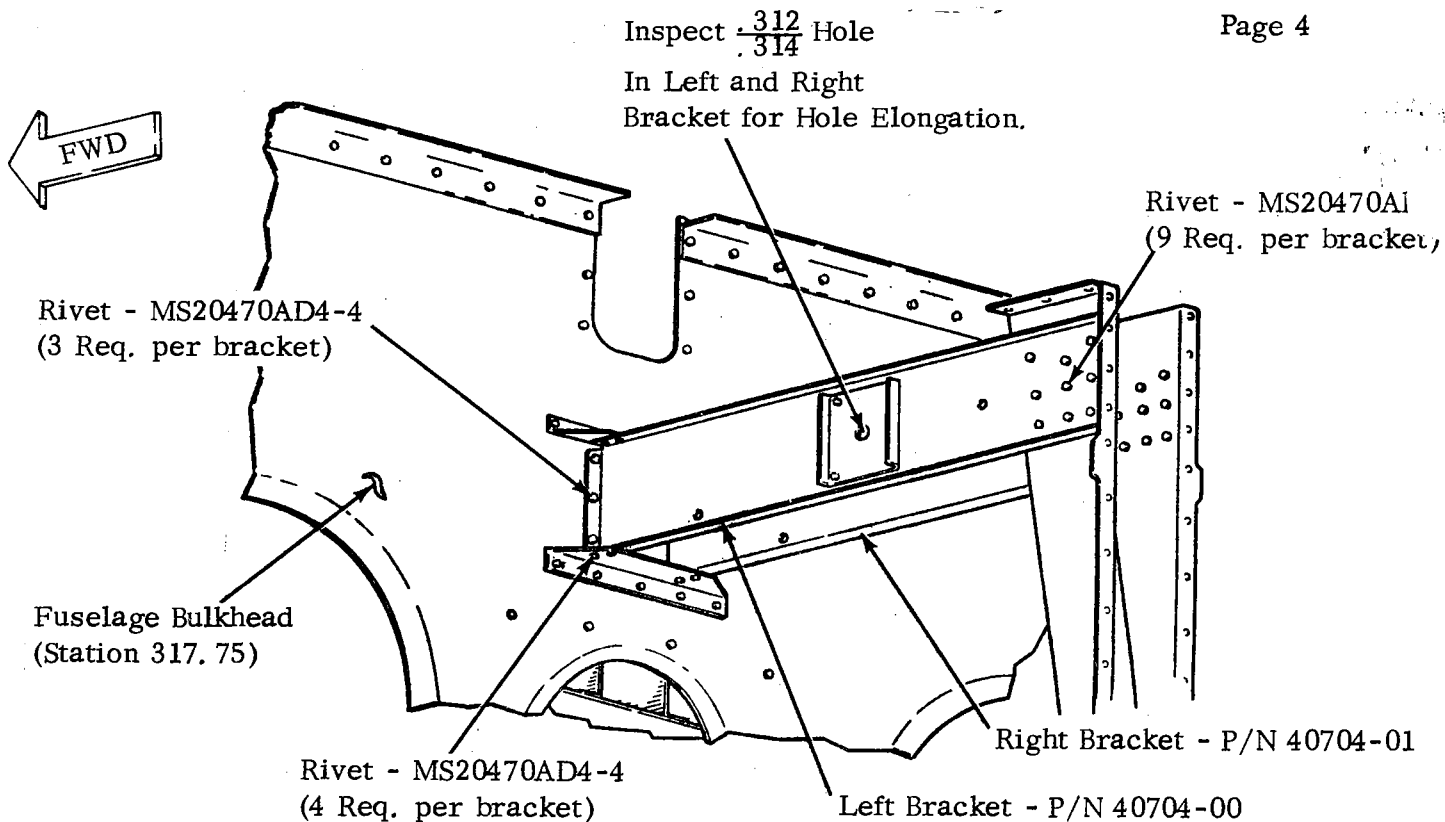
DETAIL "A"

5. Remove the bellcrank from the mounting brackets.
6. Inspect the .312/.314 hole in the bellcrank mounting brackets for possible hole elongation. Refer to Detail "A" on sketch.

7. If holes are elongated in either of the bellcrank mounting brackets, it will be necessary to remove existing bracket(s) and install new bracket P/N 40704-00 (left) and/or P/N 40704-01 (right) as required. Refer to Detail "A" on sketch and proceed as follows:

- a. Remove bracket(s) by drilling out attachment rivets. Do not enlarge rivet holes.
 - b. Position new bracket(s), align rivet holes and secure with temporary fasteners. Check the alignment of the bellcrank mounting holes.

- c. Back drill holes in new bracket(s) to .129 and install new rivets per Detail "A". Clean area of all drill chips.
8. Check rotation of center bearings in the elevator bellcrank using the following procedure:

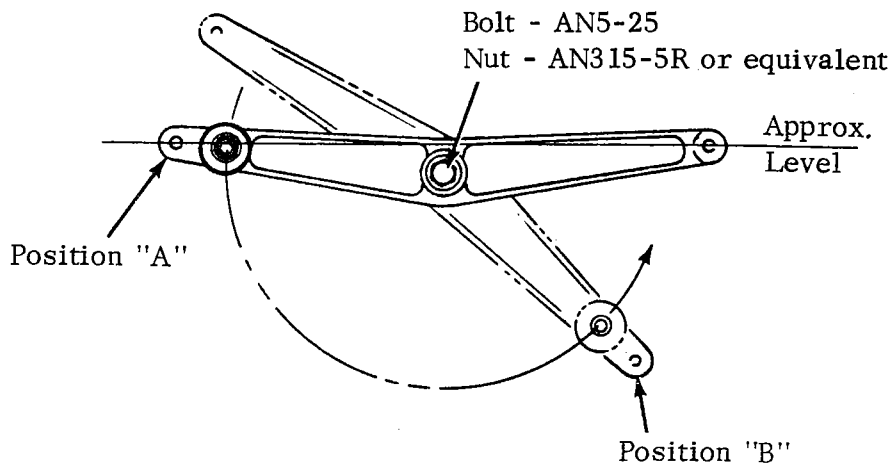
DETAIL "C"

1. Bearings must rotate freely 360°.
 2. Assembly must rotate freely, approximately 180°, from position "A" to position "B" while suspended and supported by the bolt head and nut. Refer to Detail "C" on sketch.
