SERVICE LETTER

No. 803A

Piper Aircraft Corporation

Subject: Cabin Door Latch System Refinement

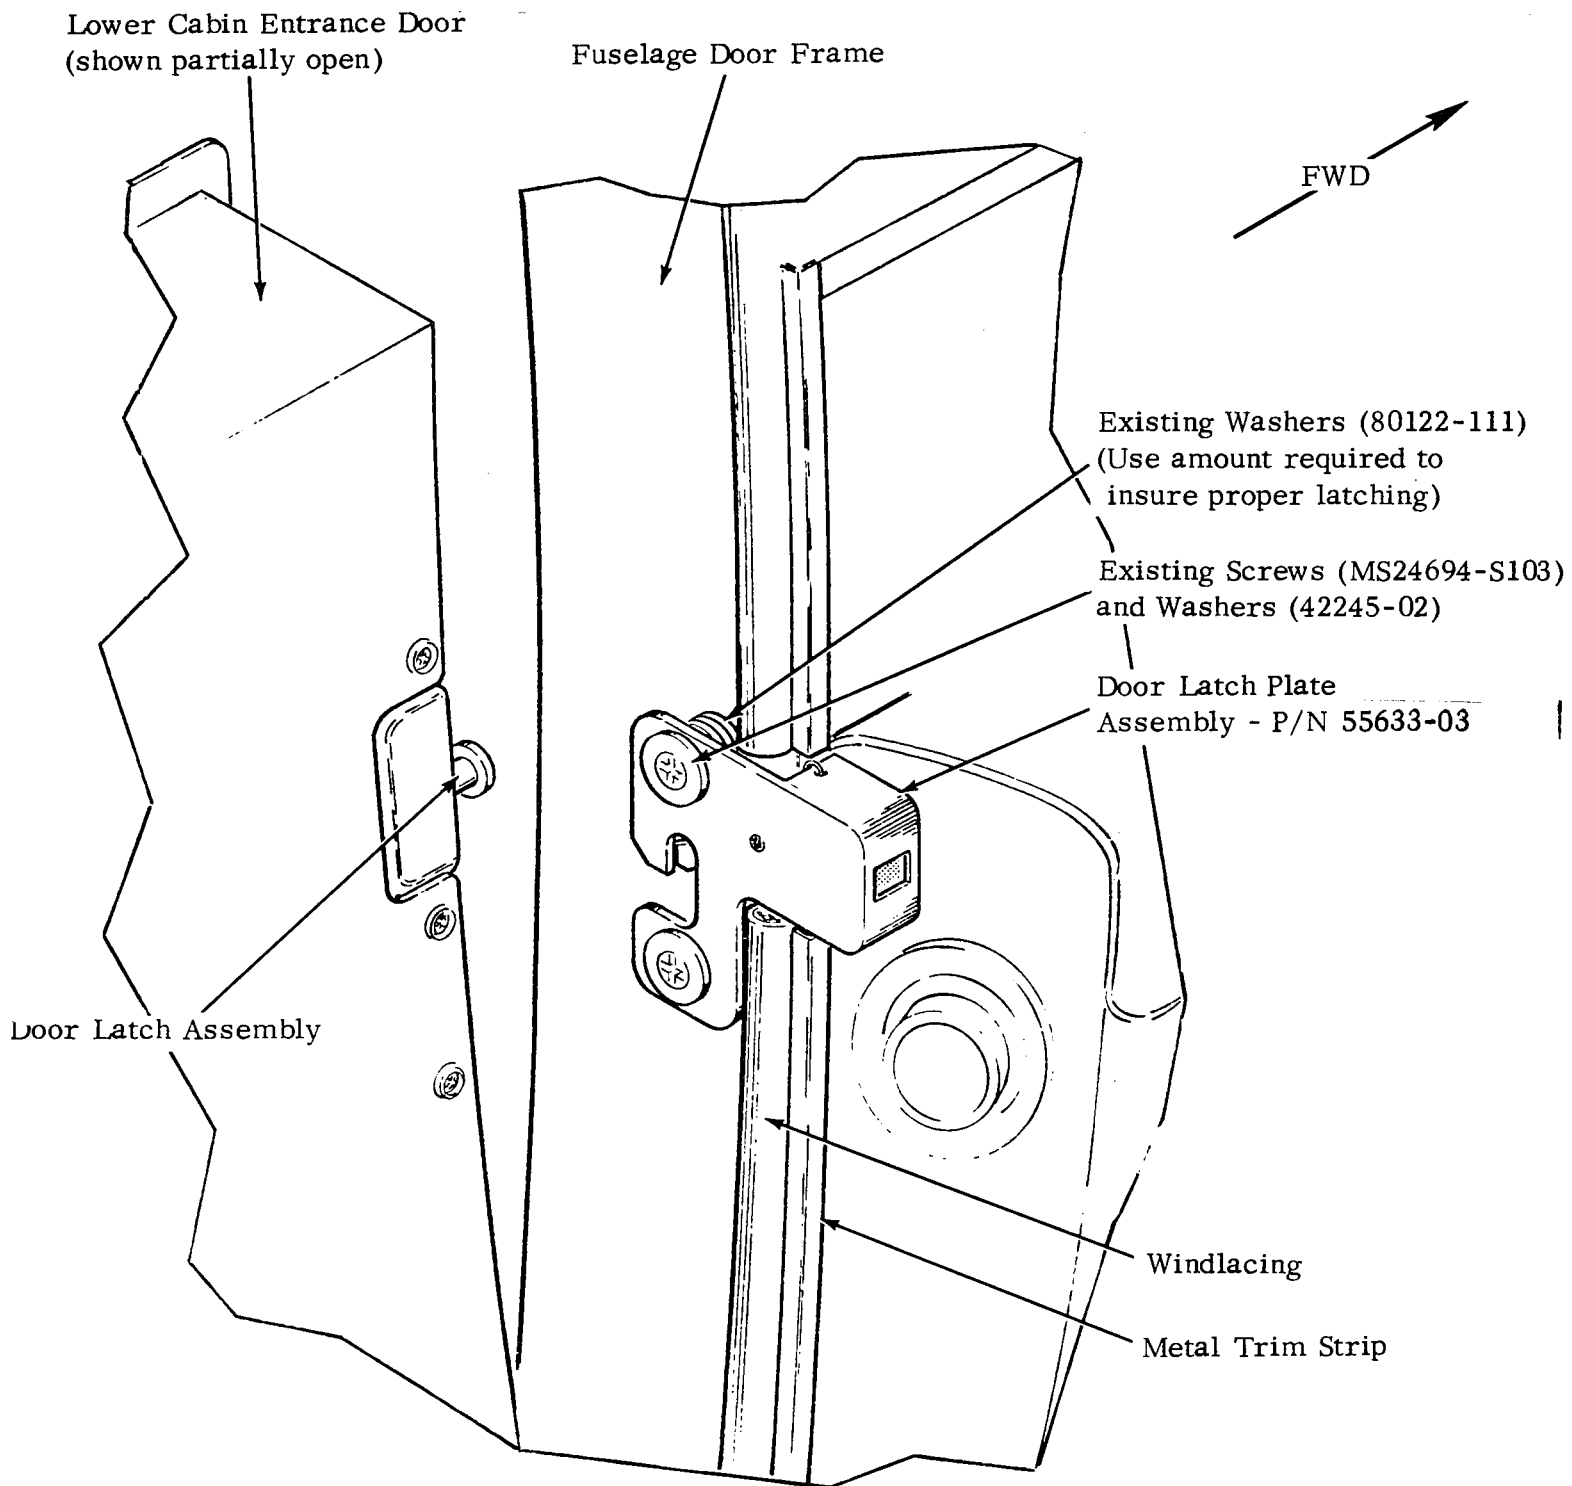
It has been found that the adhesive substance (attaches the "SAFE" flag to its mating surface) may deteriorate, allowing the placard to detach. This service release announces availability of new redesigned Door Latch Plate Assembly containing a riveted "SAFE" indicator flag (placard).

INSTRUCTIONS

1. Remove existing forward door latch plate from fuselage door frame.
2. Install new door latch plate assembly P/N 55633-03 using existing screws and washers. Cut windlacing and metal trim strip, as required, to allow the plate assembly to be properly installed as shown.
3. Close lower door and check to insure that the door latch assembly is completely engaged in the notch of the door latch plate assembly. Adjust as required.
4. Make proper Logbook entry of Service Letter compliance.
