SERVICE LETTER

No. 878A

Piper Aircraft Corporation

Subject: Oil Breather Tube Inspection/Alignment

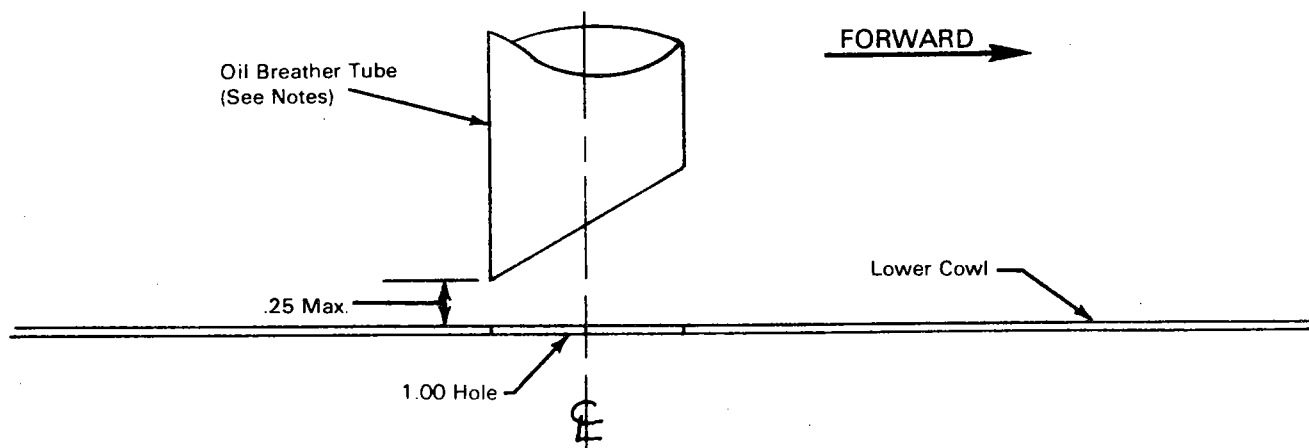
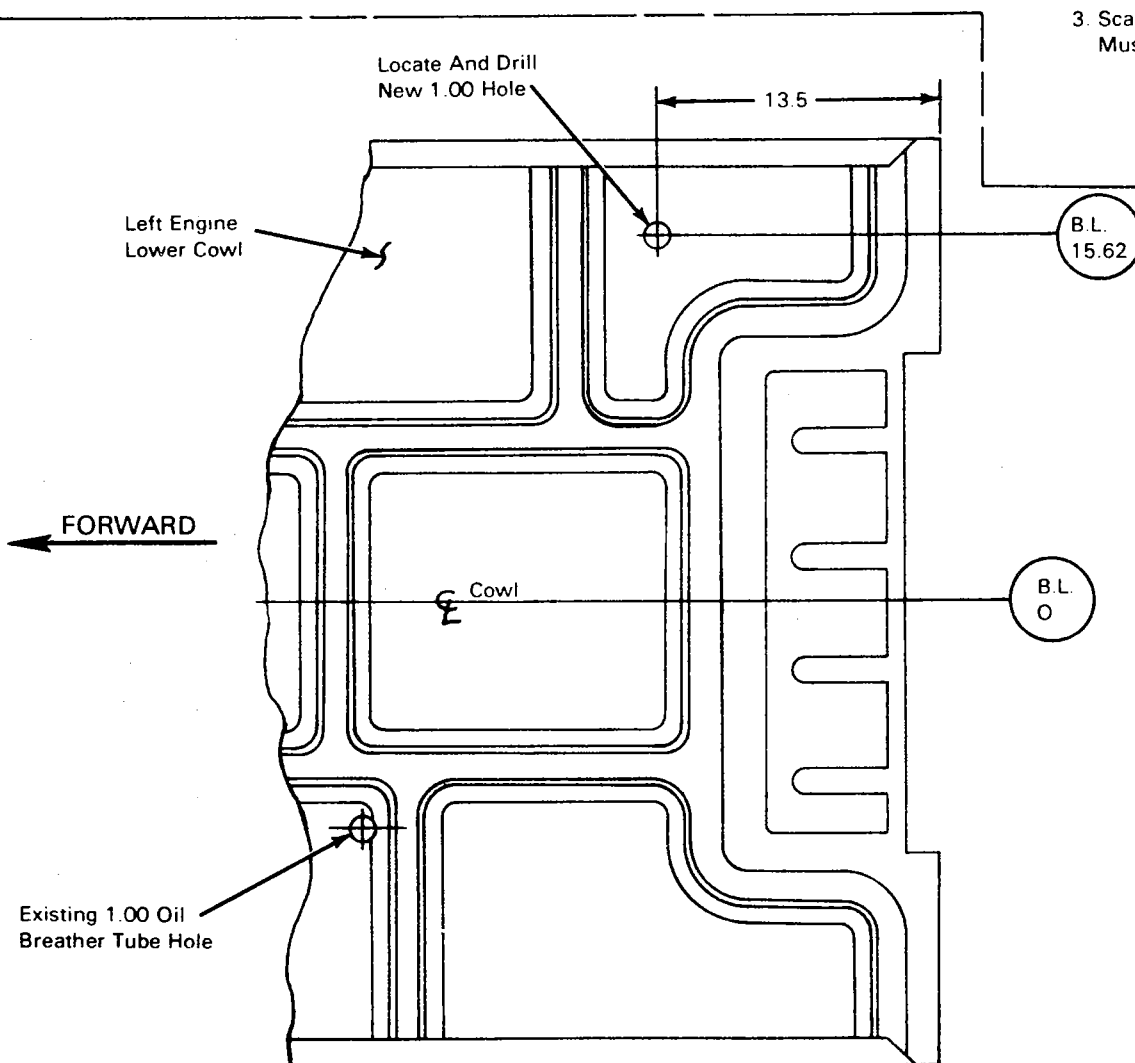
SKETCH "A"

Misalignment of an oil breather tube with the hole in the bottom of the cowl could cause oil to vent inside the cowling.

1. Centerline Of Breather Tube Must Align With Centerline Of 1.00 Hole In Lower Cowl.
2. Breather Tube Must Not Extend Thru 1.00 Hole In Lower Cowl. Maximum Distance Between End Of Tube And Cowl Surface is .25.
3. Scarf On End Of Breather Tube Must Face Forward.

1. Gain access to the oil breather tubes.
2. Inspect the tubes for proper alignment, and realign if necessary. Refer to the "Oil Breather Tube Alignment Detail" on attached SKETCH A to insure proper positioning of tubes.

1. Remove the upper and lower cowl from the left engine.
2. Locate and drill a one inch hole thru the lower cowl as shown on Sketch "A". NOTE: It is permissible to leave the existing one inch oil breather hole in the lower cowl open. If desired, a patch plate (Piper part no. 481 096) may be installed to plug this existing hole.

5. Reinstall the lower cowl. Inspect the new oil breather tube for proper alignment with the new one inch hole in the lower cowl. Refer to Sketch "A" to insure proper positioning of oil breather tube.

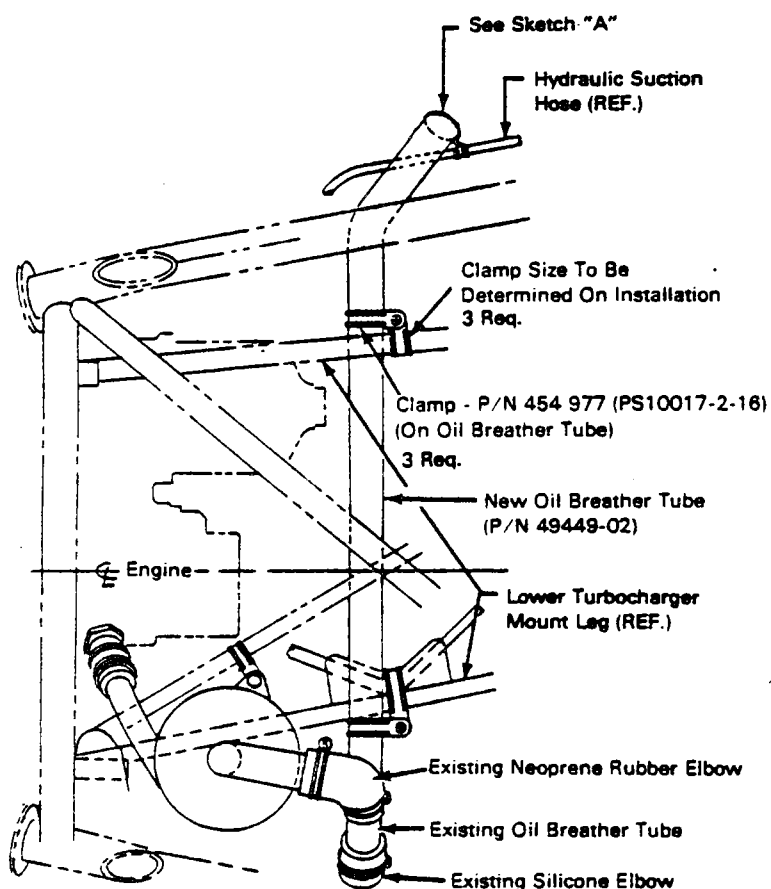
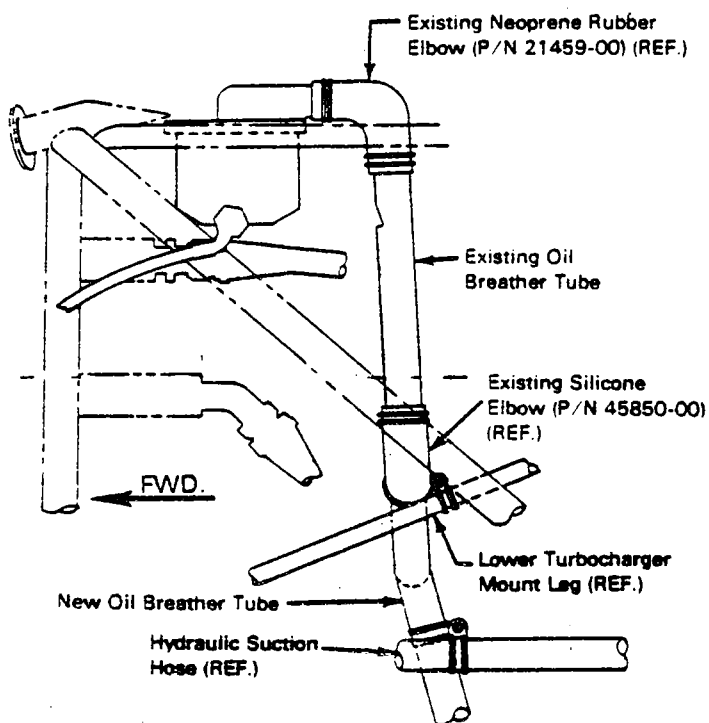
PA-31-325 AND PA-31-350 ONLY

Ingestion of oil vapor by the pneumatic air pump on the left engine can reduce the service life of the pump.

3. On PA-31-325 and PA-31-350 aircraft, remove the existing oil breather tube and install new oil breather tube (P/N 49449-02) as shown on Sketch "B". On PA-31 aircraft, remove the two (2) existing oil breather tubes and install new oil breather tubes (P/N 71830-02 and P/N 71832-02) as shown on Sketch "B". NOTE: If existing neoprene rubber and silicone elbows, as shown on Sketch "B", are deteriorated, replace with new parts.

4. Secure new oil breather tube(s) to existing structures for support and to prevent chafing and interference. Refer to Sketch "B" for recommended clamping configuration.
