SERVICE LETTER

No. 912

Piper Aircraft Corporation

Main Landing Gear Downlock Hook Rivet
Replacement

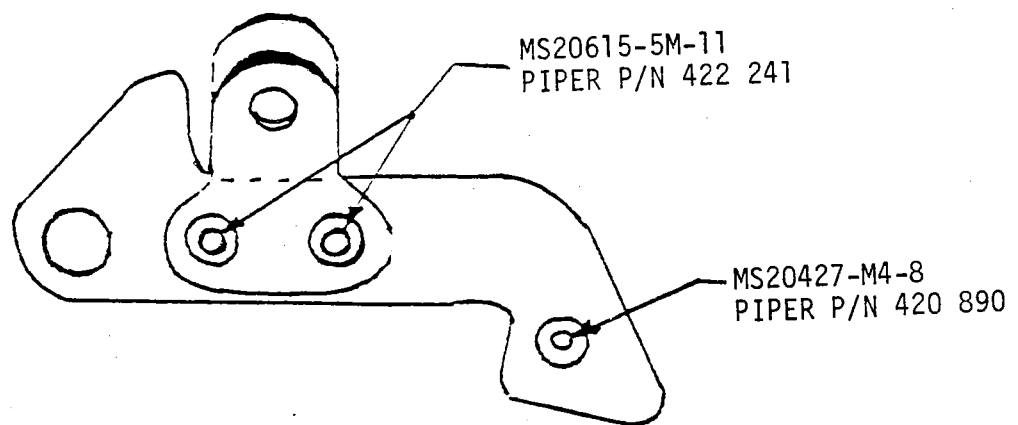
FIGURE A

Field reports show that in aircraft which have aluminum rivets attaching the steel landing gear downlock hook bracket to the downlock hook, dissimilar metals could cause corrosion to develop.

1. With a magnet, determine material composition of rivets shown in Figure A, attached.
 - a. If all rivets are magnetic (steel) make appropriate logbook entry of compliance; no further action required.
 - b. If any rivets are non-magnetic (aluminum) continue with following Instructions.
2. Place aircraft on jacks. Refer to Section II of Maintenance Manual for jacking instructions.
