SERVICE LETTER

No. 987

Piper Aircraft Corporation

Main Landing Gear Mount Bolt
Inspection

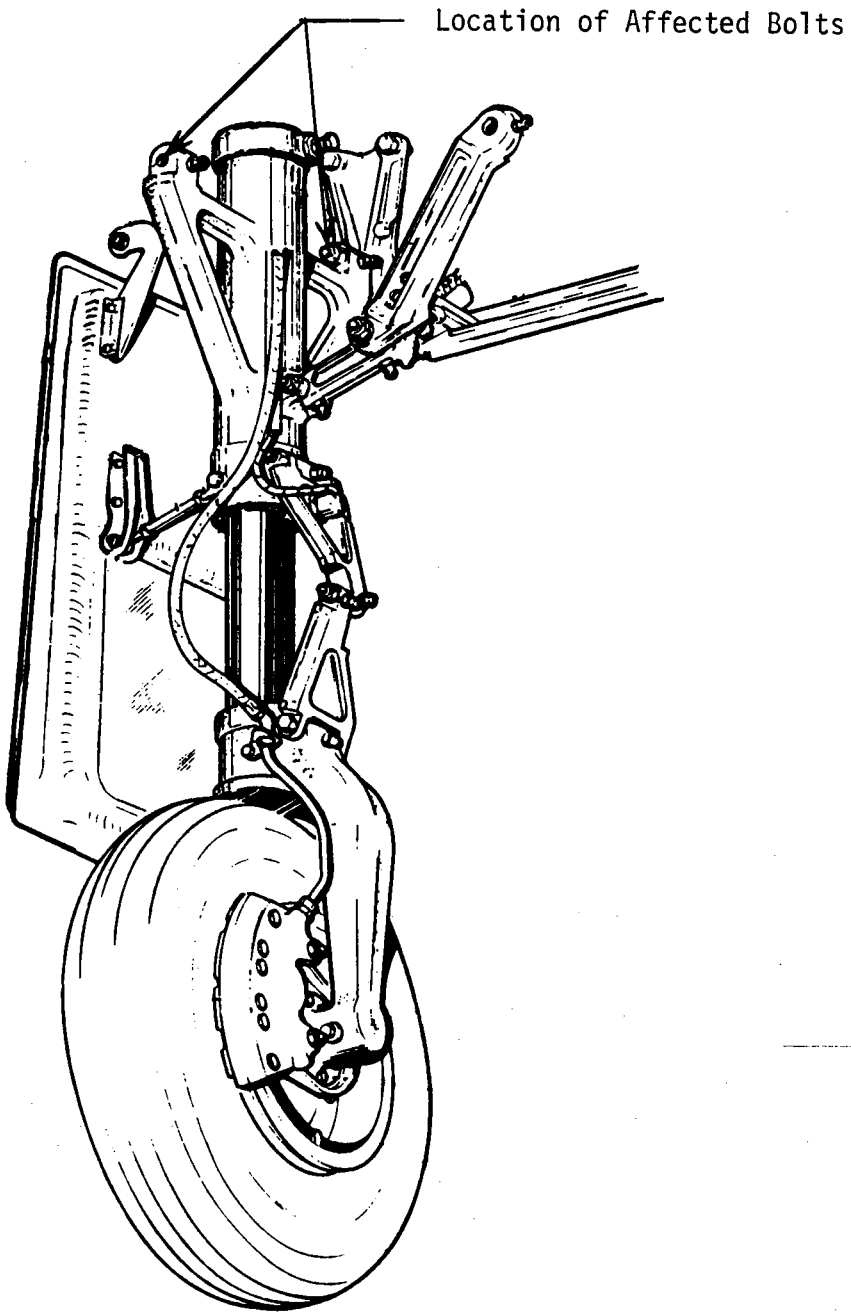
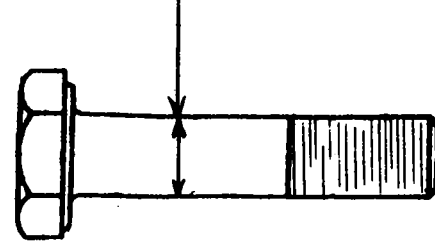
SKETCH A"

It has been determined that a group of AN-10-36 bolts, Piper Part Number 400-384 were received and distributed, which do not meet the specified minimum diameter. If an installation has been made using these bolts, accelerated wear of the main landing gear pivot point could occur, due to excess clearances at the pivot point.

Minimum Diameter .620 inches

1. Refer to the appropriate aircraft parts catalog and/or maintenance manual for location and quantity requirements for specific model application.
2. Following instructions in the appropriate maintenance manual, remove the affected bolts. See Sketch "A" attached.
3. Measure bolt shank to assure a dimension of .620" to .624", discard any bolt(s) measuring less than .620". See Sketch "A".
4. Reinstall acceptable and/or new bolts as required, perform a landing gear function check per the appropriate maintenance manual.
5. Make an appropriate logbook entry of compliance with this Service Letter.
