VENDOR SERVICE PUBLICATION

SUBJECT: Oil Pump Impeller and Drive Replacement; AVCO Lycoming Service Bulletin No. 385C dated October 3, 1975 (attached).

Service Bulletin No. 385C
(Supersedes Service Bulletin No. 385B)
Engineering Aspects are
FAA (DEER) Approved

SUBJECT: Oil Pump Impeller and Drive Replacement

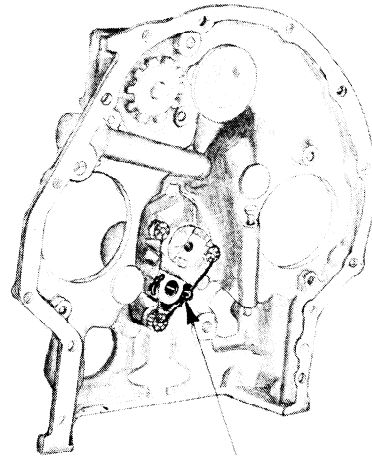
Figure 1. Interior View of Accessory Housing Showing
Location of Cotter Pin in Oil Pump Idler Shaft

INSPECTION: Applicable remanufactured engines shipped after December 21, 1972 should be inspected to determine if this modification is required: first of all, if the engine log book indicates the engine has not been modified in accordance with Service Instruction No. 1230 or No. 1272, proceed to remove the accessory drive cover from the mounting pad at the lower right side of the accessory housing to obtain access to the area between the crankcase and the accessory housing. On some engines this accessory drive pad is not machined, in this event it will be necessary to remove either the left magneto or the *fuel pump to obtain access to the area between the crankcase and the accessory housing. Regardless of which accessory pad is used, determine if the oil pump idler gear is secured with a cotter pin at the location shown in figure 1. This can be accomplished using an inspection mirror, preferably an illuminated one. If the cotter pin is visible, it is unnecessary to perform the modification required by this bulletin.

IF IDLER SHAFT IS SECURED
WITH A COTTER PIN AT THIS LOCA-
TION MODIFICATION IS NOT REQUIRED

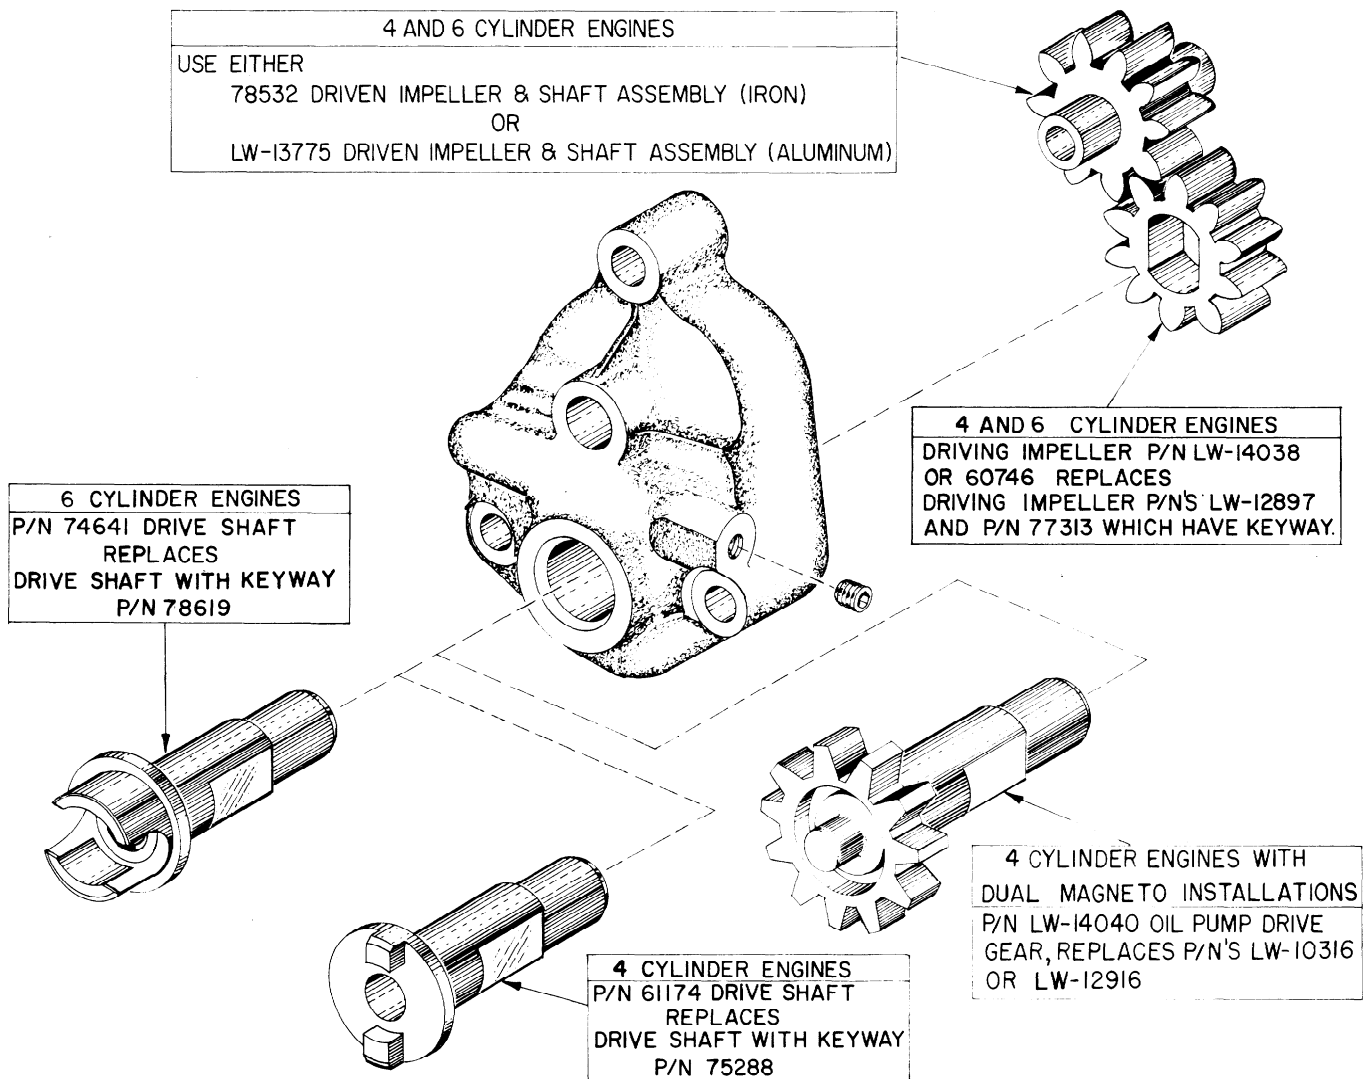
Figure 2. Oil Pump Drive Assembly

This modification consists of replacing the oil pump drive shaft and drive impeller to eliminate the Woodruff key drive which has proven to be the cause of excessive wear in the keyway of the hardened drive impeller. Therefore, it is recommended that all of the applicable engines listed in the chart, as well as any others that may have been modified in accordance with Service Instruction No. 1272, use the following procedure for parts replacement.

3. Reassemble the oil pump using the new drive shaft and drive impeller supplied with the kits shown in the following "Parts Data" section. See figure 2. Be sure all of the parts are lubricated thoroughly during assembly.
