VSP-23  
September 25, 1980

Subject: Avco Lycoming Service Bulletin No. 450  
(AiResearch Service Bulletin No. TP60-0119)

# SERVICE BULLETIN

SUBJECT: BYPASS VALVE MODIFICATION

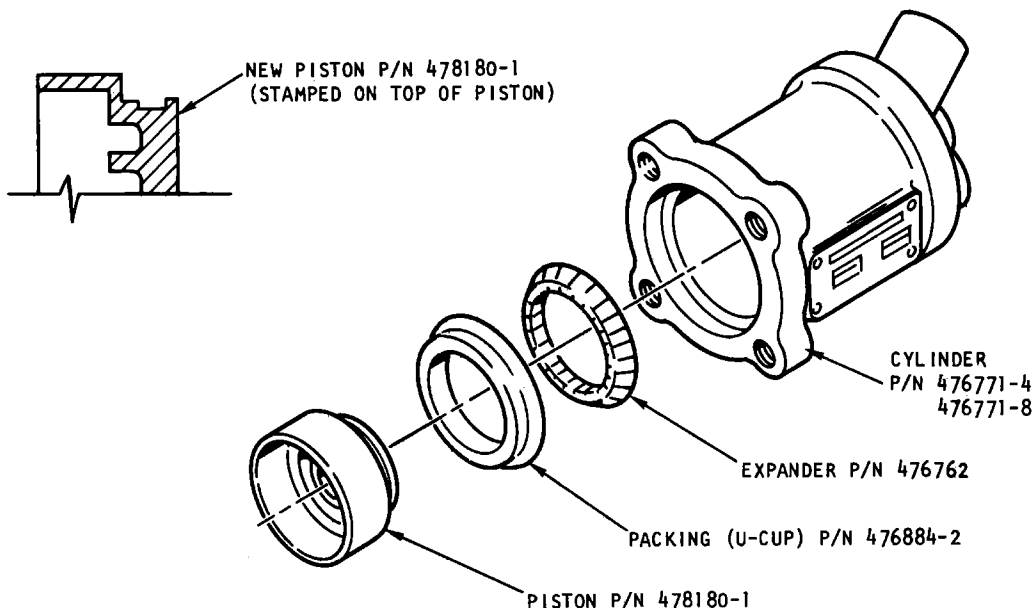
Figure 1. Affected parts in installation of Piston, Packing (U-Cup) and Expander

AiResearch has become aware of several instances in service when the subject valve has allowed, over a brief period of time, substantially all the engine oil to drain overboard. Continued operation of the engine with such leakage can result in damage to the engine and ultimate loss of power.

7. Using packing (U-Cup) insertion tool, P/N 410070, install piston, P/N 478180-1; packing (U-Cup), P/N 476884-2; and expander, P/N 476762 back into cylinder as shown in Figure 1. Insert the new piston, packing (U-Cup), and expander (as a unit) into top (widest opening) of U-Cup insertion tool. Position insertion tool into cylinder bore, and tool should be rotated while inserting piston assembly into cylinder, to center piston. Stroke piston by hand three to four times to assure packing (U-Cup) is moving freely prior to reassembling cylinder to cylinder plate.
