VSP-31
August 7, 1981

VENDOR SERVICE PUBLICATION

Subject: Bendix Service Bulletin No. 618
(Replacement or inspection of distributor gears
in D-3200 series pressurized (blue) magnetos.

Models Affected: PA-31-350 Chieftain

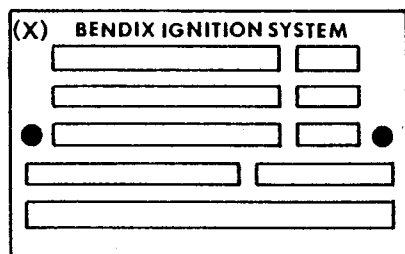
1. All subject magnetos with over 100 operating hours must have the distributor gears replaced or inspected prior to further flight, unless the magneto is identified by the letter "x" in the upper left corner of the identification plate (see figure 1). The "x" on the identification plate indicates previous compliance with this Service Bulletin.

Figure 1. Location of "x" on Identification Plate

5. Reassemble the distributor block with new serviceable gears and reassemble the magneto.
6. After installing new serviceable gears, identify the magneto by stamping the letter "x" in the upper left corner of the identification plate, before the word "Bendix" (see figure 1).

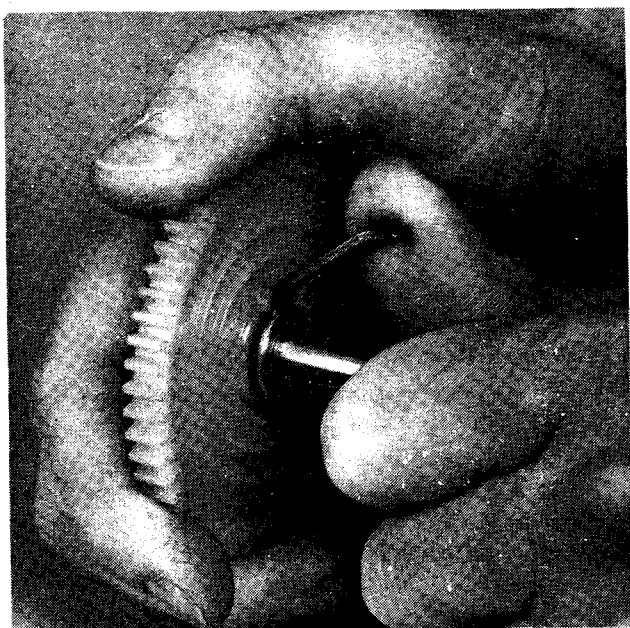
The distributor gear electrode has come loose in service on some D-3200 Series Magnetos. If this condition exists, the distributor gear electrode may contact the distributor block stationary electrodes causing contamination in the distributor in the form of dusty brass particles. This contamination may cause arcing within the distributor resulting in misfiring. This could in turn cause rough engine operation or cylinder or engine damage.

Figure 2. Checking For Loose Electrode

9. Inspect each gear for a loose electrode by grasping the gear firmly in one hand and alternately exerting clockwise and counterclockwise force against the electrode with maximum hand pressure. This should be done in a manner that would attempt to pivot the electrode around the axle (see figure 2). If any movement between the electrode and gear is detected, the gear must be discarded and replaced with a serviceable gear.
